RE: 100 W WASHINGTON

**COMMERCIAL BUILDING INSPECTION REPORT**

## PHASE 1 IMMEDIATE ACTION REPORT

Building Location: 100 W. Washington Ave., Jonesboro, AR

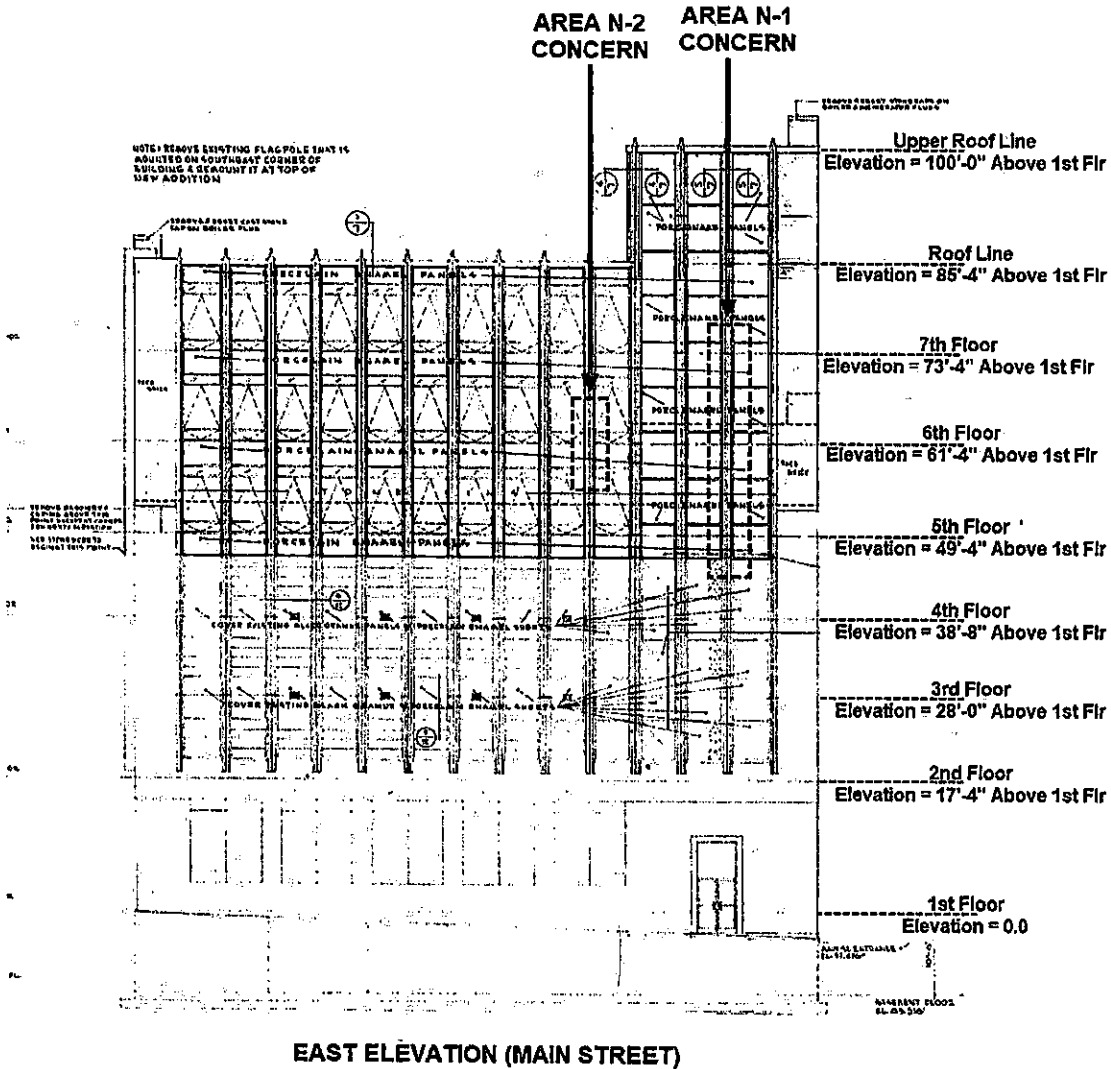
**Figure 1: Elevation Showing Wall Areas That Have Lost Substantial Lateral Support**

There are two areas where the exterior wall structure appears to have lost lateral support, and the wall structure has moved away from the building and is deflecting out to the east towards Main Street. See figure 1 and figure 2 below and photo 1 showing these areas. The wall structure area furthest north (between the stairwell and elevator structure) has moved the most and is the most concerning at this time. The area of concern for wall area N-1 is located between the 5th and 7th floor of the building between the stair structure and elevator structure. The area of concern for the wall area N-2 is more isolated and occurs above and below the 6th floor level.

Wall area N-1 is deflecting outward (towards the east) several inches and appears to be at risk of collapse. The lateral ties from the steel beams to the vertical precast elements at area N-1 have been compromised and appears to have lost support for at least a twenty foot vertical length near the 6<sup>th</sup> floor level. Area N-2 is also deflecting outward (towards the east) several inches but does not appear to be as concerning as wall area N-1 at this time.

After the scaffolding and wood protection wall is constructed, it is recommended to add lateral bracing to the vertical precast concrete elements at area N-1 and N-2. This should be done before any other work or demolition begins on the structure. The lateral bracing should be made to area N-1 near the 5th and 6th and 7th floor levels and can be extended into the building and anchored to the concrete floor slab or some other solid structure. The lateral brace can be in the form of steel angles to grab the vertical precast concrete elements and stabilize them and possibly even pull them back into the building slightly. A licensed contractor should be engaged to add the lateral bracing to areas N-1 and N-2 before any façade removal begins.

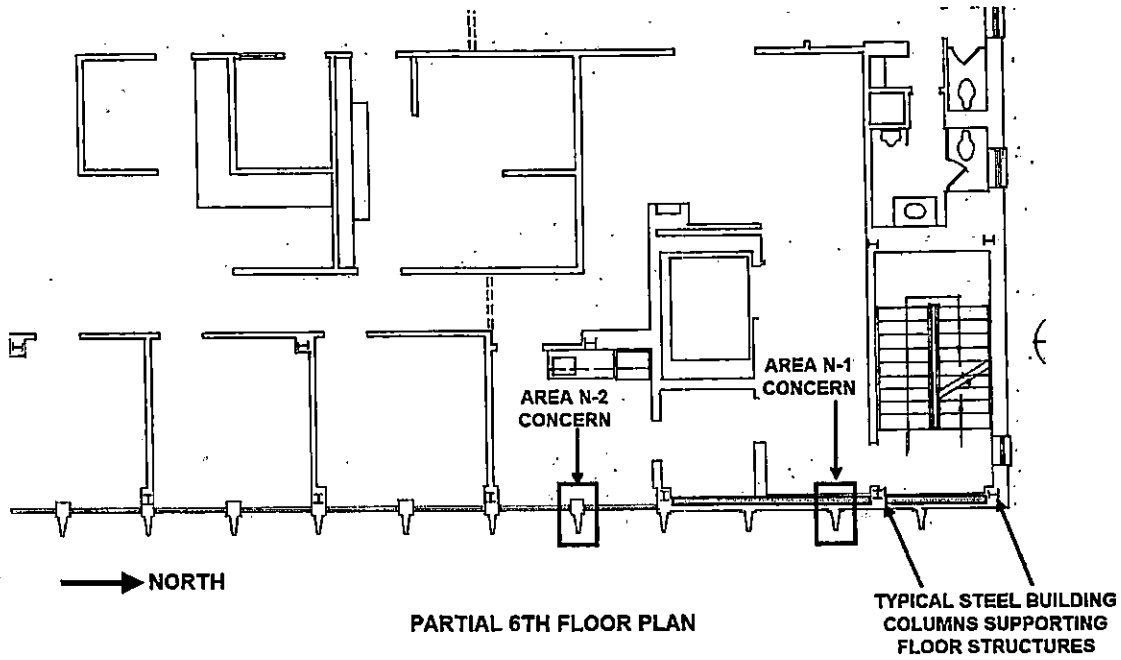
**Figure 2: Floor Plan Showing Wall Areas That Have Lost Substantial Lateral Support**

**AREA N-2 AREA N-1  
CONCERN CONCERN**

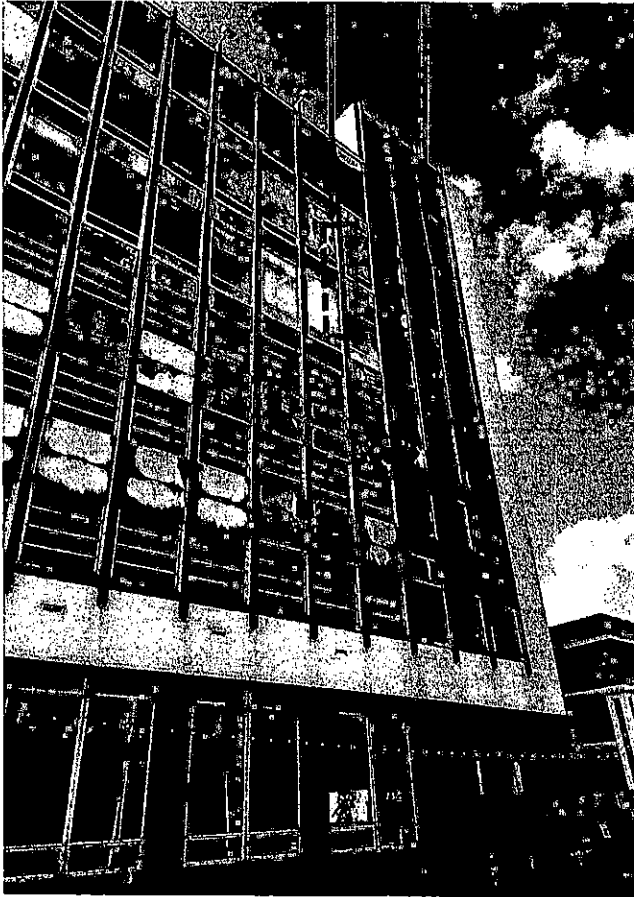
**Photo 1: East Wall Elevation Showing Deflecting Wall**
