Hickory Circle Flooding Issue Hilltop Area of Jonesboro

Photos of water from most recent
event on March 17, 2021.

Photos and brief explanation of what
is causing the majority of our
flooding issues.

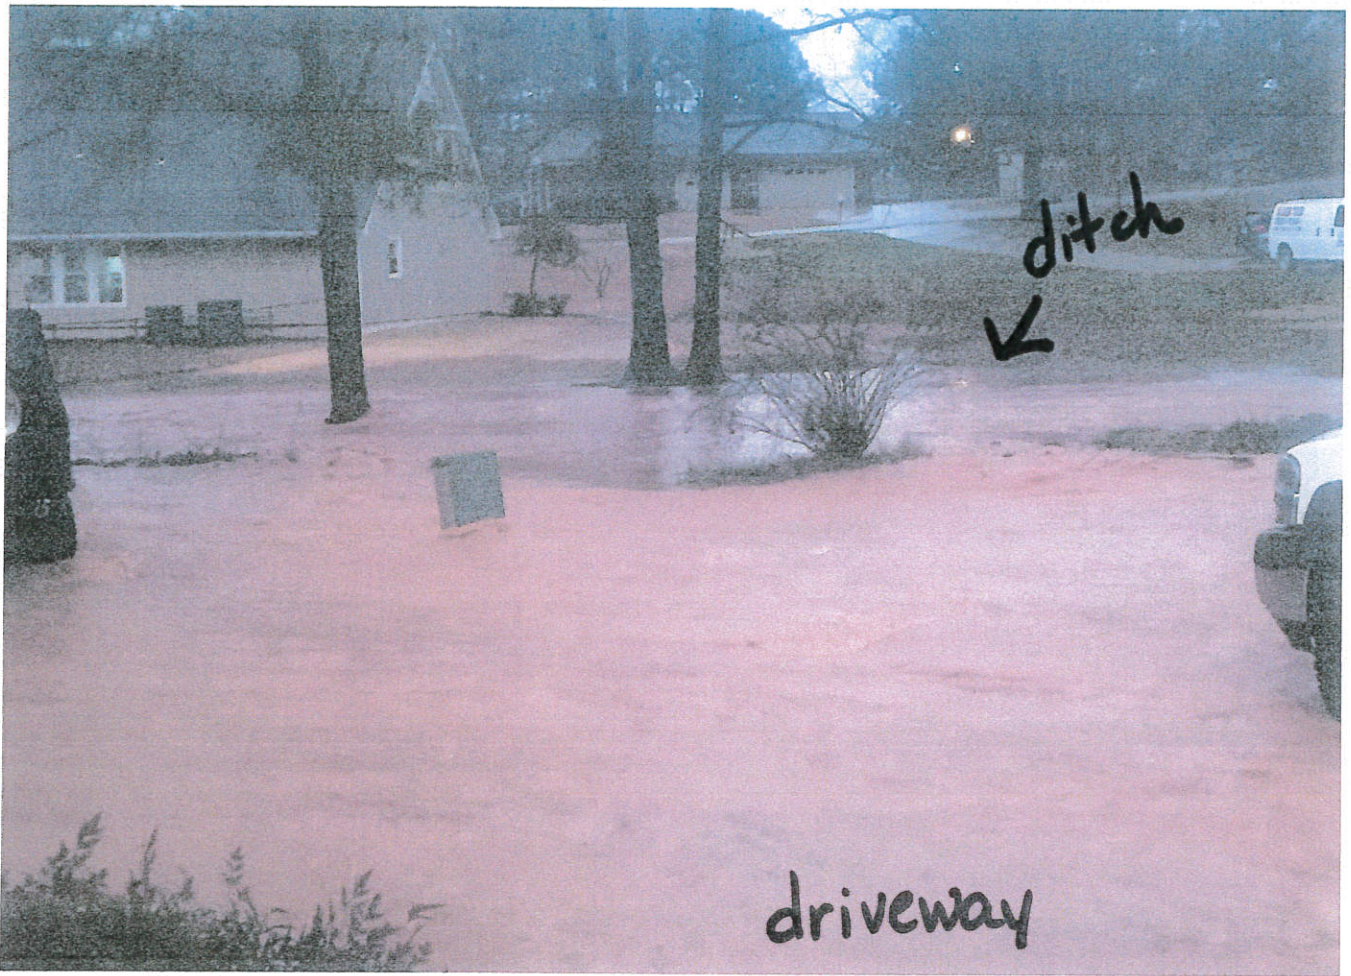
driveway

ditch
↙

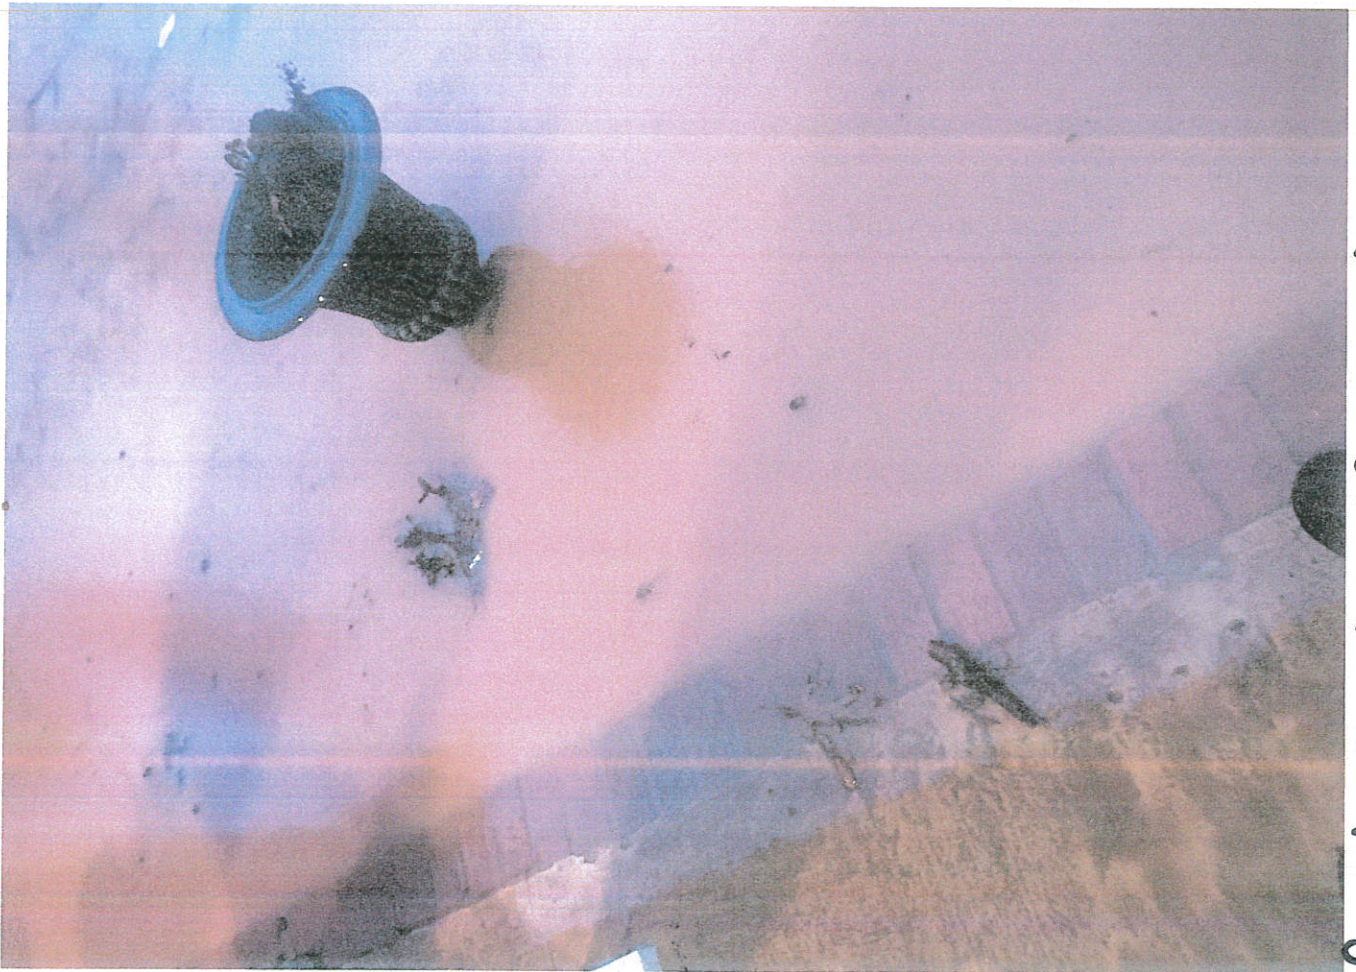
front porch after water
leaving recording

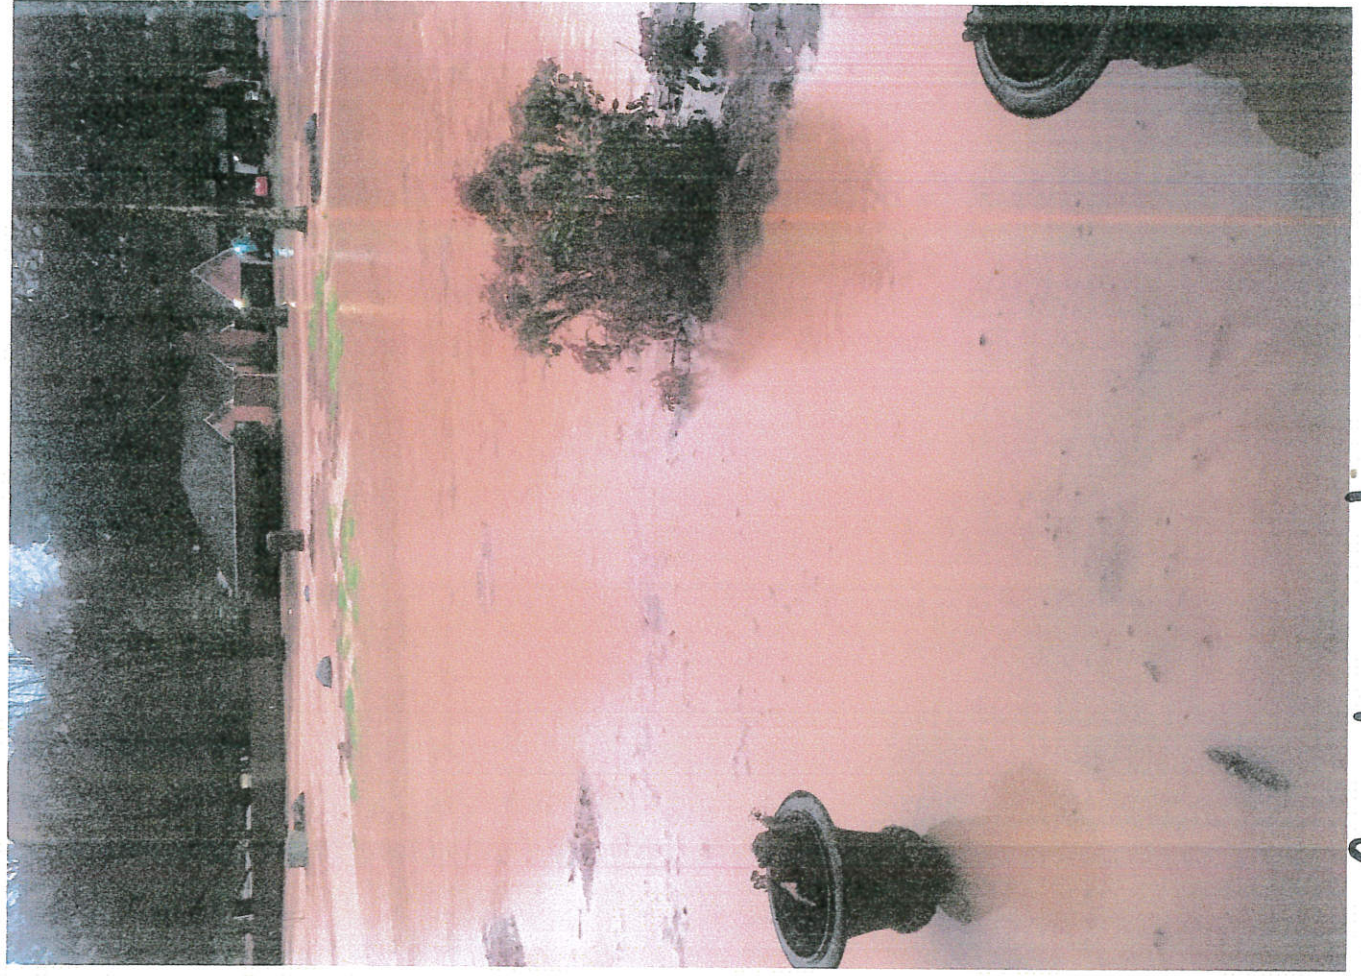
front yard

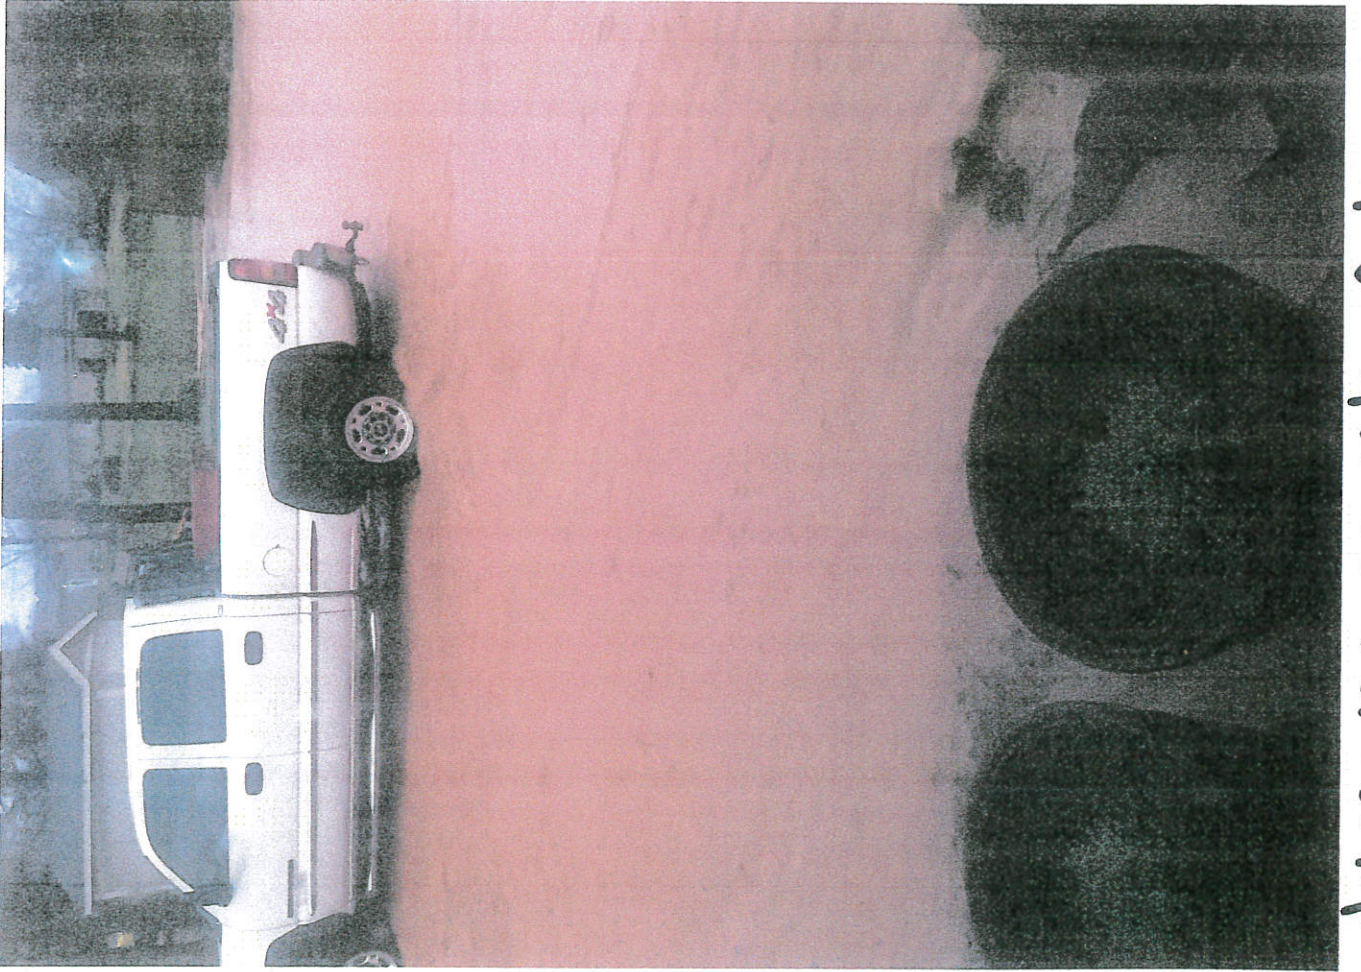
drive way on side of house

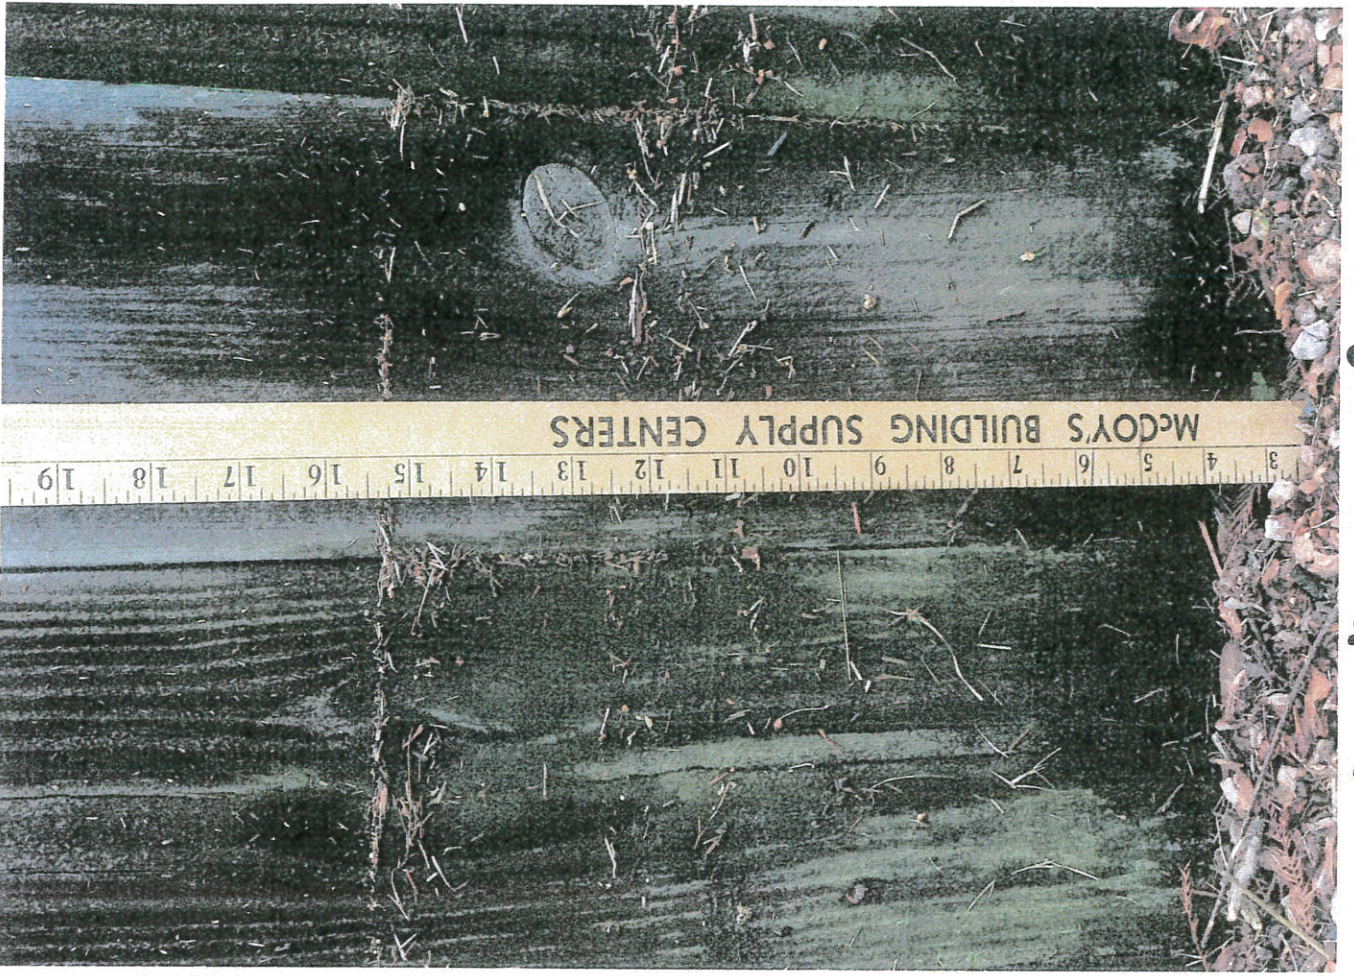
water line on fence

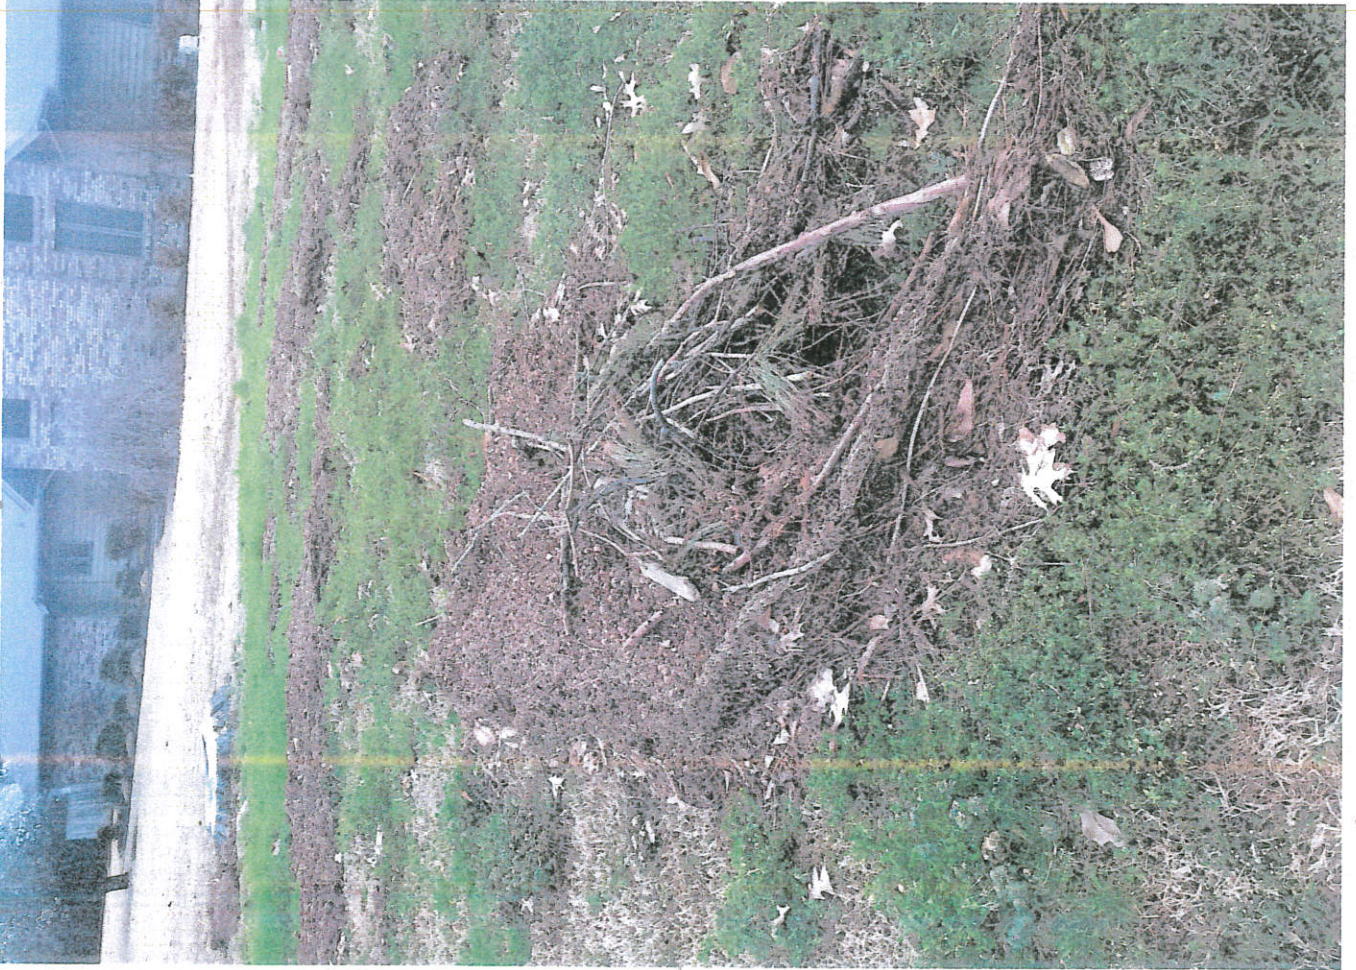
debris after math

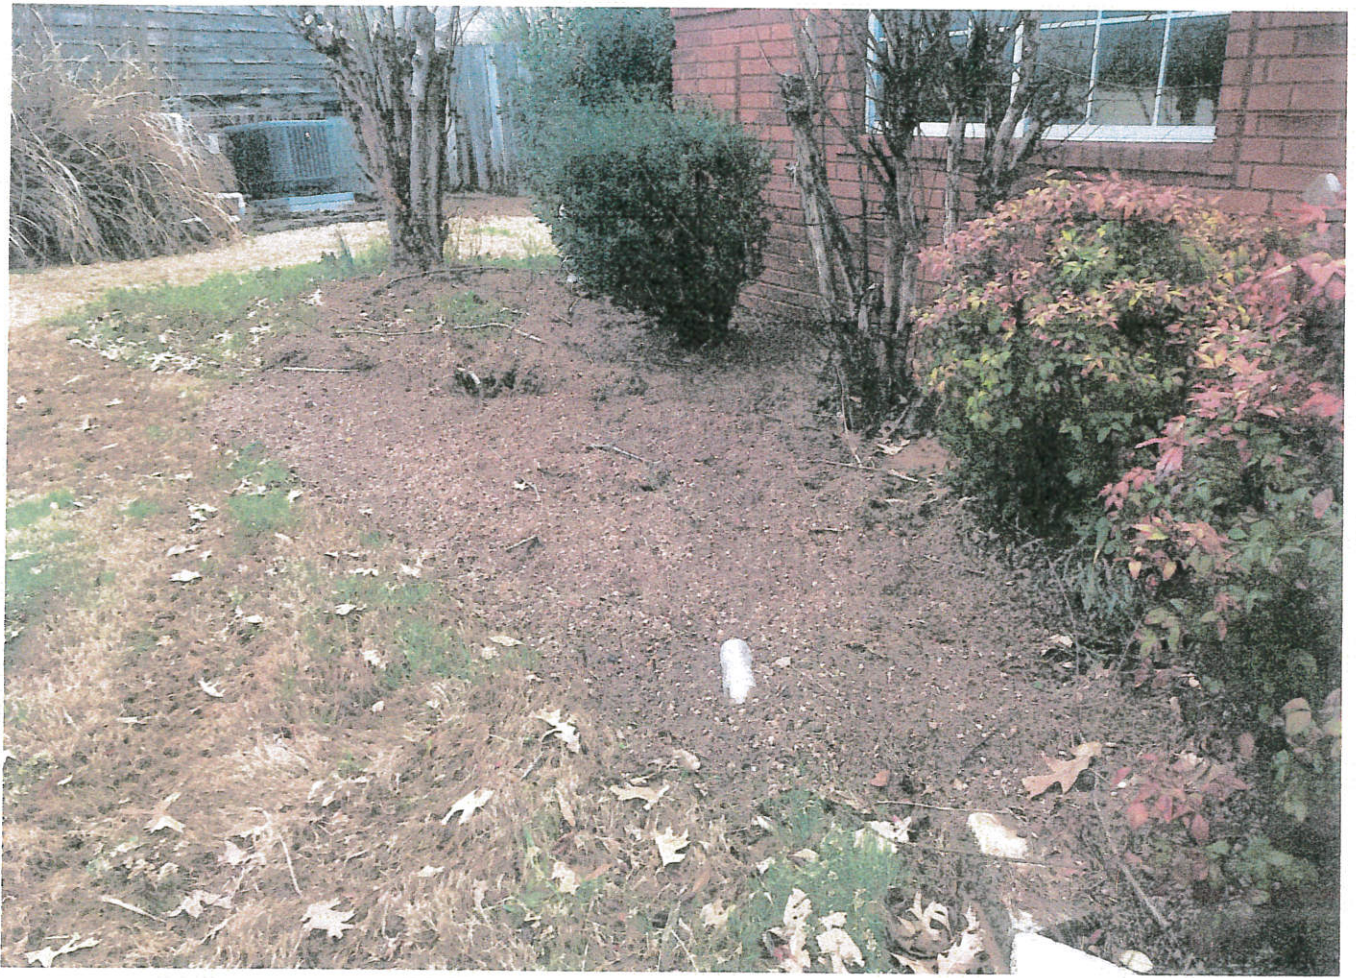
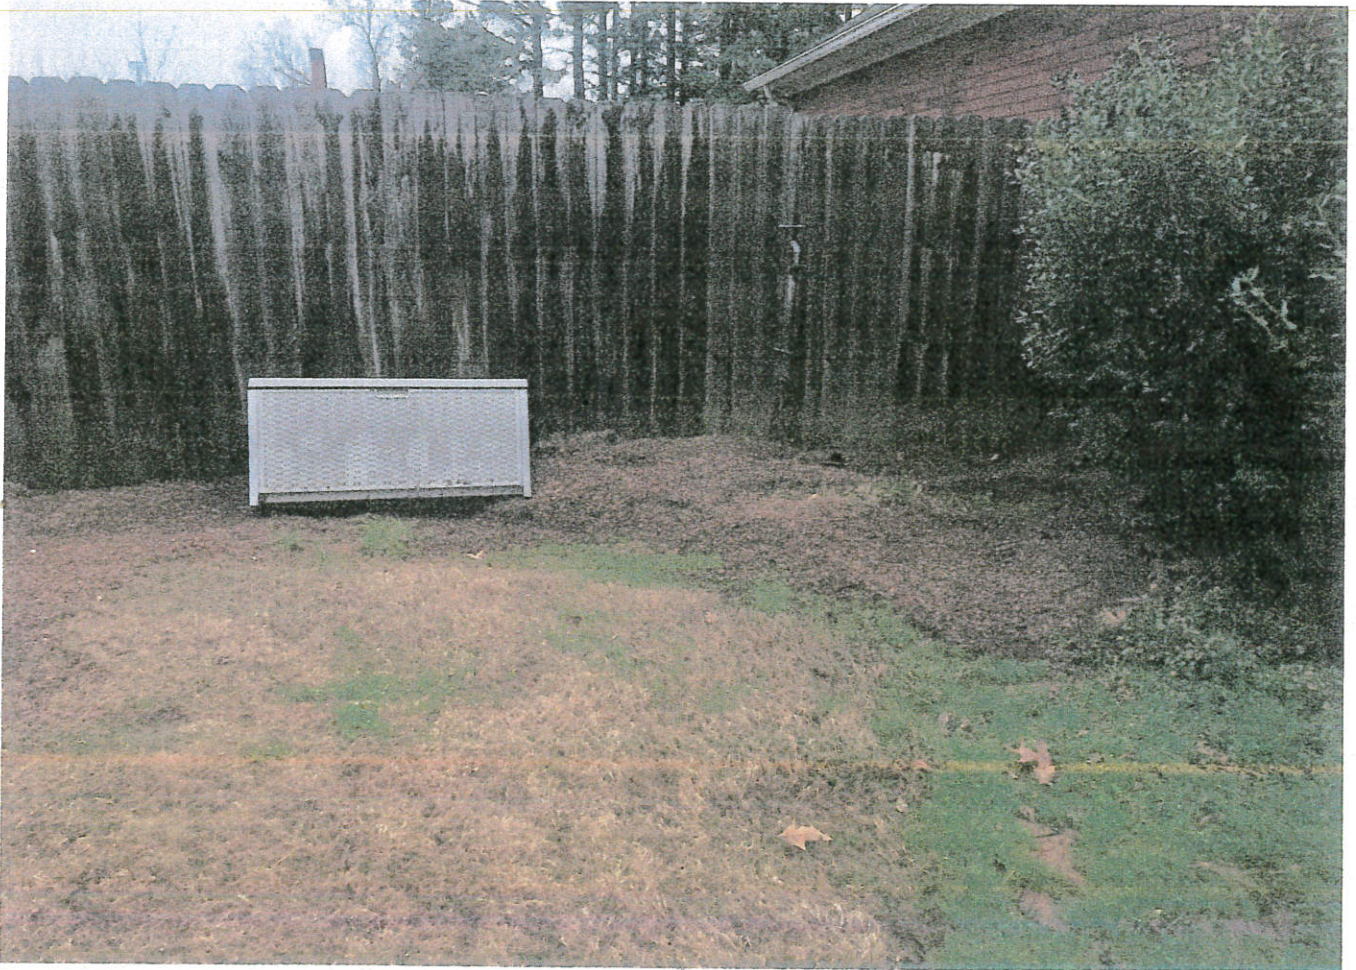
debris aftermath

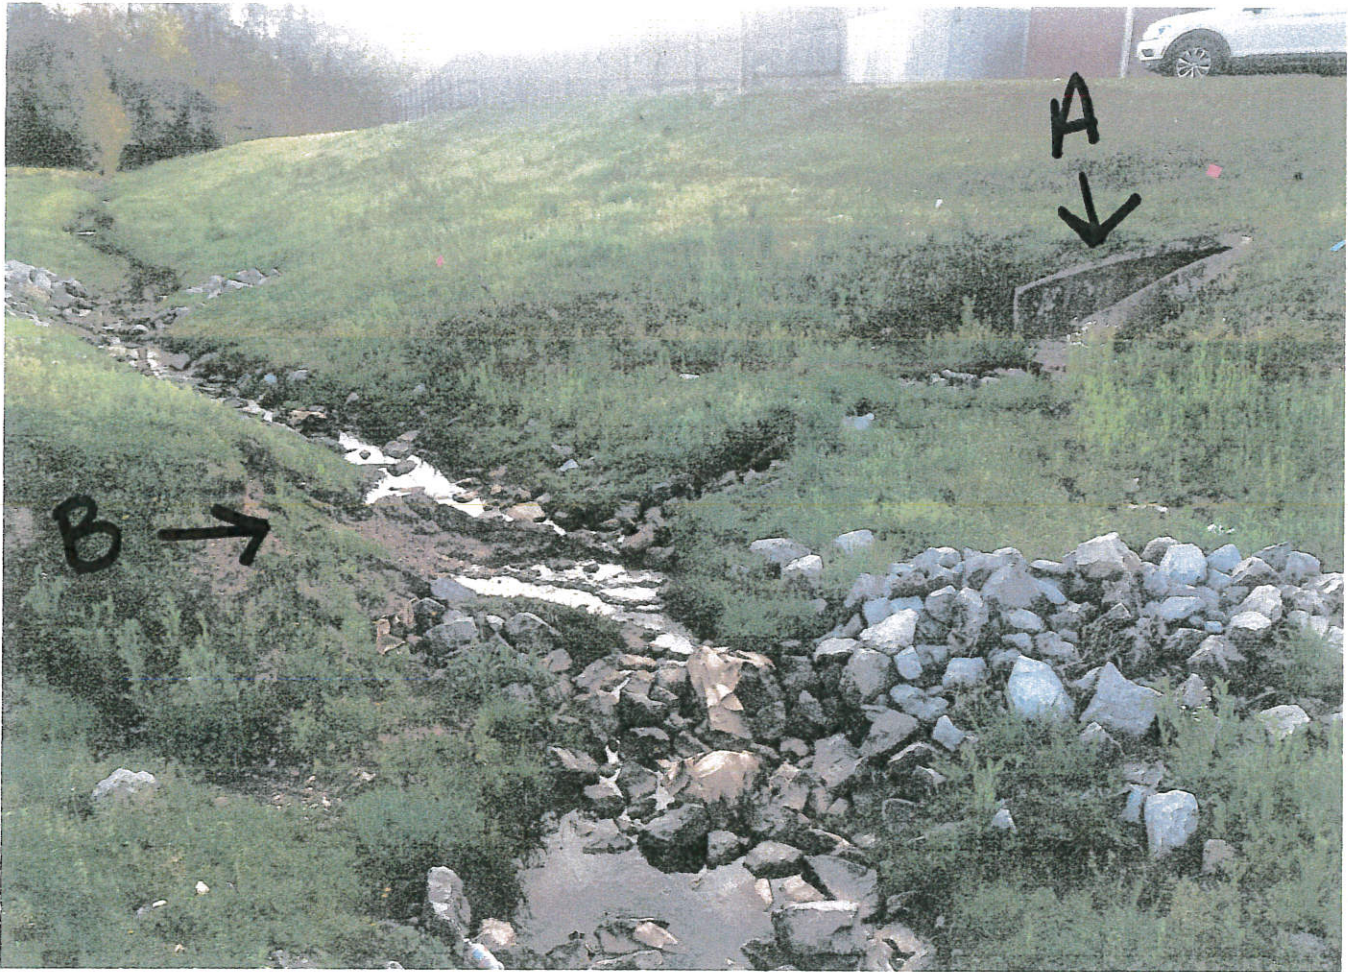
Photo 1

Photo 1: Retention Pond behind Fat City

The majority of the water enters the the retention pond from the area at the top left of the picture. At point A, water enters the pond at the mouth of the pond. Point B is the mouth of the pond that does nothing to control the flow of the water. Over the years, water has cut a creek through the pond, and the pond never holds any water back. The recommendation of the residents for years has been to build a spillway at the mouth of the pond in order to control and reduce the flow of water into the drainage ditch. No other retention pond we have seen in the city has an open flow system. Flow should be less volume than the tile under Hickory Circle. See photo 5 for explanation.

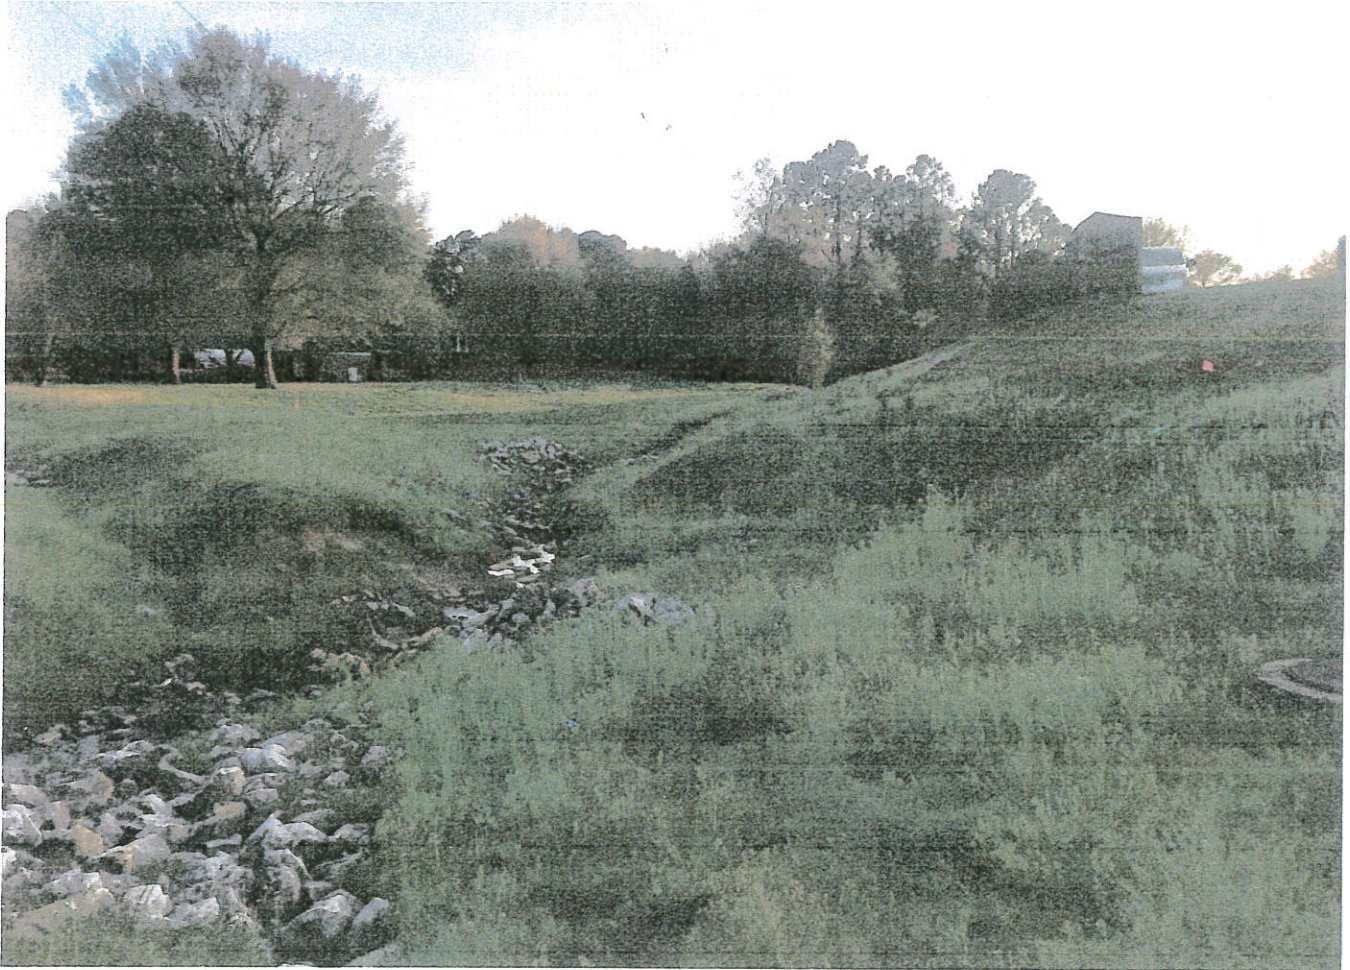
Photo 2

Photo 2: Retention Pond behind Fat City

This is a wider view of the pond. It is very shallow and never holds any water. It is the recommendation of the residents that this be reshaped so that it will fulfill its purpose.

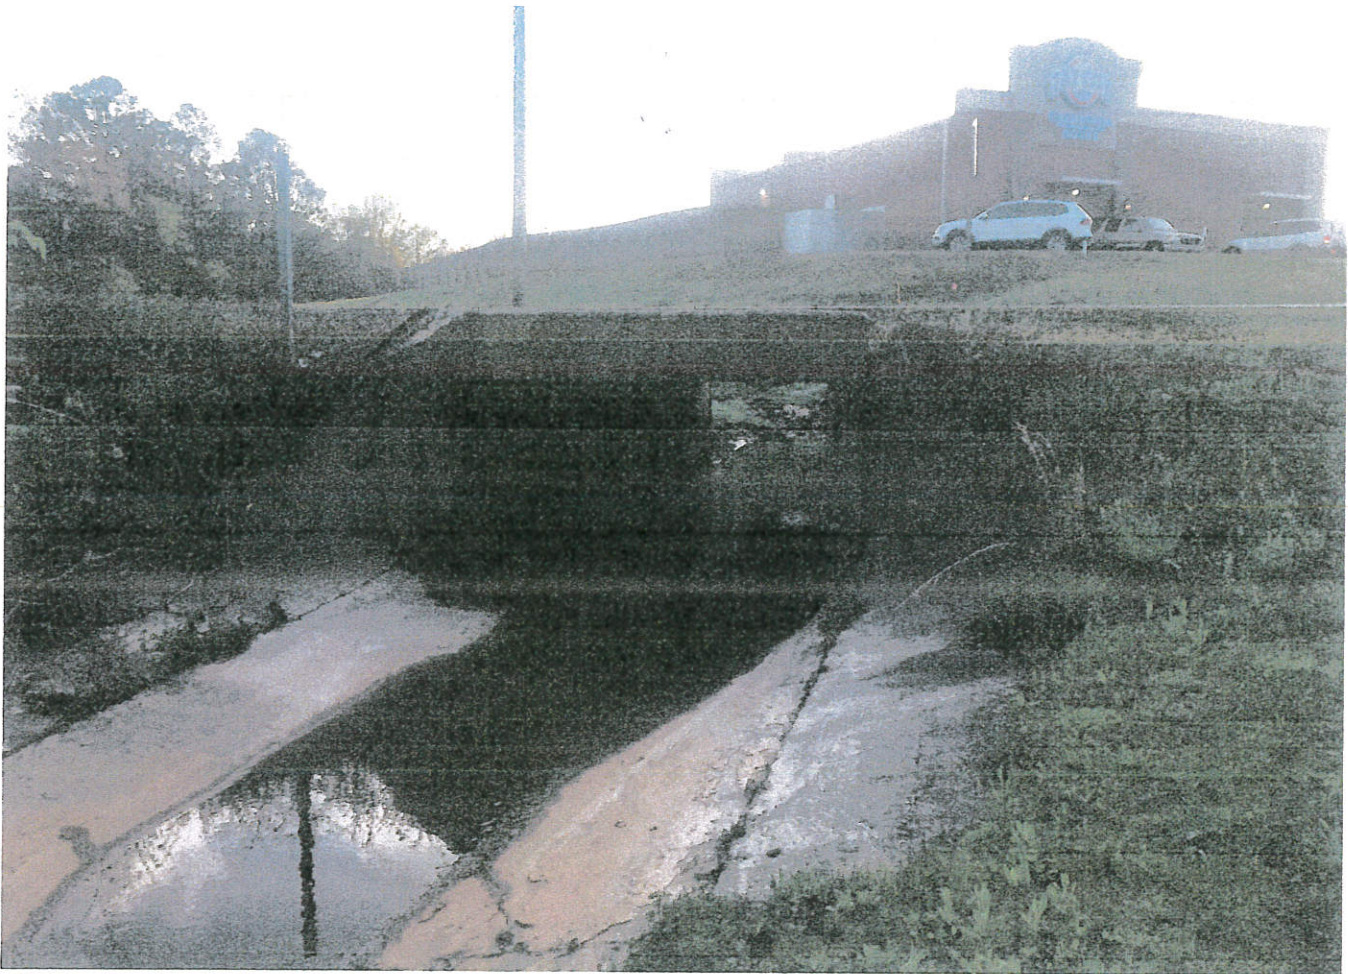
Photo 3

Photo 3: Drainage Tile under Airport Road

This is an 8 foot by 4 foot tile allowing all water to pass under Airport Road.

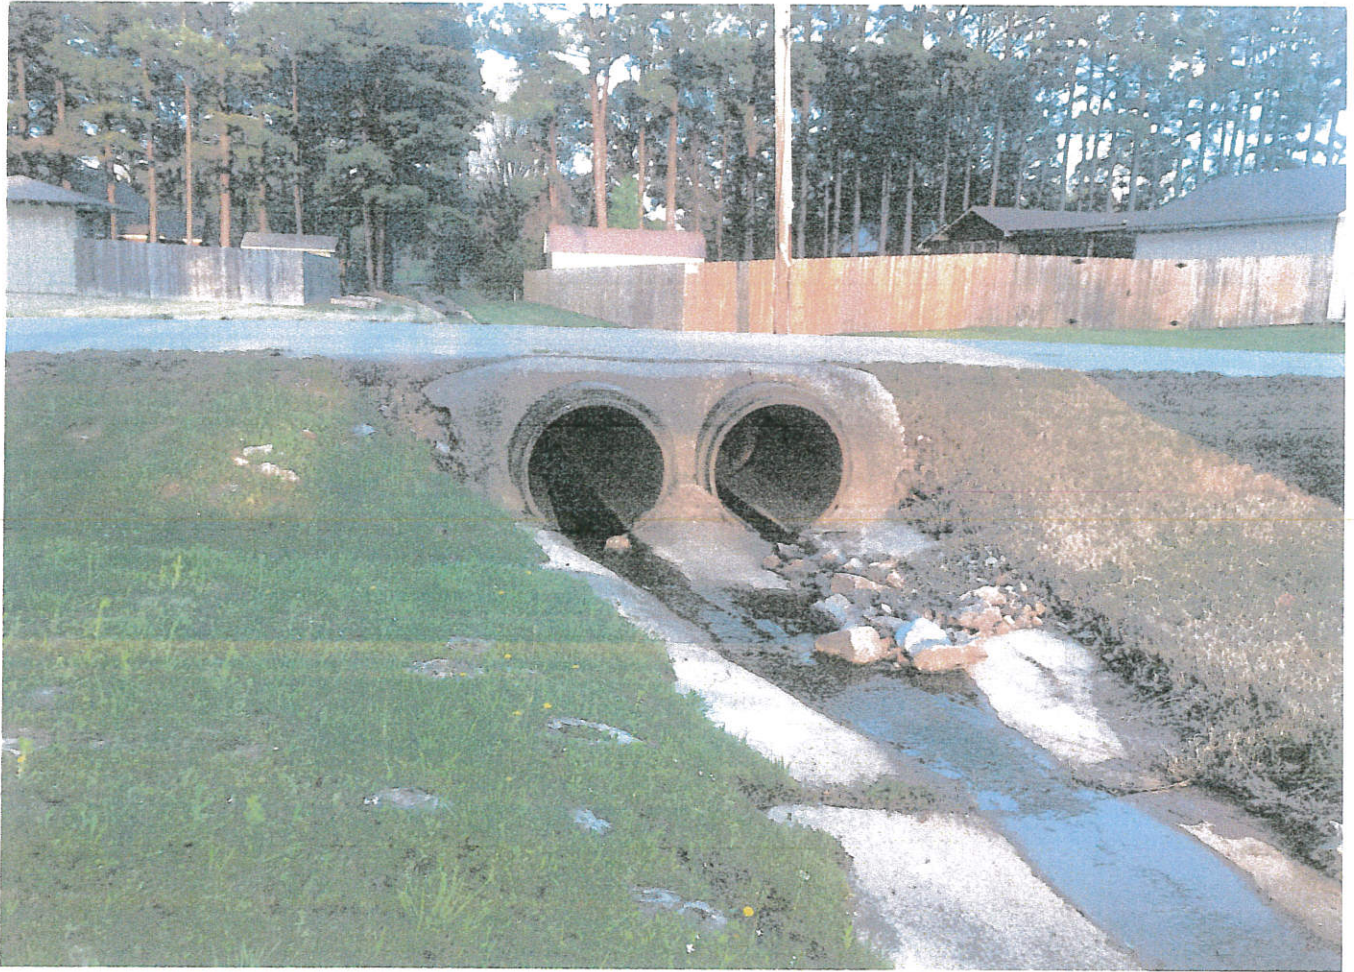
Photo 4

Photo 4: Tile under Hickory Circle

Two 42 inch water drain tiles for a total of 84 inches allowing water to flow under Hickory Circle. This reduction in size, combined with a shallow ditch, creates a bottleneck effect in the ability for water to flow. This is the point in which most water leaves the banks of the ditch and enters Hickory Circle. In addition, the two smaller tiles frequently will not allow debris that passes through the larger rectangular tile to pass. This stops the flow of water compounding the problem.

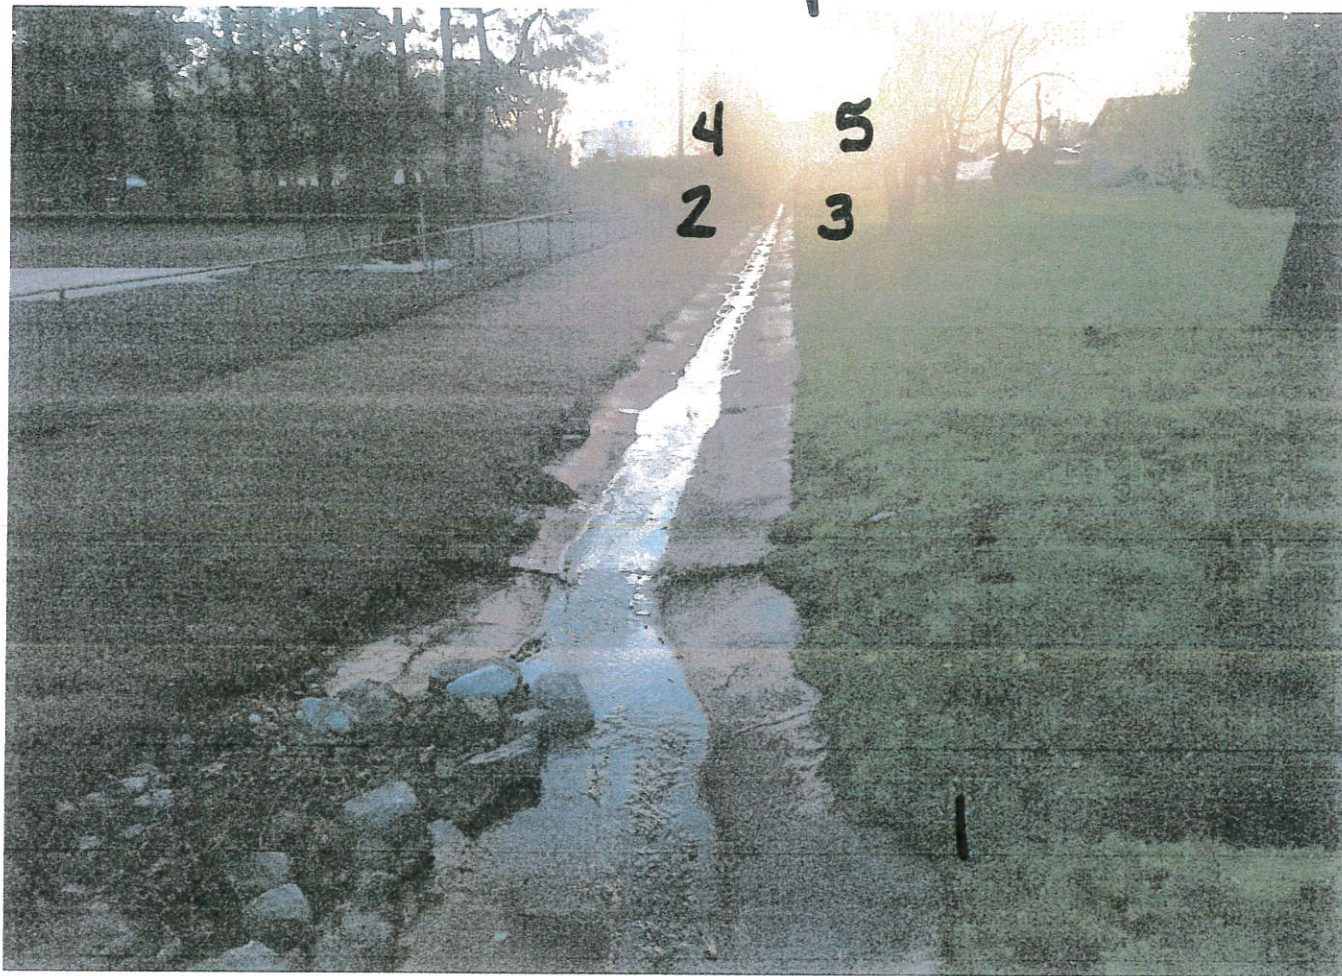
Photo 5

Photo 5: View Standing on Hickory Circle looking toward Airport Road

Water enters the ditch at 5 additional points beyond the mouth of the retention pond. This additional water compounds the excess water that is being released from the pond. For this reason, the spillway added to the mouth of the retention pond should release less volume than the ditch and tile on Hickory Circle can carry.

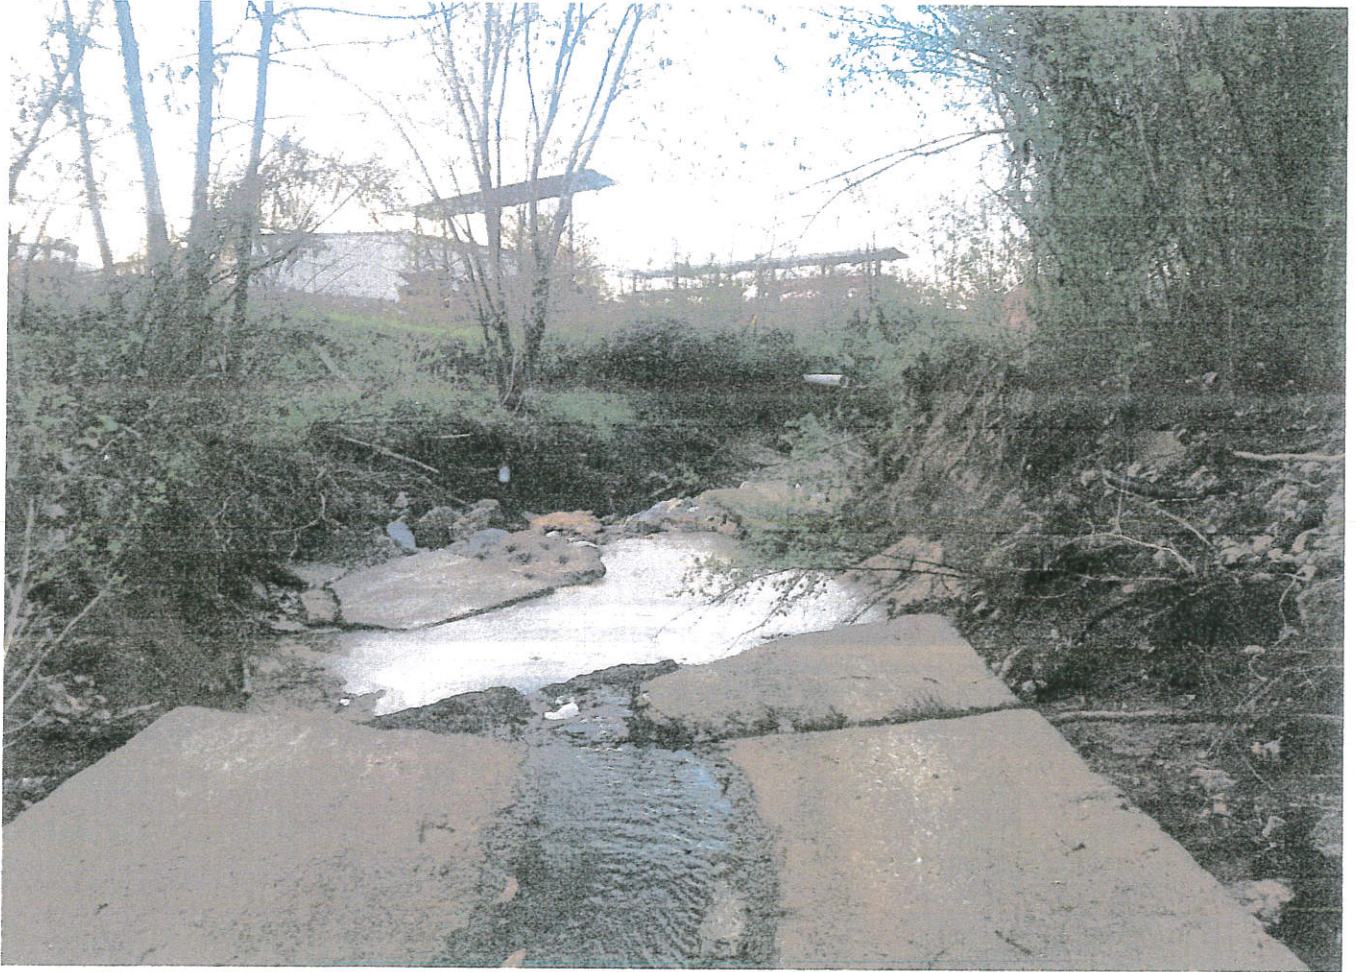
Photo 6

**Photo 6: Current View of Ditch Behind 4126
Hickory Circle Where Concrete Ends**

This area is littered with debris and brush overgrowth. The concrete allows the water to move swiftly with little to no restriction and then BAM! The water hits an area where it cannot flow. Engineering has told us that this area has the capabilities of carrying the same volume of water as the ditch. However, with the debris and overgrowth, this is unlikely. Compare it to a 16 ounce cup and a 16 ounce soft drink. You can pour the entire drink into an empty cup. But, once you add a few ice cubes, your cup no longer holds 16 fluid ounces. Water has moved so swiftly, that it has broken pieces of the concrete and washed it into the ditch. This area need to be cleaned out.
