## PHASE 1 IMMEDIATE ACTION REPORT

Building Location: 100 W. Washington Ave., Jonesboro, AR

**COMMERCIAL BUILDING INSPECTION REPORT**

DATE OF INSPECTION:	<b>09-25-24</b>
PROPERTY ADDRESS:	<b>100 W WASHINGTON</b>
PROPERTY OWNER:	<b>BRUCE BURROW</b>

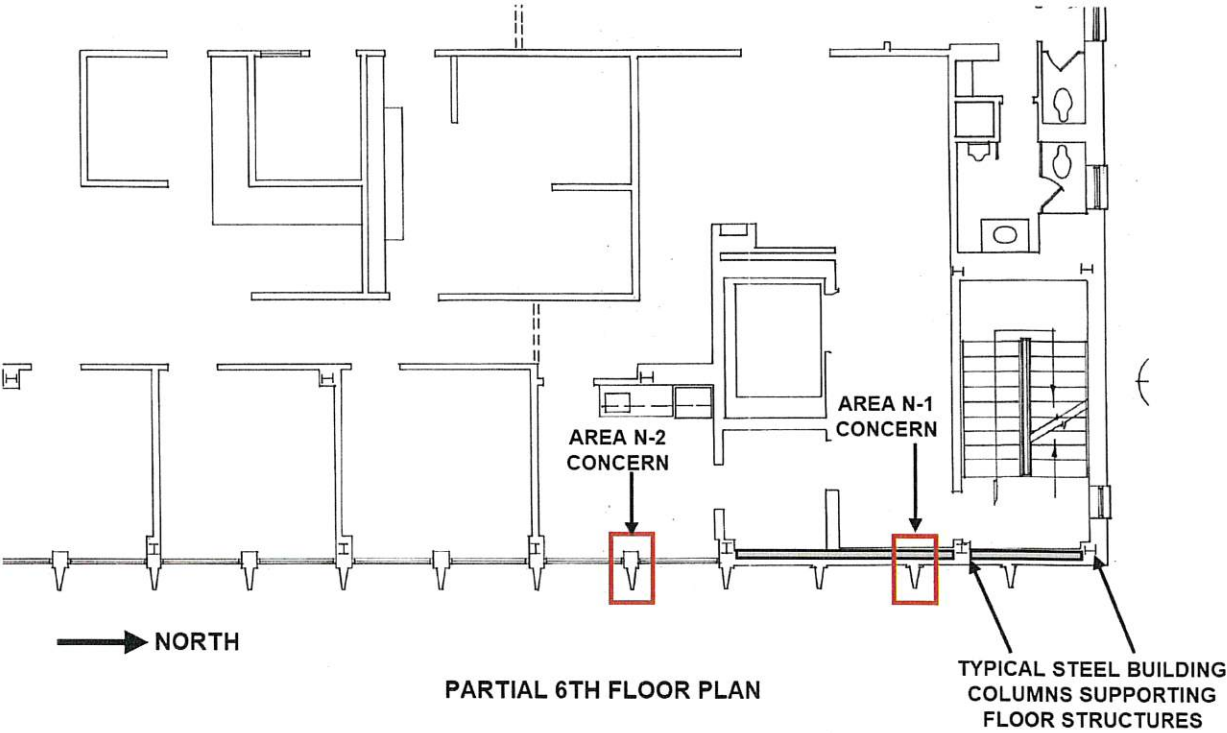
Figure 2: Floor Plan Showing Wall Areas That Have Lost Substantial Lateral Support

There are two areas where the exterior wall structure appears to have lost lateral support, and the wall structure has moved away from the building and is deflecting out to the east towards Main Street. See figure 1 and figure 2 below and photo 1 showing these areas. The wall structure area furthest north (between the stairwell and elevator structure) has moved the most and is the most concerning at this time. The area of concern for wall area N-1 is located between the 5th and 7th floor of the building between the stair structure and elevator structure. The area of concern for the wall area N-2 is more isolated and occurs above and below the 6th floor level.

The wall area around area N-1 (reference figures below) consists of vertical architectural precast concrete elements between porcelain enamel panels. The vertical architectural precast elements are considered non-load bearing elements and are primarily only carrying their own self-weight. The building structure is supported by steel columns and steel floor members that supports the concrete floor slab. The wall areas around area N-2 consists of vertical architectural precast elements between glass wall panels.

Wall area N-1 is deflecting outward (towards the east) several inches and appears to be at risk of collapse. The lateral ties from the steel beams to the vertical precast elements at area N-1 have been compromised and appears to have lost support for at least a twenty foot vertical length near the 6<sup>th</sup> floor level. Area N-2 is also deflecting outward (towards the east) several inches but does not appear to be as concerning as wall area N-1 at this time.

After the scaffolding and wood protection wall is constructed, it is recommended to add lateral bracing to the vertical precast concrete elements at area N-1 and N-2. This should be done before any other work or demolition begins on the structure. The lateral bracing should be made to area N-1 near the 5th and 6th and 7th floor levels and can be extended into the building and anchored to the concrete floor slab or some other solid structure. The lateral brace can be in the form of steel angles to grab the vertical precast concrete elements and stabilize them and possibly even pull them back into the building slightly. A licensed contractor should be engaged to add the lateral bracing to areas N-1 and N-2 before any façade removal begins.
