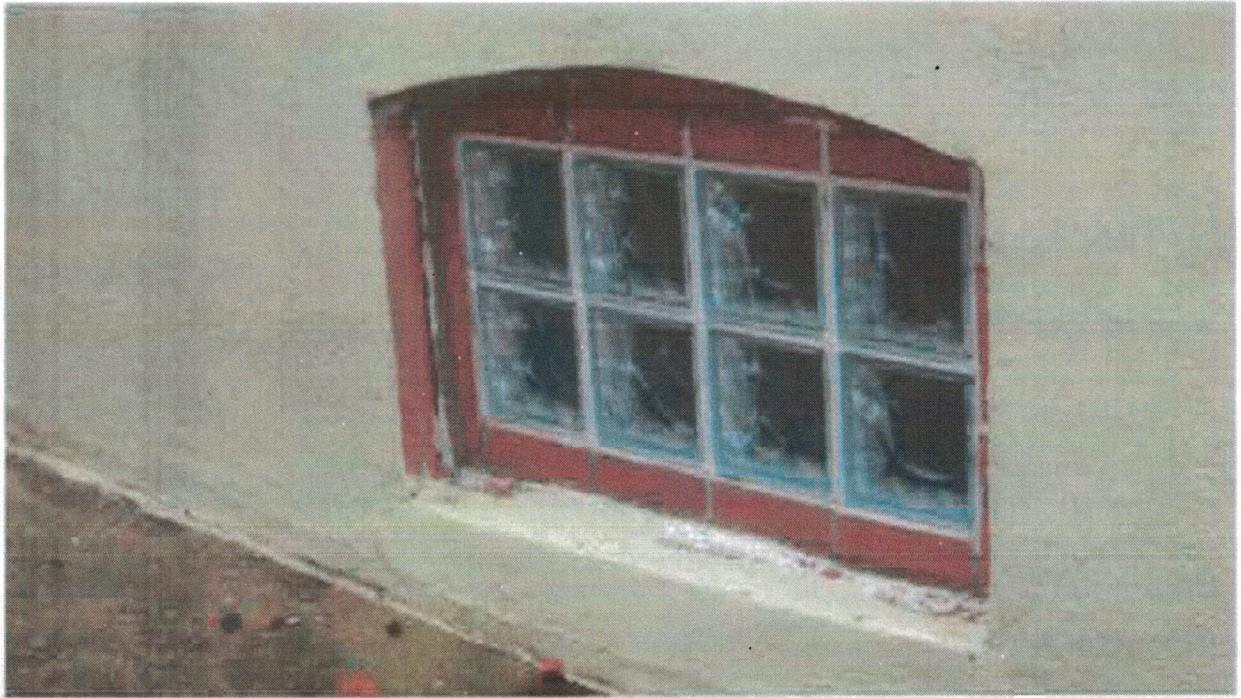
Photo 15 - North exterior wall. Broken glass block.

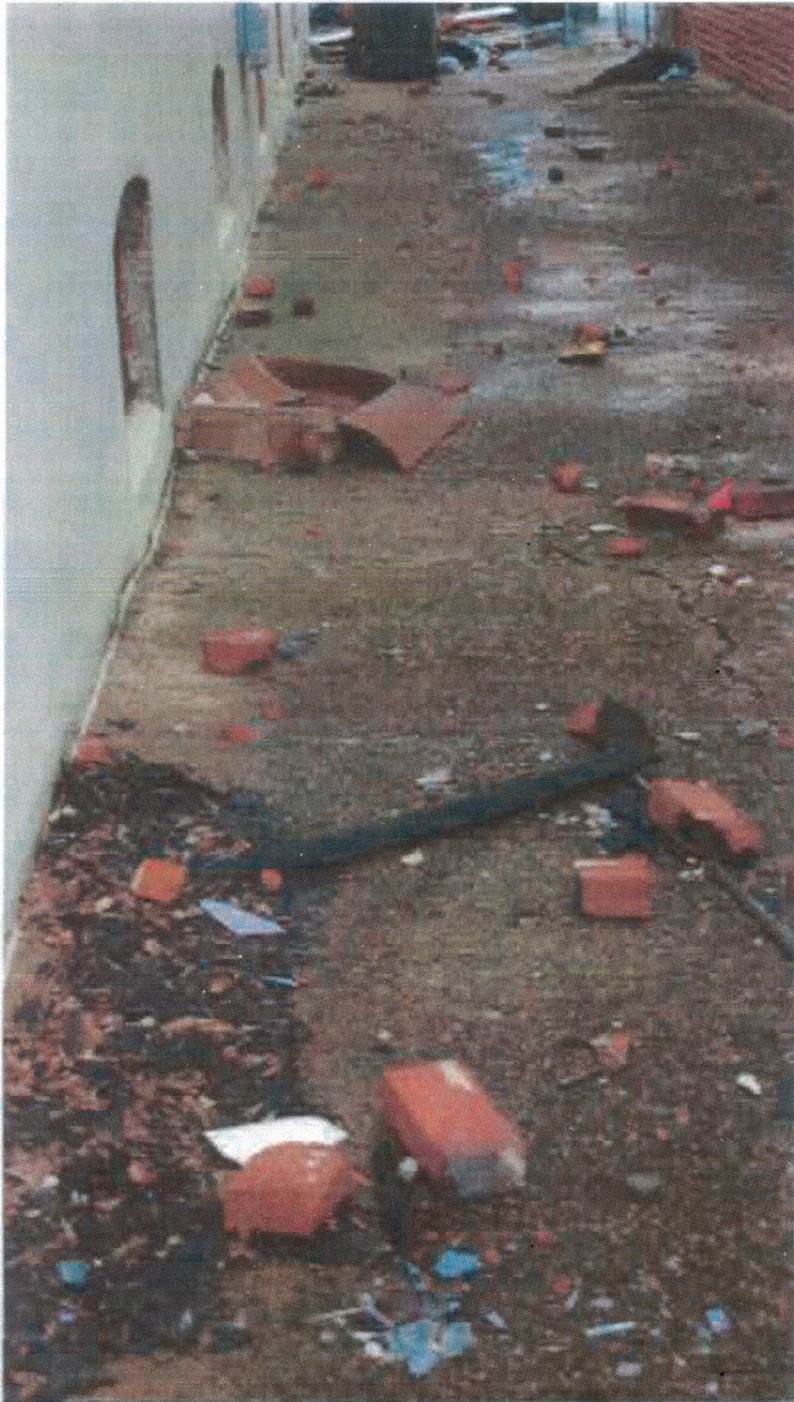
Photo 16 - North exterior wall. Fallen bricks from parapet.

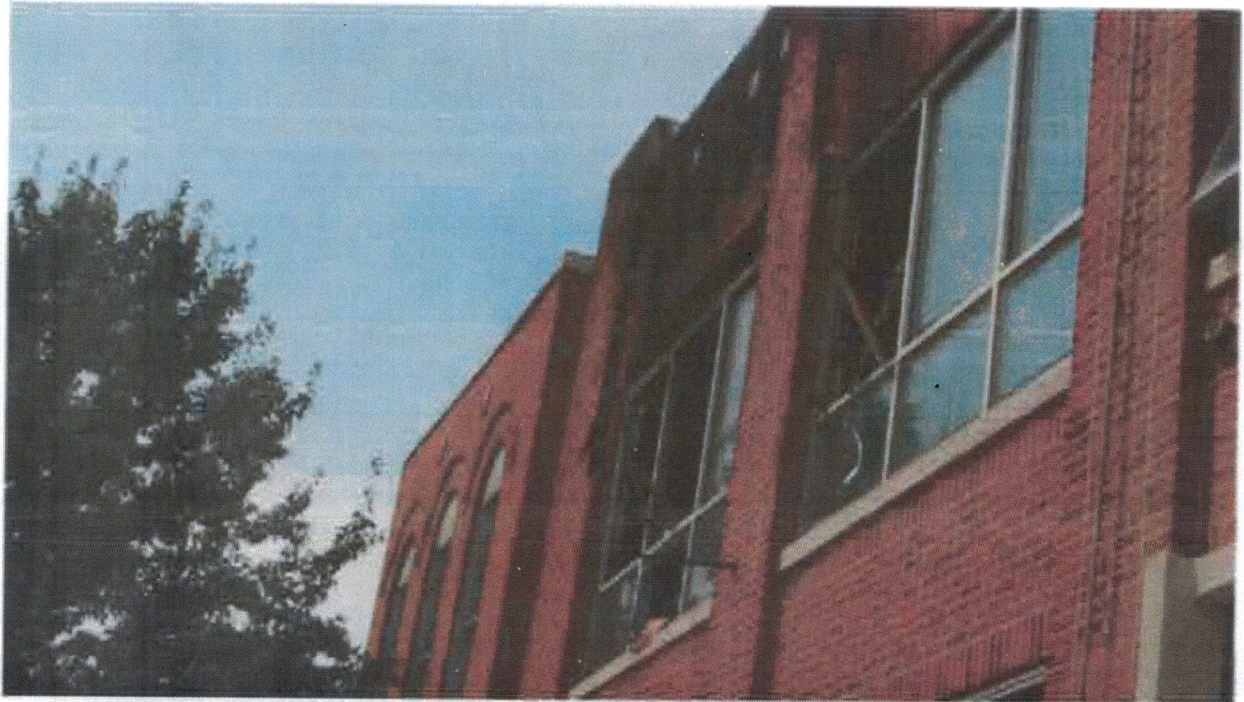
Photo 18- East exterior wall. Brick not original, or has been pointed with cement mortar. Fire blackening on parapet.

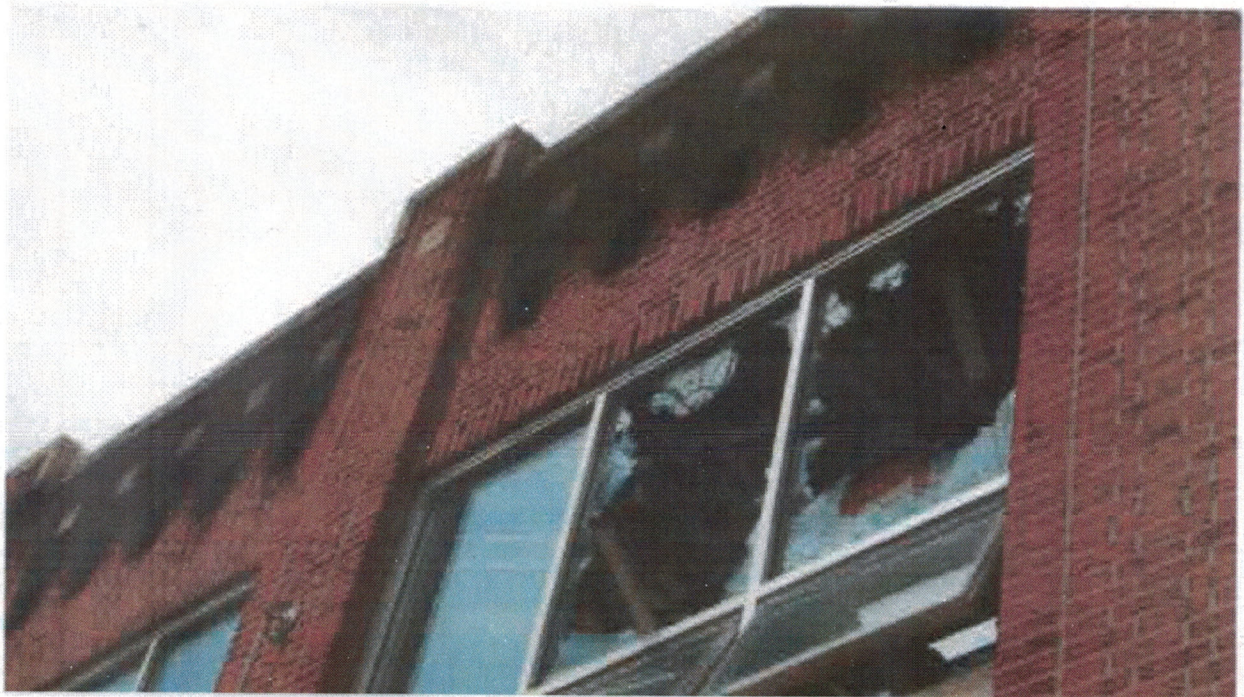
Photo 19- East exterior wall. Brick not original, or has been pointed with cement mortar. Fire blackening on parapet.

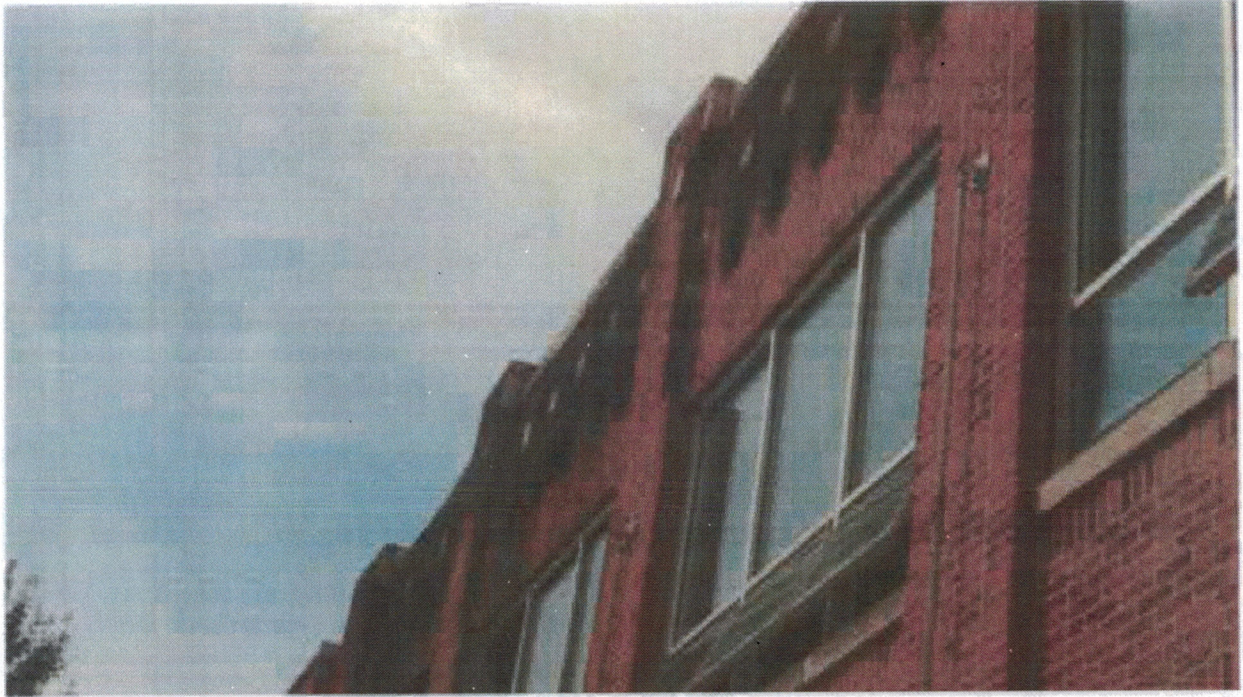
Photo 20- East exterior wall. Brick not original, or has been pointed with cement mortar. Fire blackening on parapet.

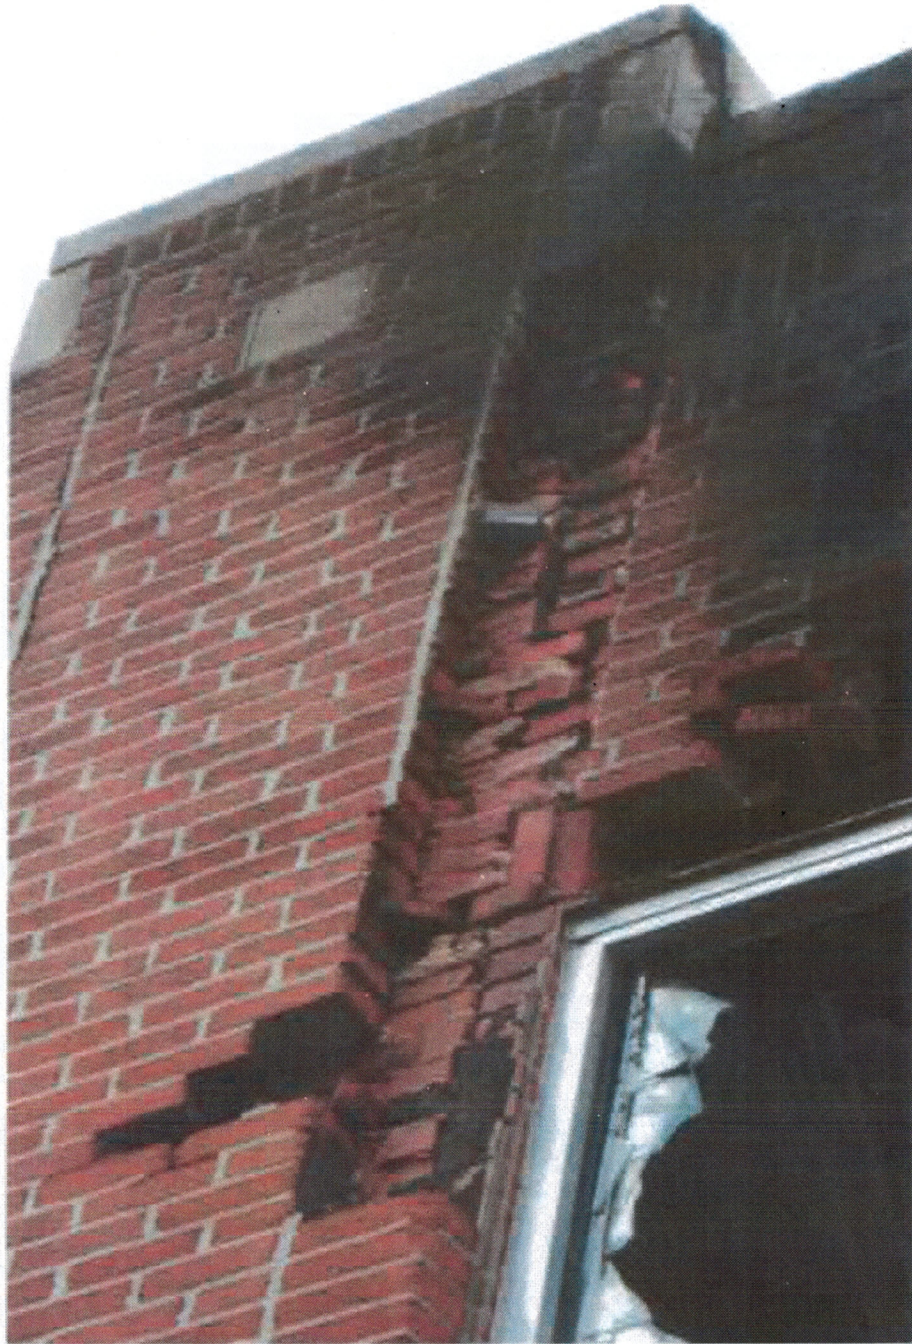
Photo 21 - East exterior wall. Brick not original, or has been pointed with cement mortar. Brick is stacked and not properly bonded with mortared or not tied with soldier course.

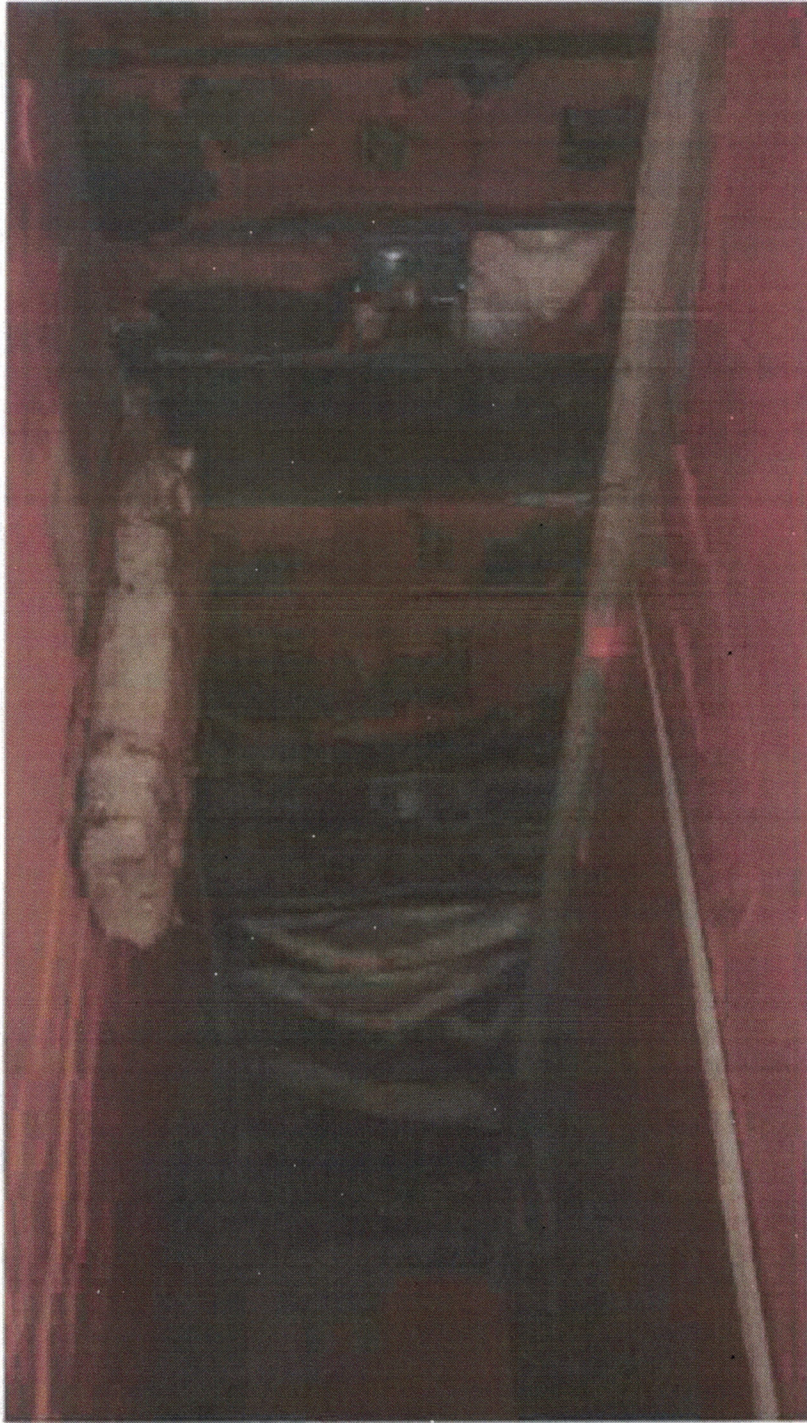
Photo 22 - stair well to 'Loft'. Water soaked gypsum board.

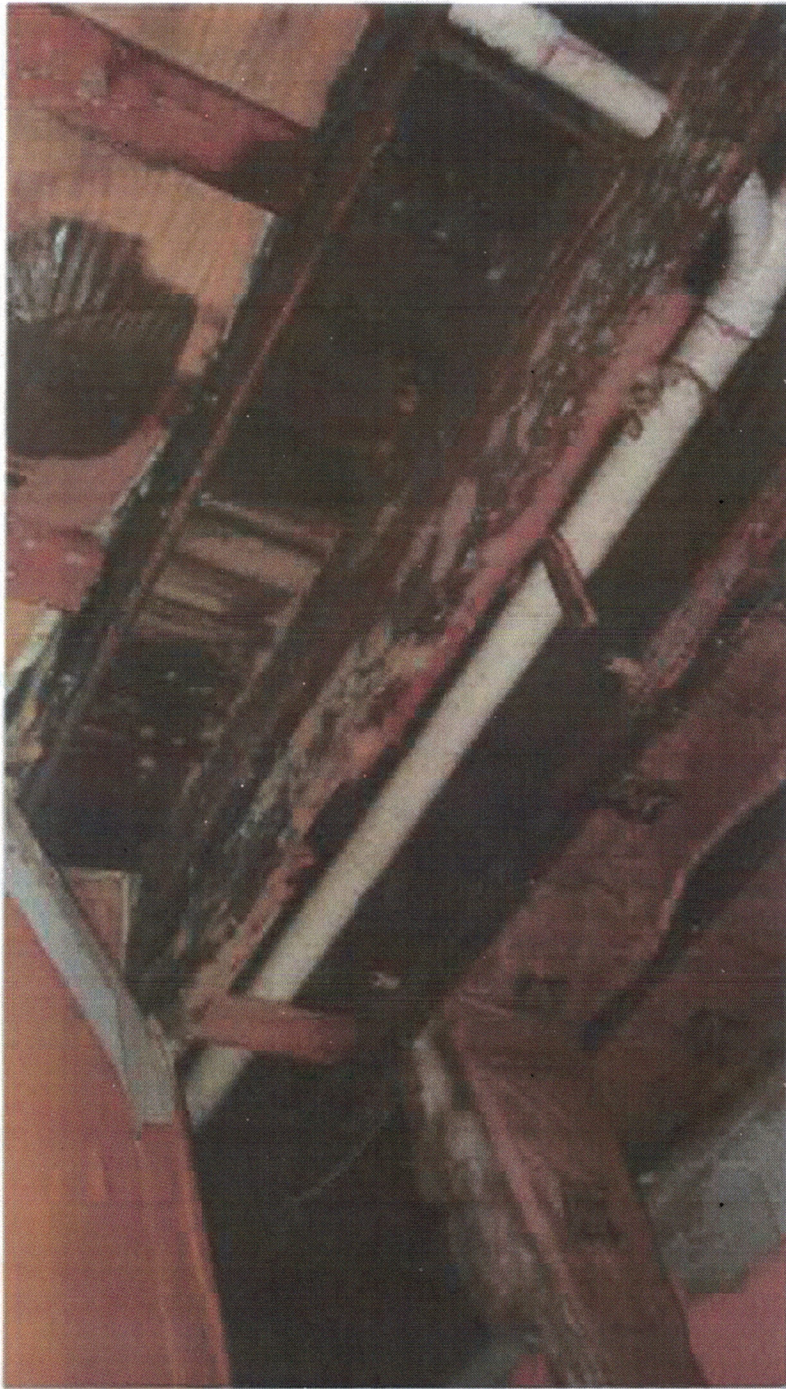
Photo 23 - Ceiling in stairwell. Gypsum board and insulation water soaked

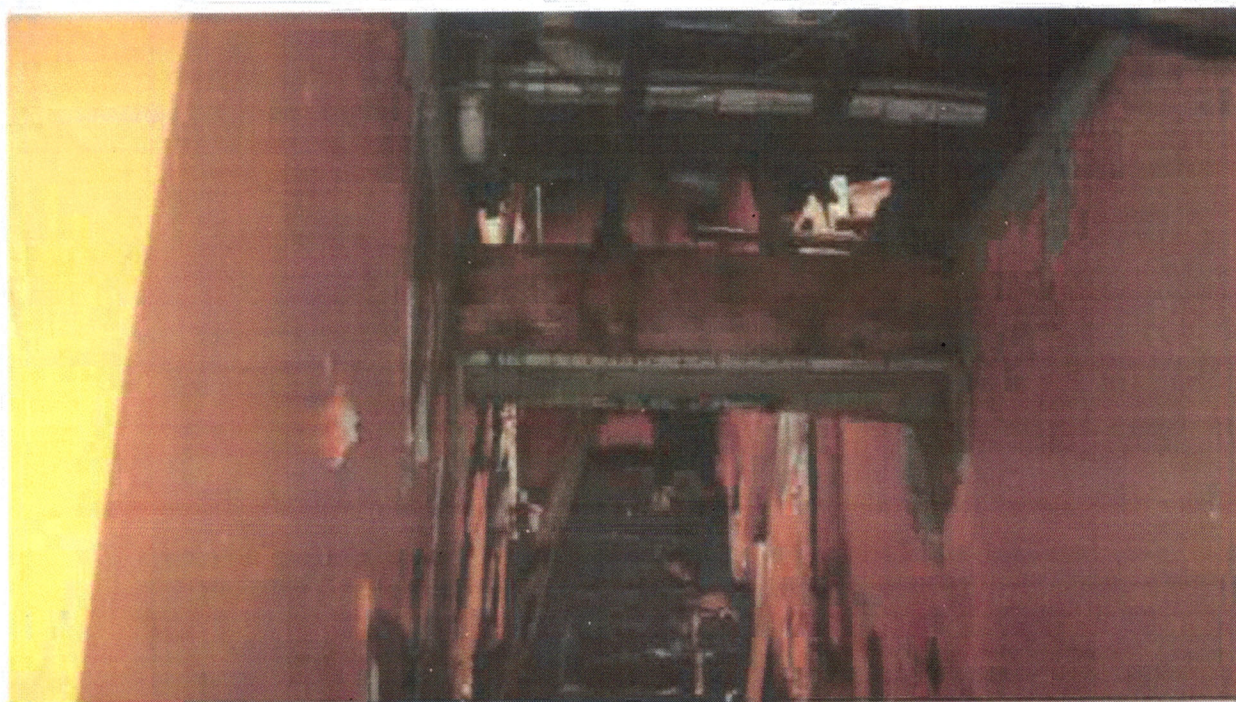
Photo 24 - Ceiling in stairwell. Gypsum board and insulation water soaked

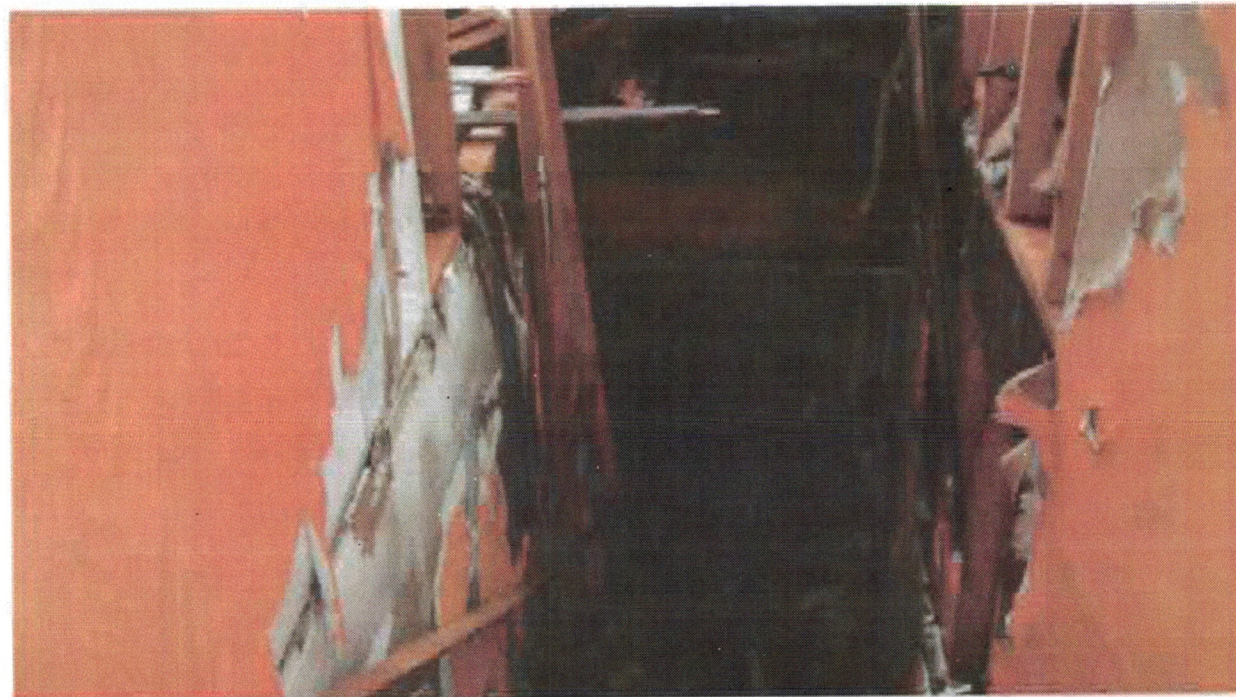
Photo 25 - Ceiling in stairwell. Gypsum board and insulation water soaked

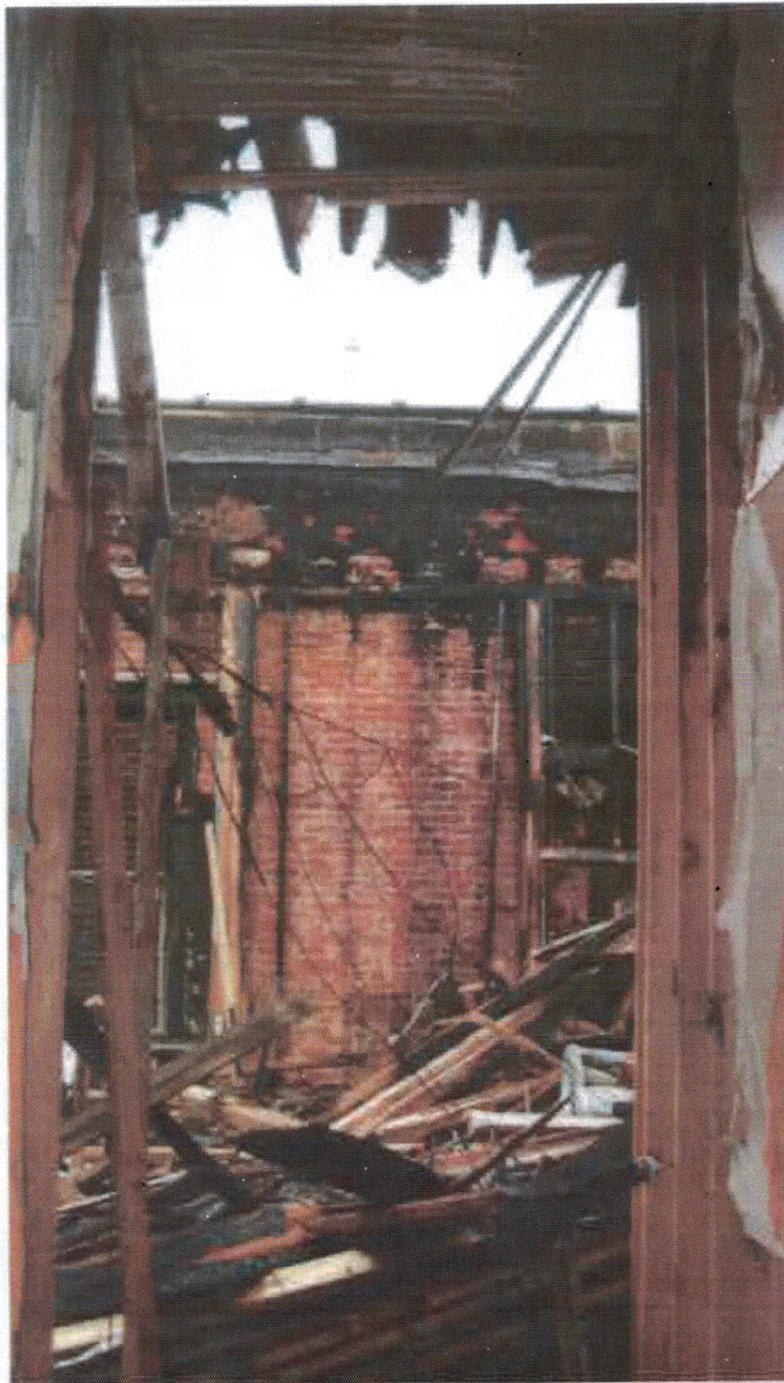
Photo 26 - Loft looking south. Ceiling consumed by fire and collapsed onto floor. Windows look into light well formed by adjoining building.
