411 UNION STREET, JONESBORO ARKANSAS - Exhibit A

Typical Unreinforced Masonry Bearing-wall Building - Exhibit B

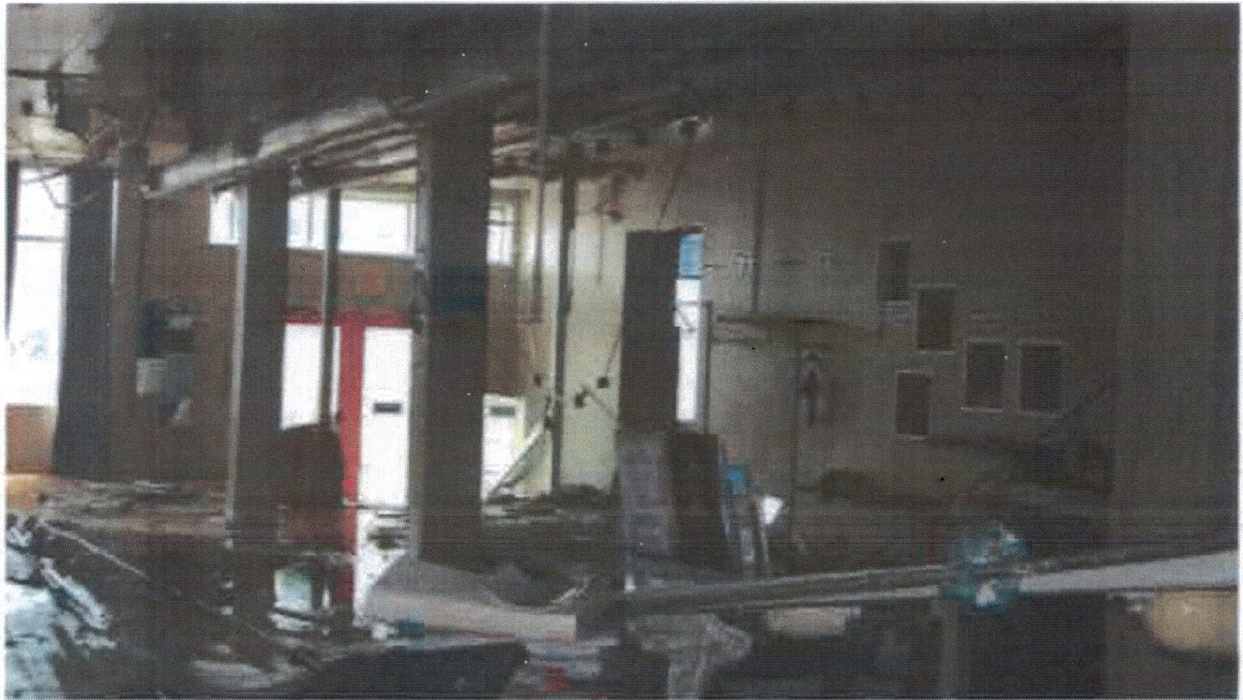
Photo 1 - Ground floor water damage to floors walls and ceiling.

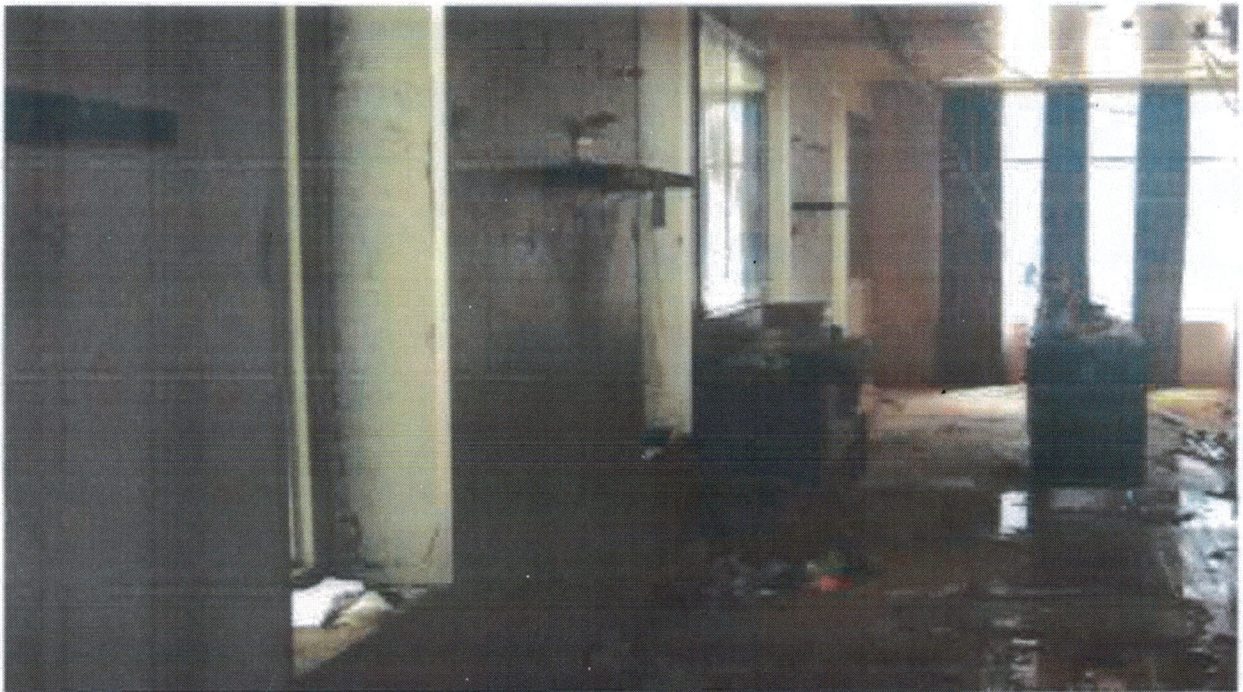
Photo 2 - Ground floor water damage to floors walls and ceiling. Mildew and mold growing on the walls.

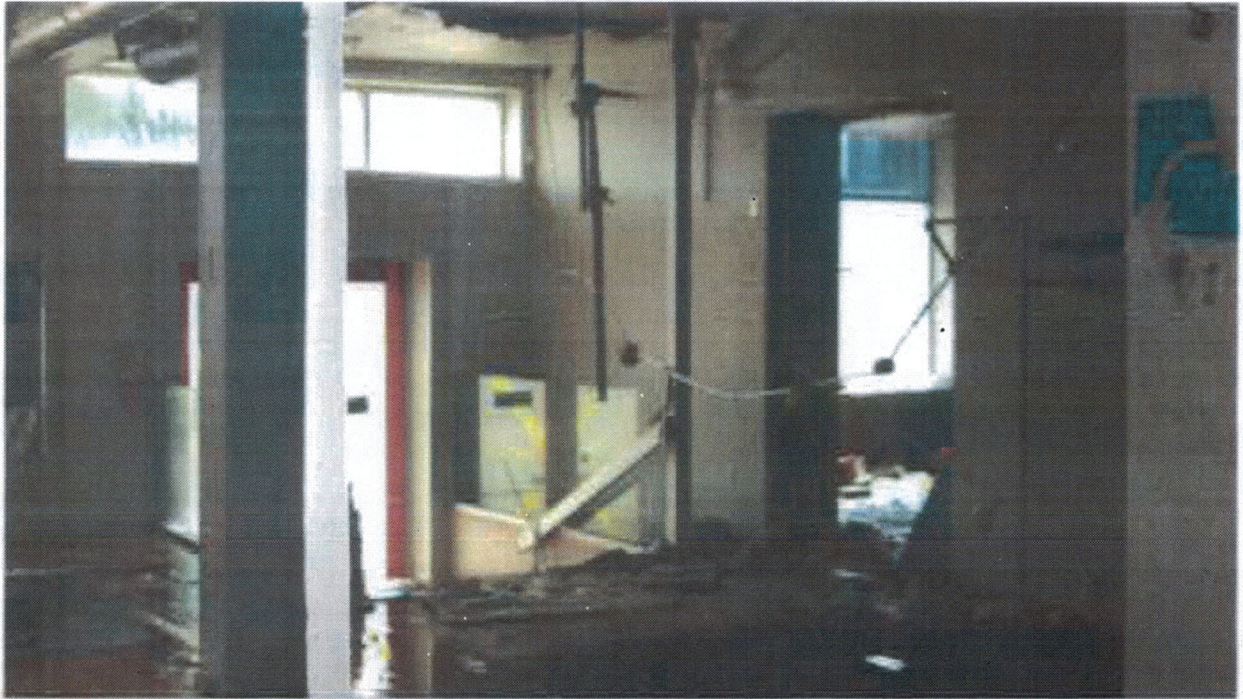
Photo 3 - Ground floor water damage to floors walls and ceiling. Conduit lost support from wetted ceiling board

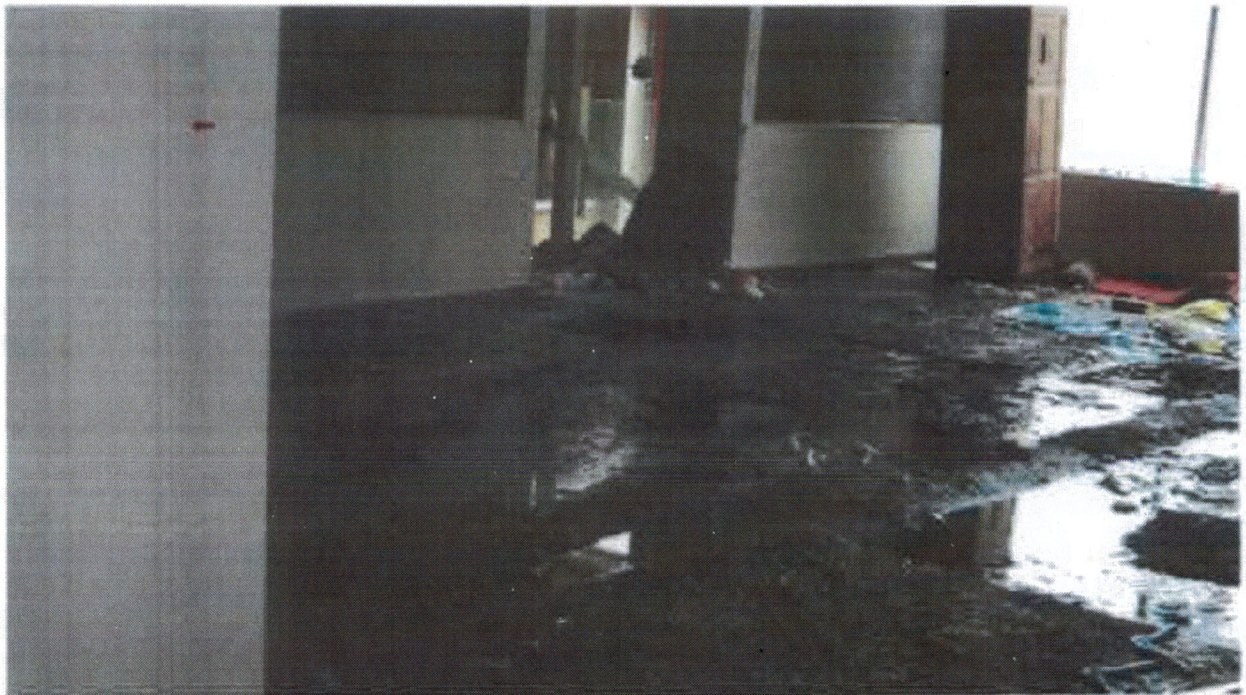
Photo 4 - Ground floor water damage to floors walls and ceiling.

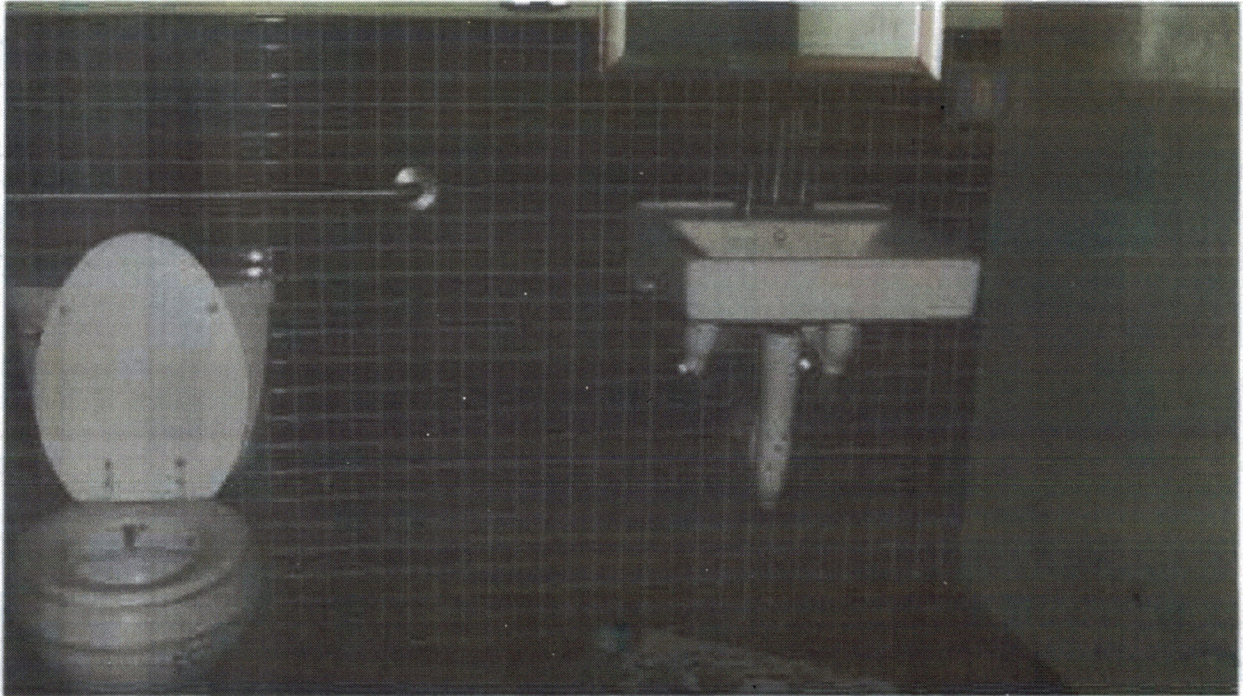
Photo 5 - Bathroom on ground floor. Mold and mildew starting to grow on walls and fixtures. Fixtures and plumbing appear to be functional.

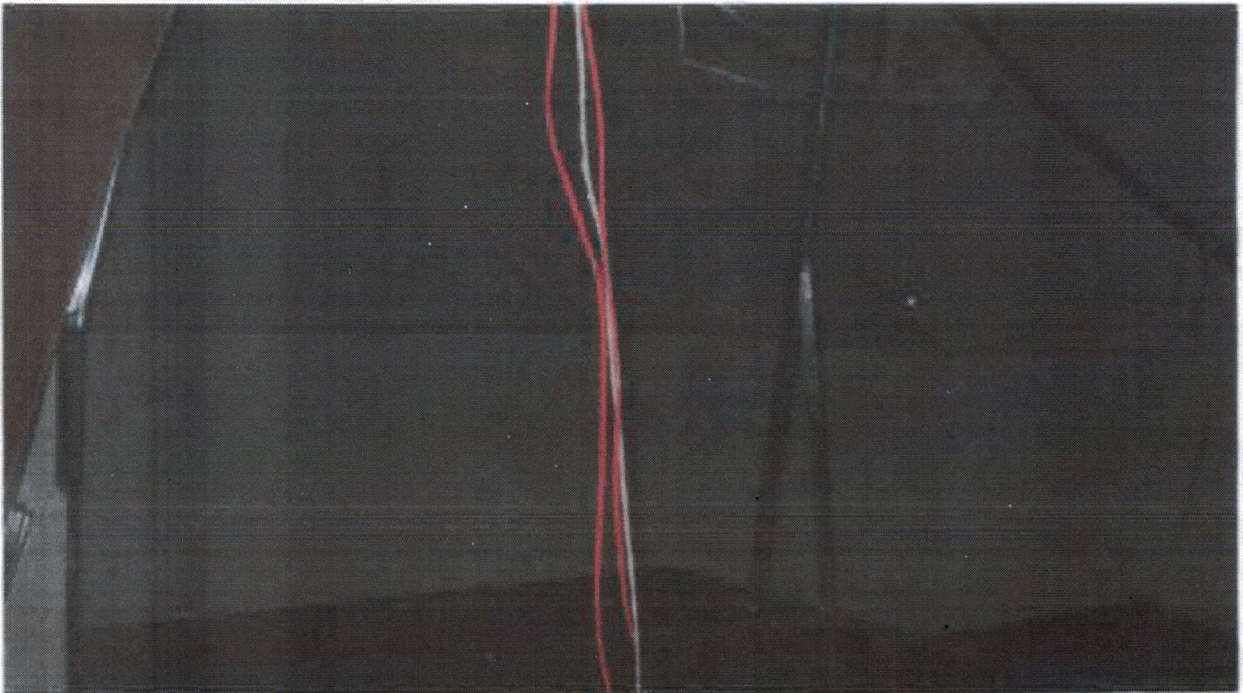
Photo 6 - Ground floor water damage to floors walls and ceiling. Mildew and mold growing on the walls.

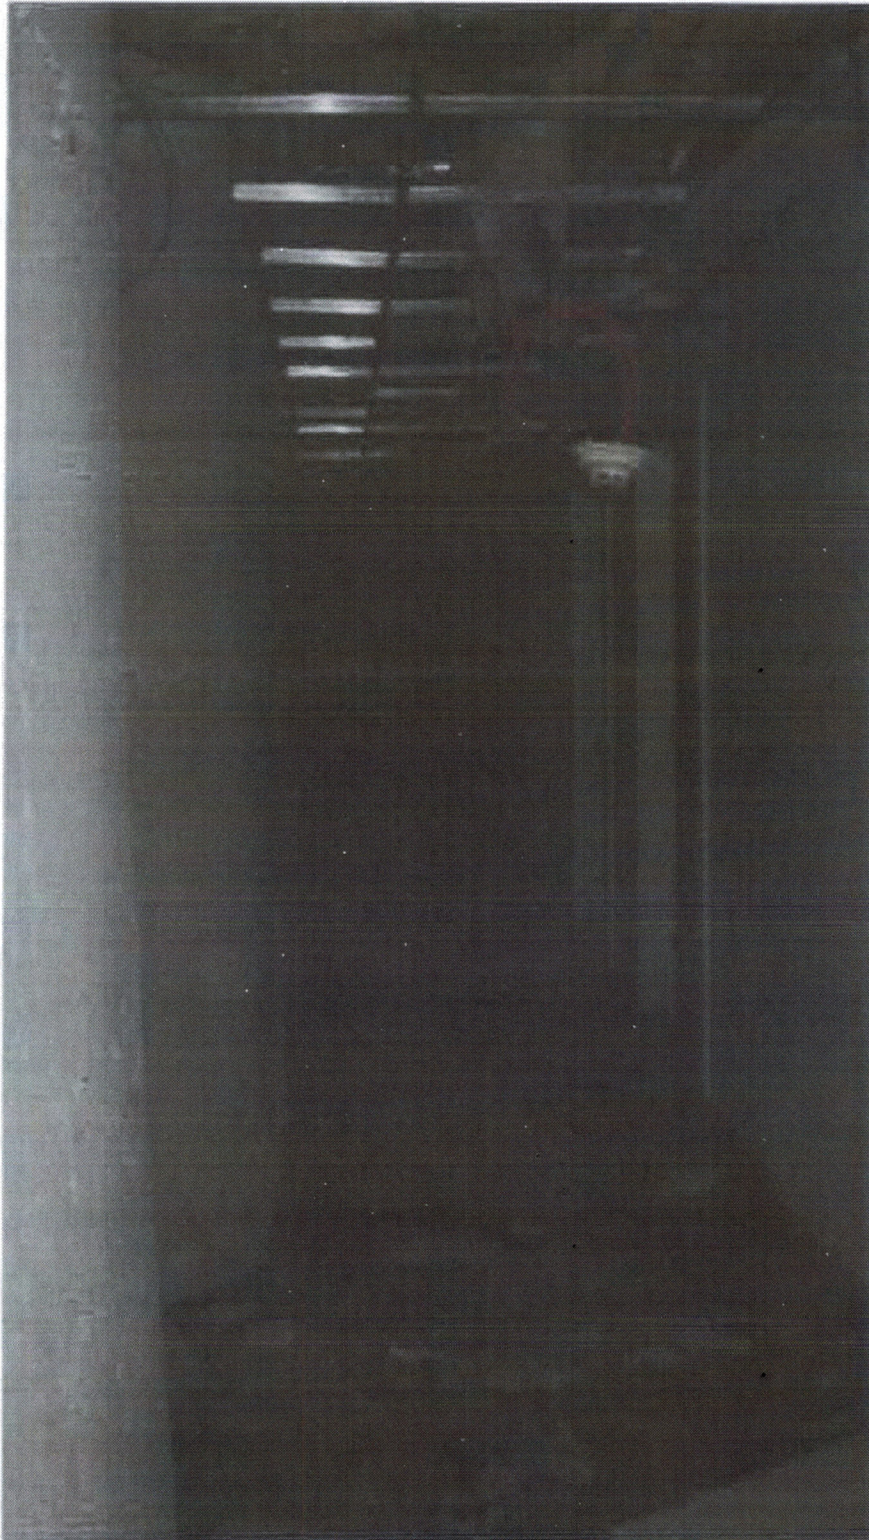
Photo 7 - Basement with approximately 1' of water. Gypsum wall board and suspended ceiling are water soaked

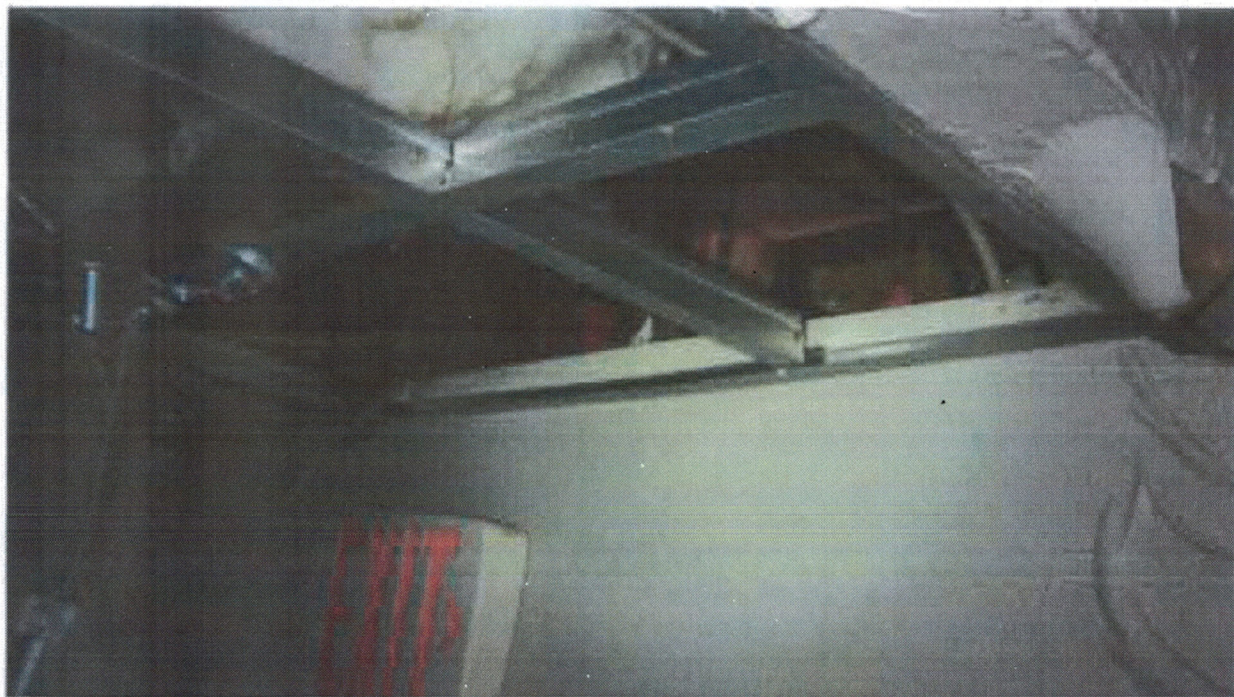
Photo 8- Basement ceiling. Brick wall is visible between joist above suspended ceiling.

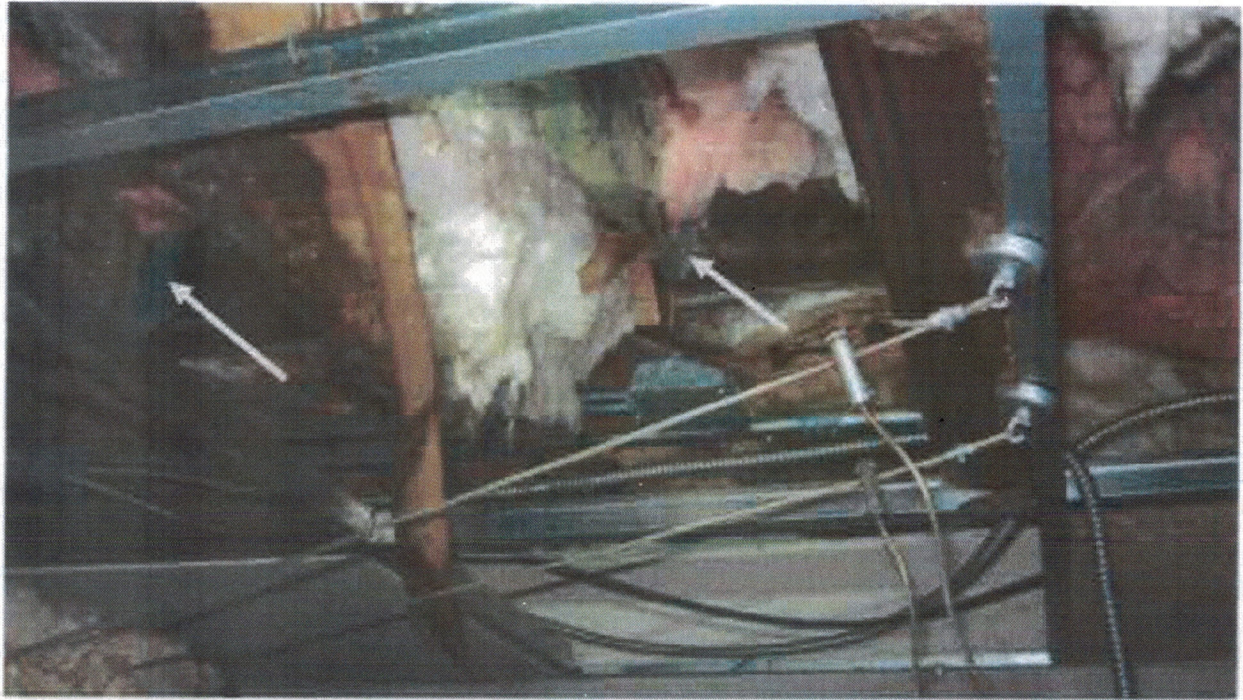
Photo 9 - Basement ceiling framing visible, see joist clips indicating a structural retrofit in the past 20-years or so.

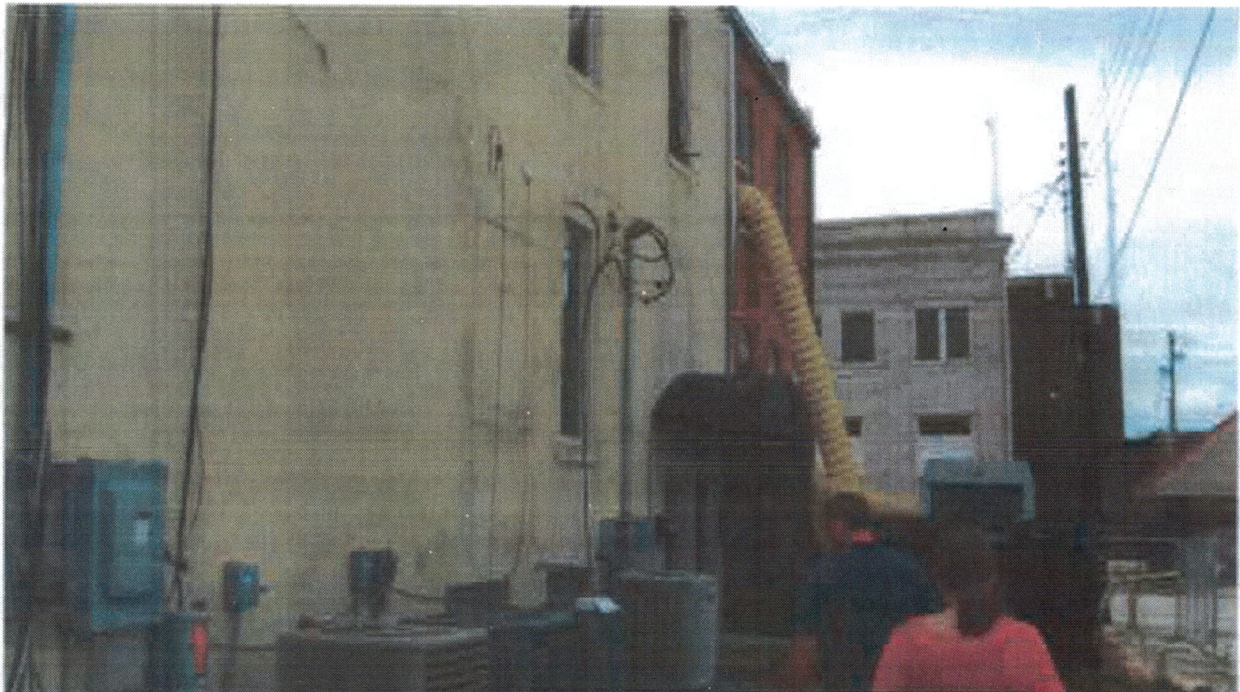
Photo 10 - West exterior wall, cracks in stucco finish do not appear to be recent. AC condensers appear salvageable.

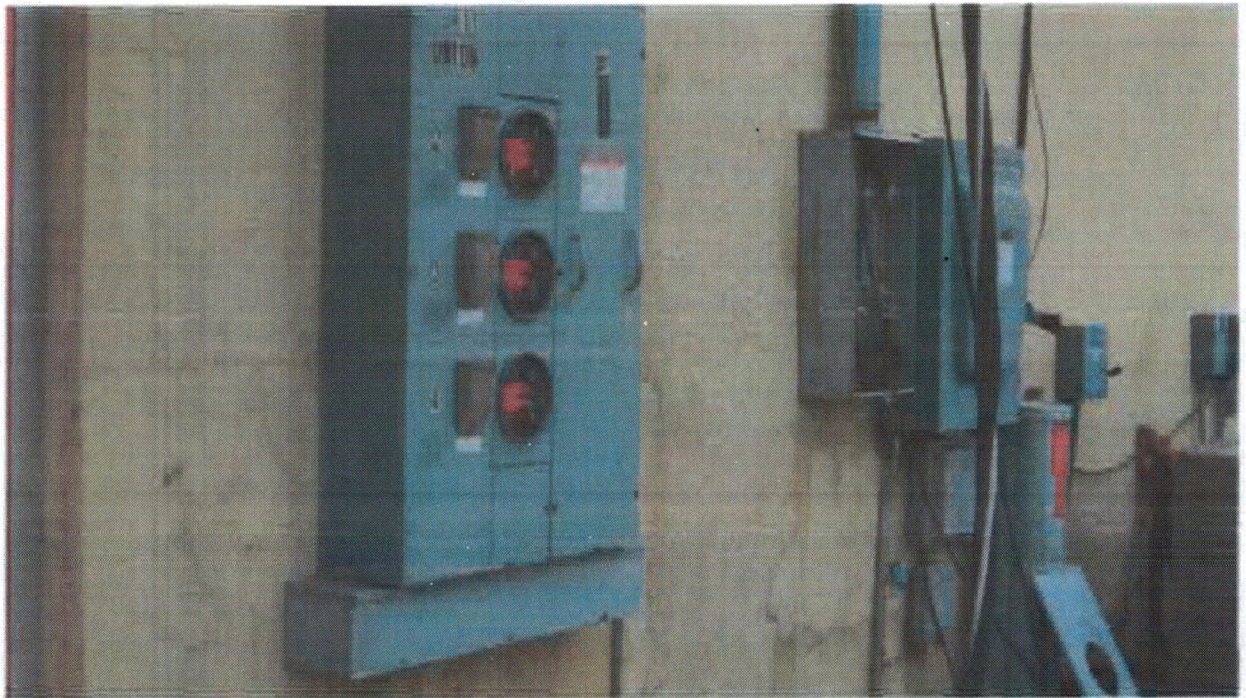
Photo 11 - West exterior wall, cracks are superficial. Electrical meter box and control boxes are undamaged.

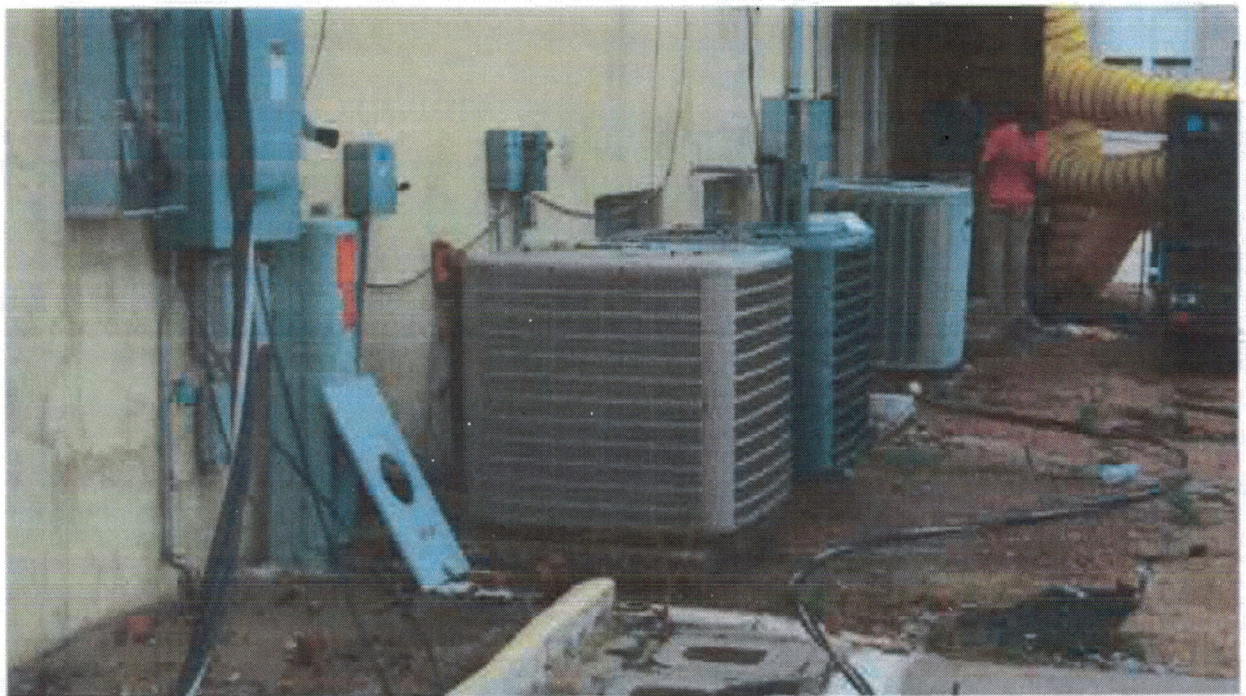
Photo 12 - West wall. Condensing units are undamaged.

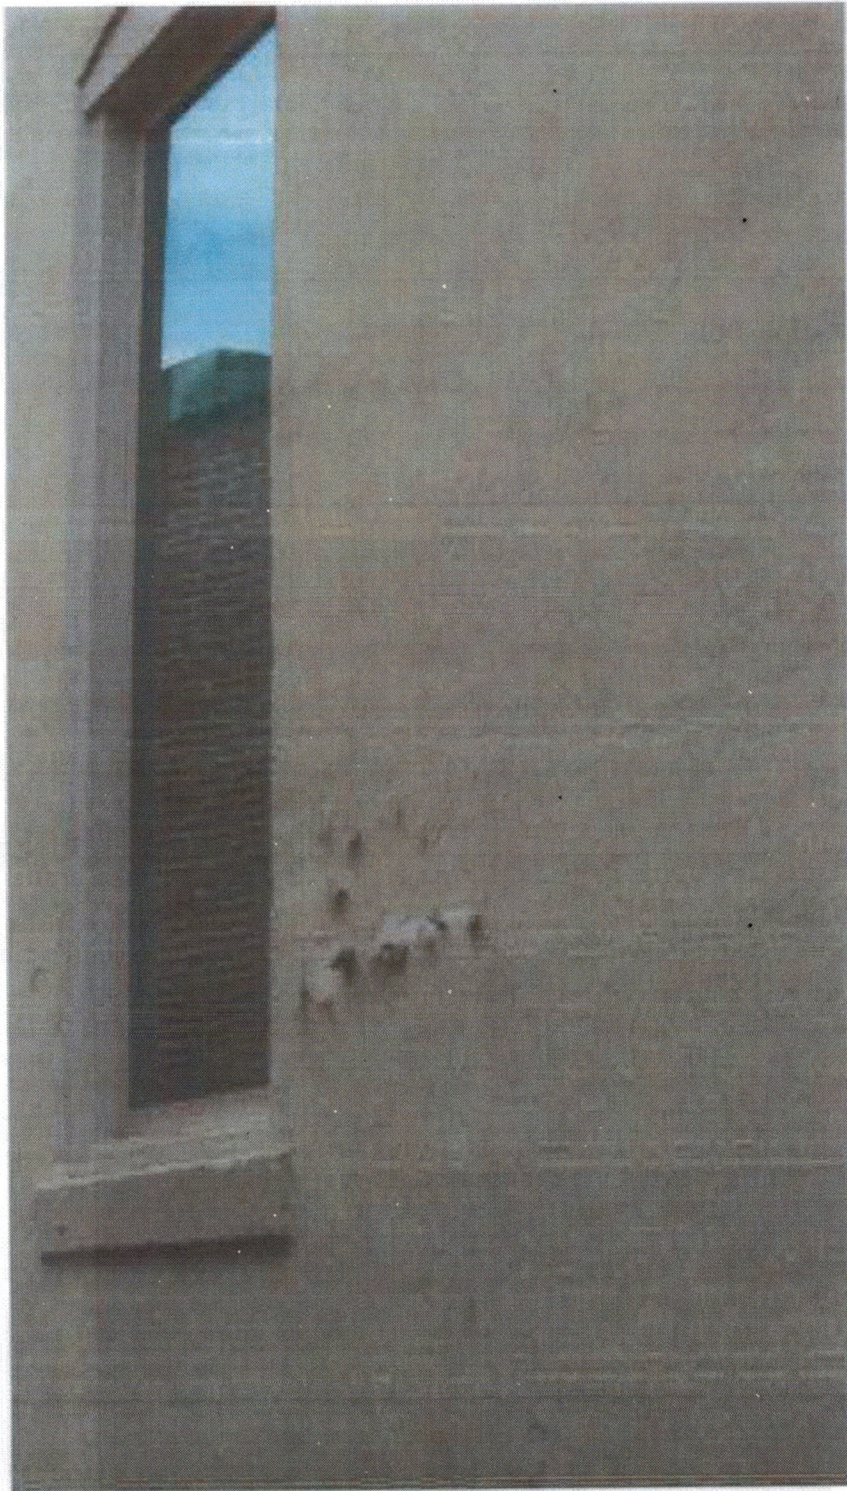
Photo 14 - North wall. Peeling paint.
