PARSONS ENGINEERING, INC
P.O. BOX 1027
STATE UNIVERSITY, AR 72467

STRUCTURAL INSPECTION REPORT

Client: City of Jonesboro
515 West Washington
Jonesboro, Ar. 72401

Services: A structural inspection of Justice Complex at 410 West Washington in Jonesboro, Arkansas was conducted. The inspection was limited to the roof system of the building. An as-built roof trusses analysis was performed on the roof system. The trusses were measured and analyzed for existing dead loads and a 20 pound per square foot live load.

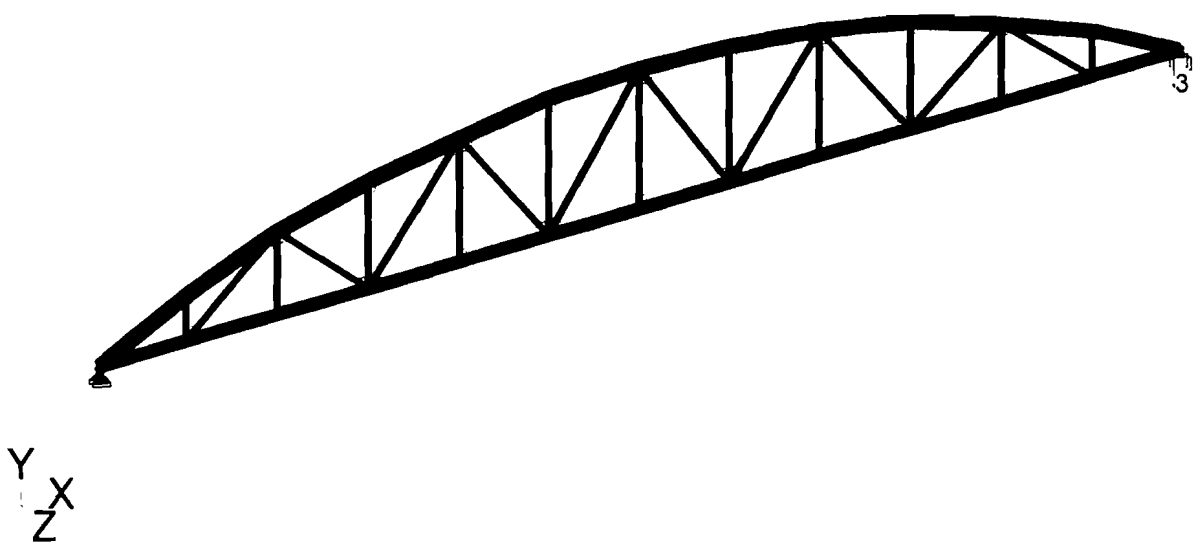
Figure 3 - Finite Element Model

Findings: The roof trusses were inspected and measured so an finite element model of the trusses could be formulated. The trusses consist of a double top cord that is tapered. The top edge of the top cord is curved. See Figure 1. The member is 15' - 4" long with the center 10.5" deep and the ends ranging from 7.25" to 7.5" deep. The member is 3.5" thick. The building plans provided by the city for the remodeling of the building reported the member to be 16" by 3.5 inches. The members were constructed so that the butting of two members on one side of the truss was at the center of the member on the other side of the truss. The bottom cord was a double member that measured 7.75" by 3.5". The verticals and diagonals that ran between the top and bottom cords measured 5.5" by 3.5". The finite element model generated is shown in Figure 2.

The trusses were reinforced with 1.5 inch steel tension rods that ran on each side of the truss. See Figure 3. The tension rods were attached to the truss at the ends of the truss. They were not attached to the truss at interior points. The center of gravity of the rods were 7.125 inches above the center of gravity of the bottom cord. This was modeled in the finite element model.
