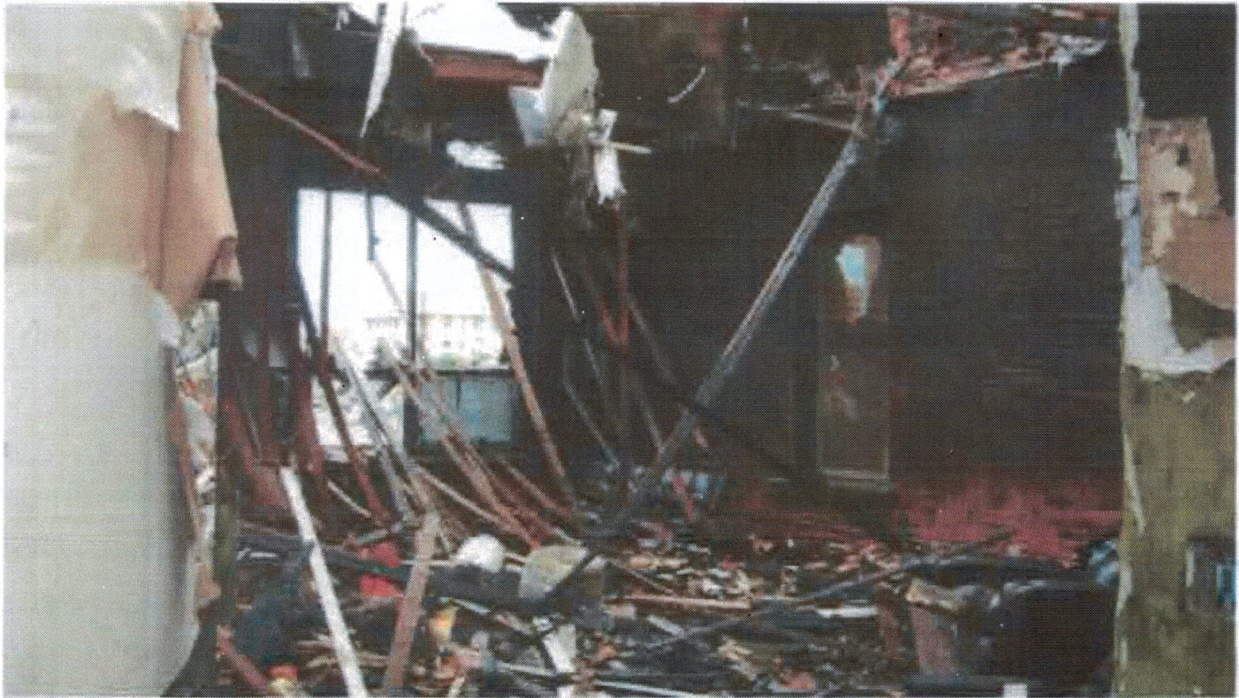
Photo 26 - Loft southeast corner. Ceiling consumed by fire and collapsed onto floor. Noticed wood timber lintel. Parapet above front windows is unstable.

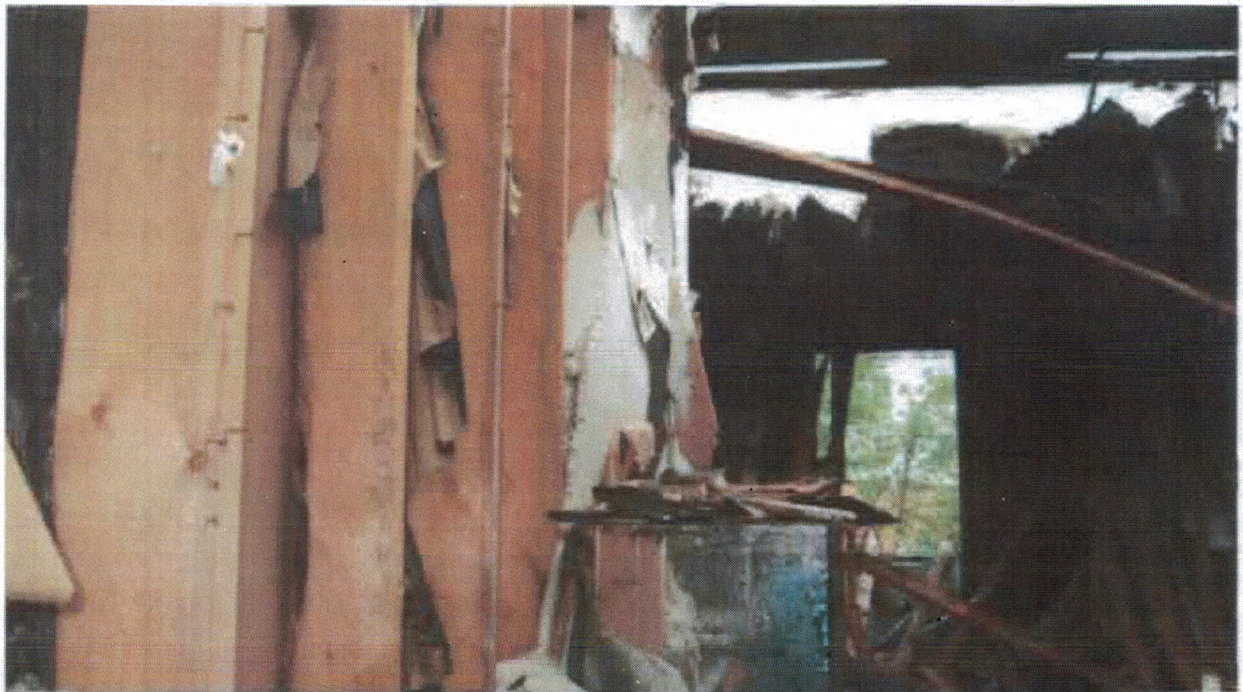
Photo 27 - Loft southeast corner. Ceiling consumed by fire and collapsed onto floor. Gypsum board has been pulled off of interior partition.

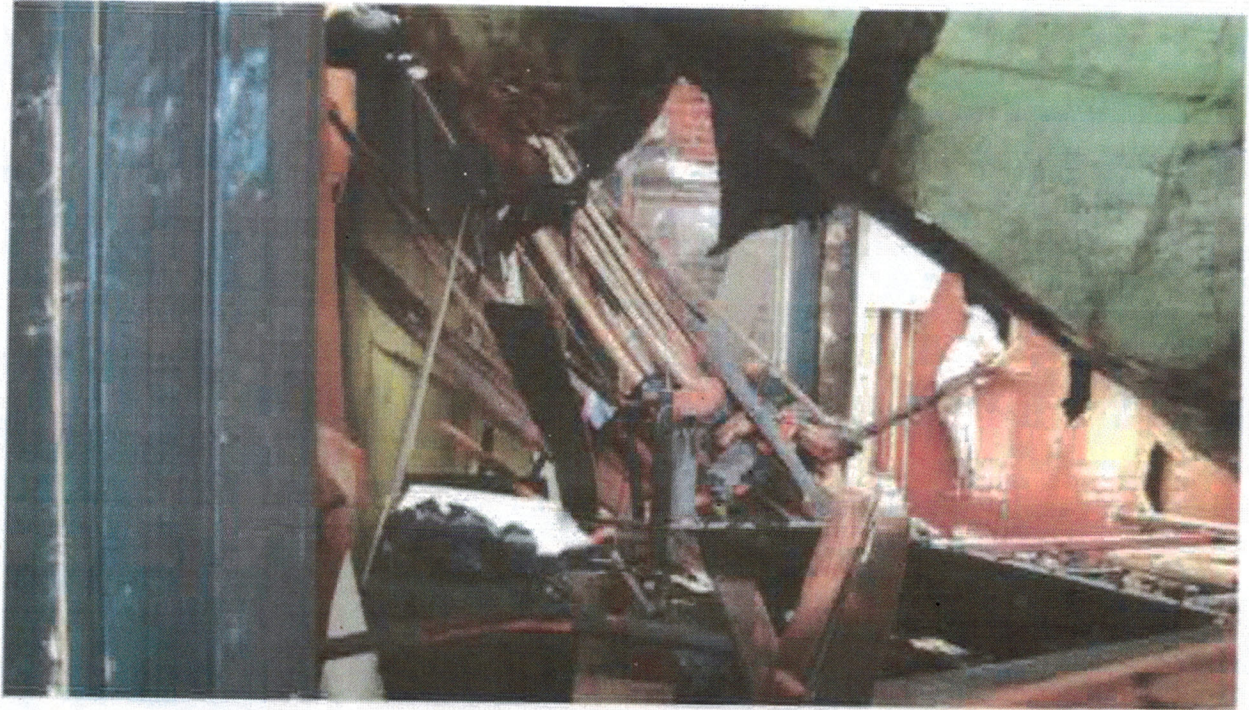
Photo 28 - Loft southwest unit. Collapsed ceiling and walls.

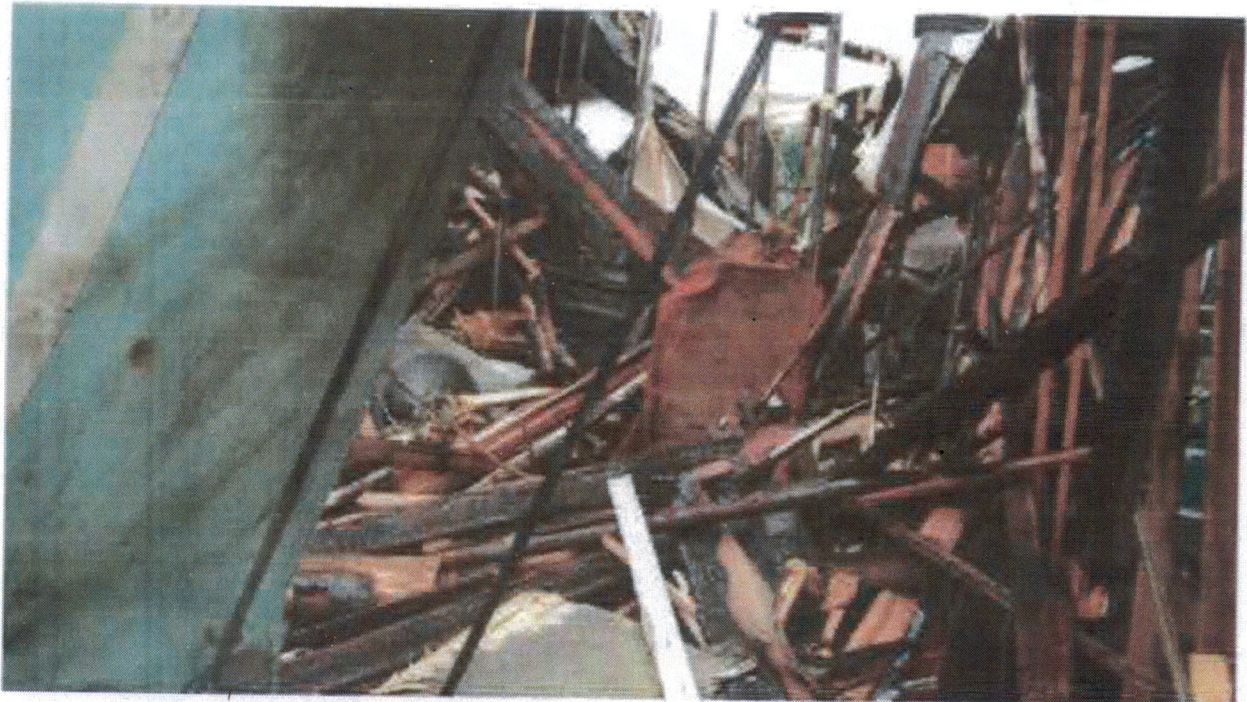
Photo 29 - Loft southwest unit looking west. Collapsed ceiling and walls.

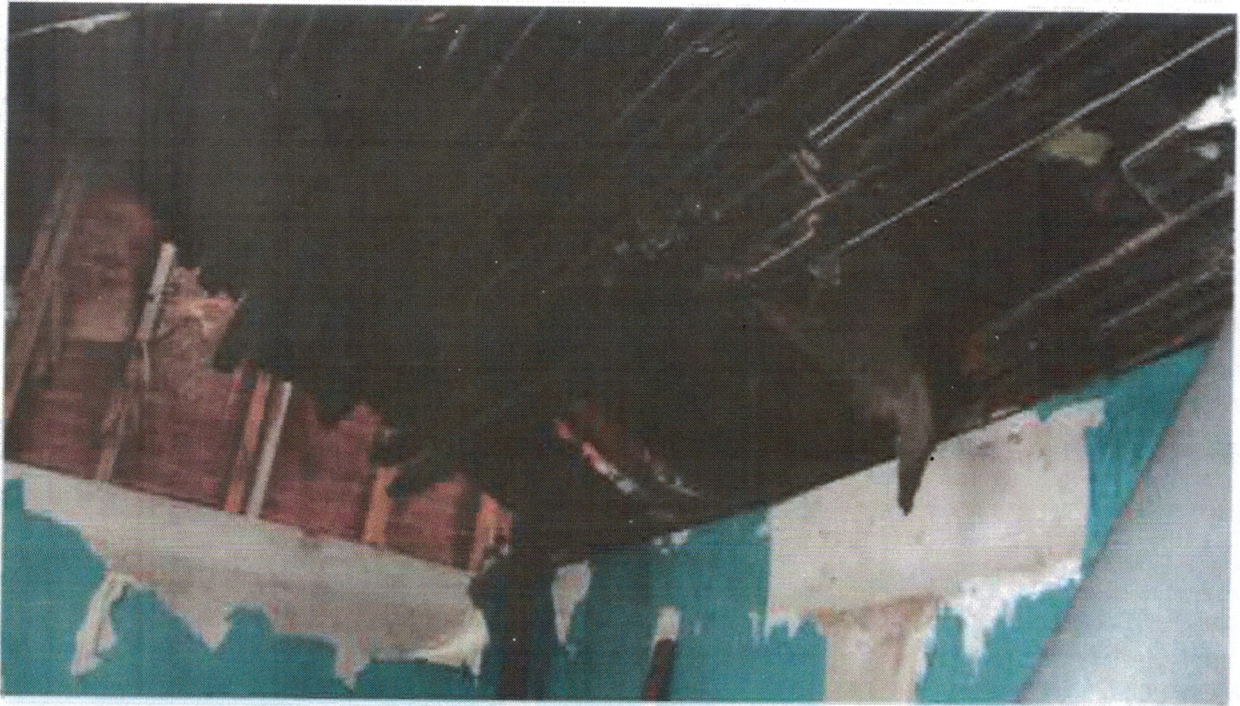
Photo 30 - Loft southwest unit looking north. Ceiling joists consumed by fire has fallen onto interior partition

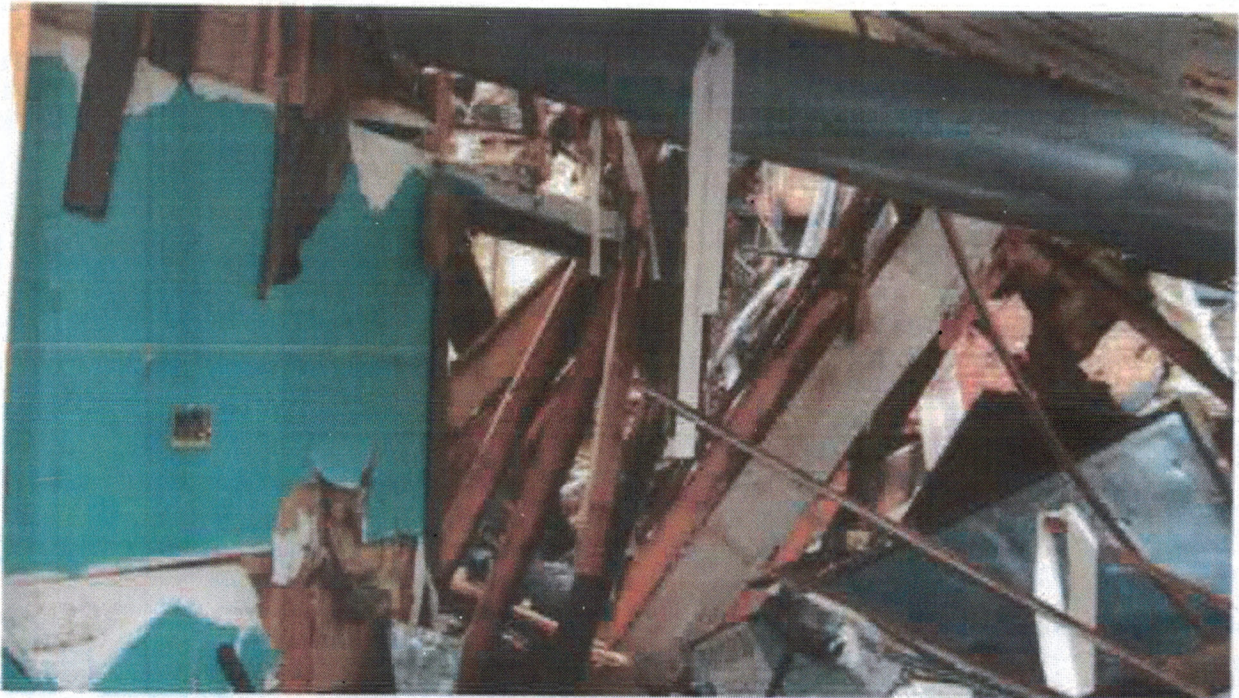
Photo 31 - Loft southwest unit looking south. Ceiling and walls collapsed onto floor.

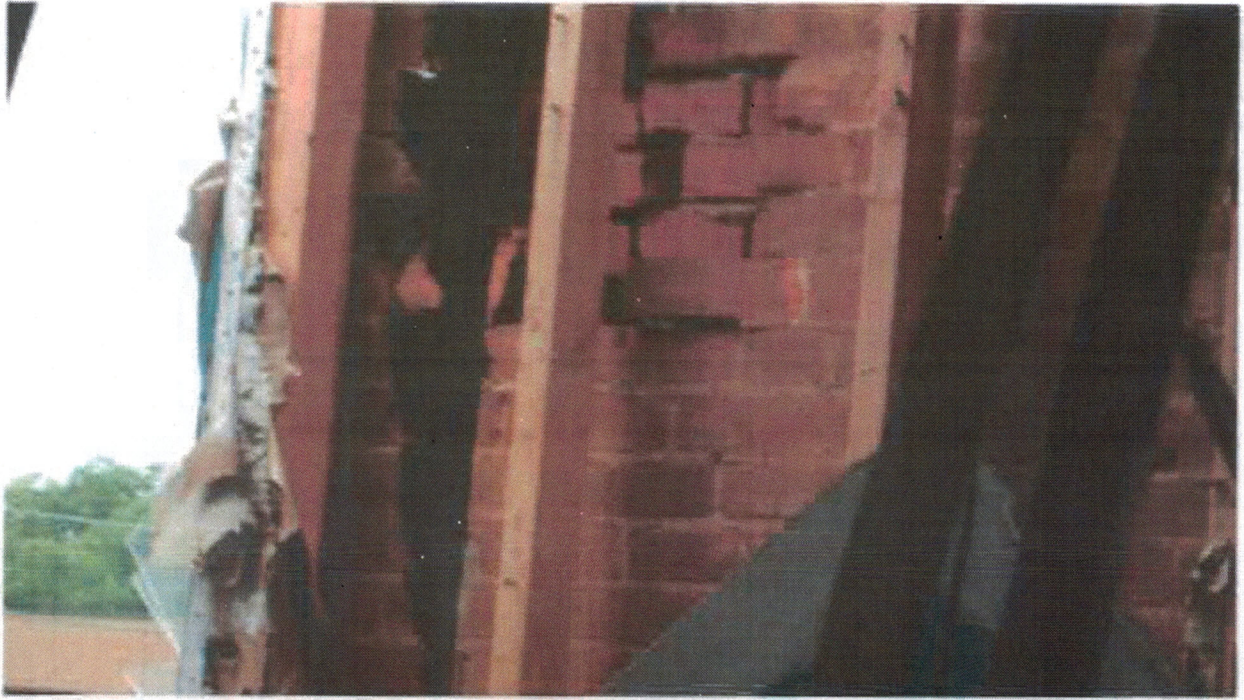
Photo 32 - Loft southwest unit looking south along west wall at window. Window & frame knocked out, damaged brick

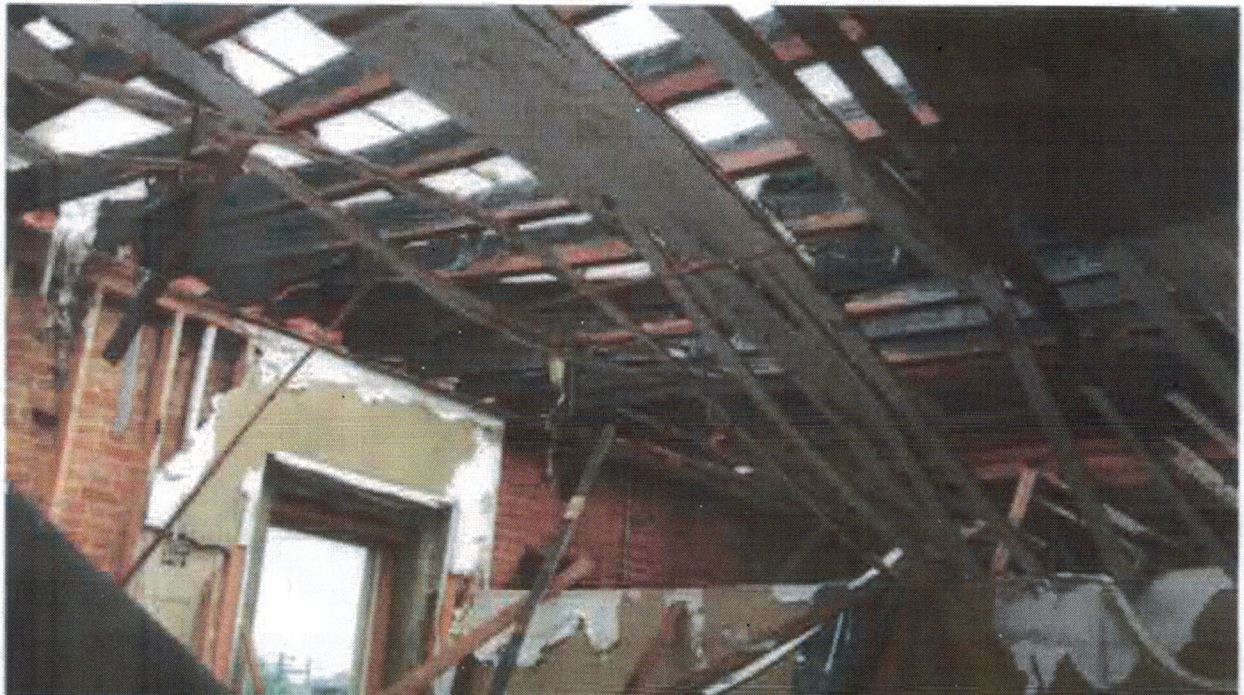
Photo 33 - Loft southwest unit looking north. Roof joists consumed by fire, roof and partition walls have collapsed.

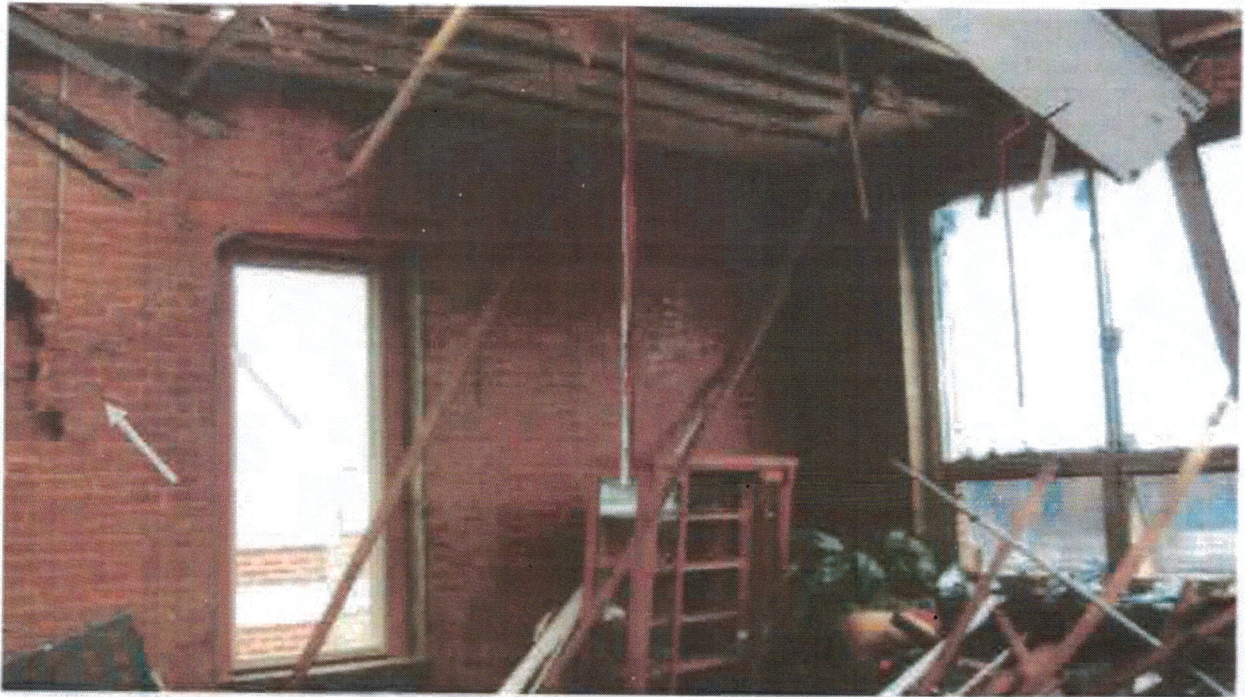
Photo 34 - Loft northeast unit looking north: ceiling collapse. Location where delaminated brick was noted.

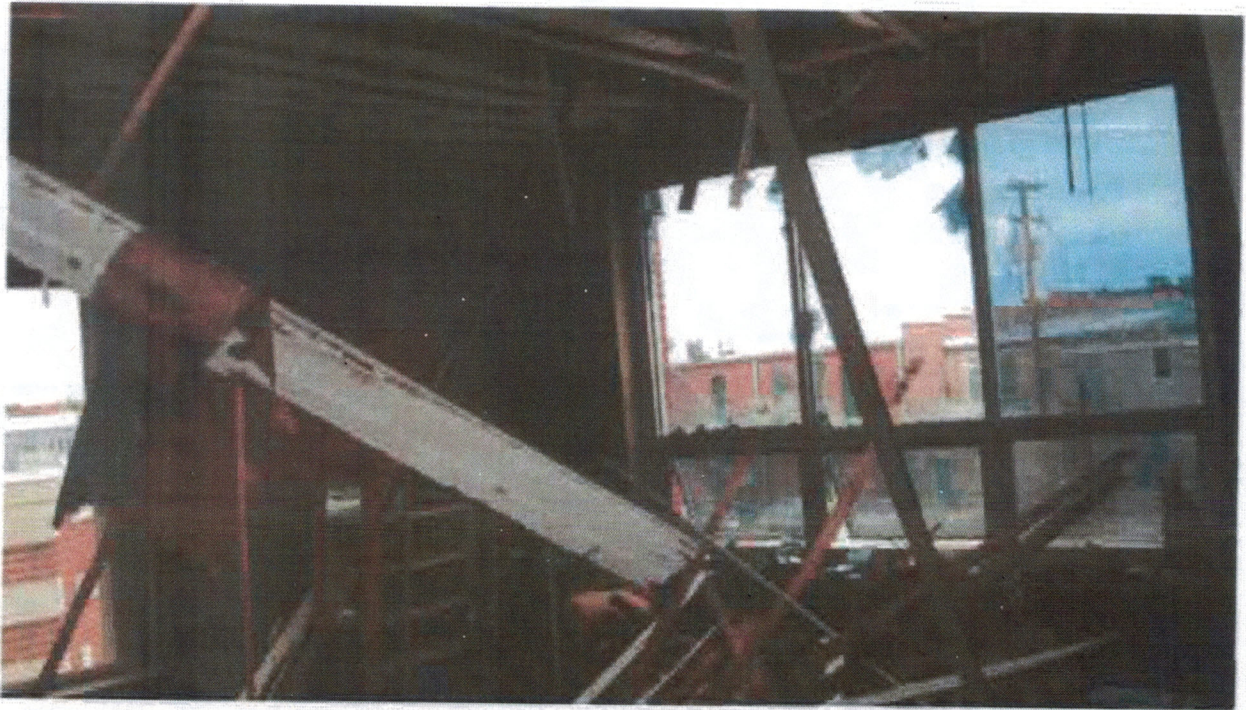
Photo 35 - Loft northeast unit looking at northeast corner of building. Ceiling collapse.

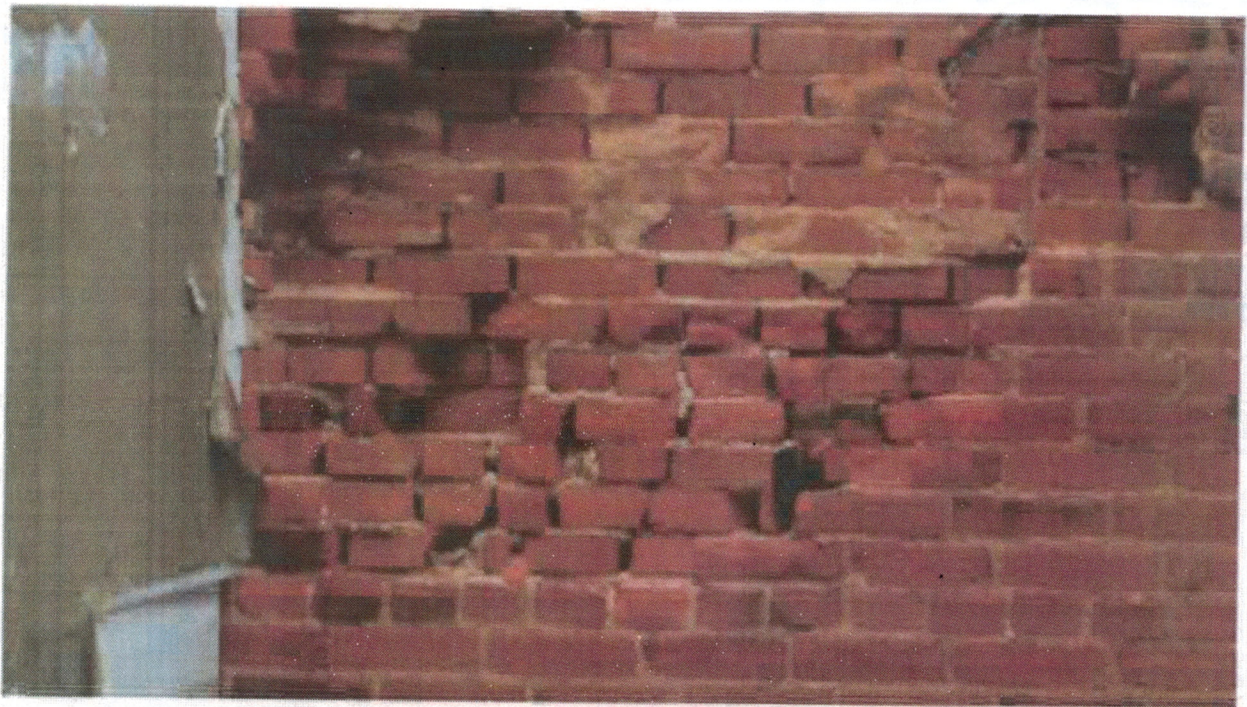
Photo 36 - Loft northeast unit looking east. Example of brick construction - missing bricks are piled on the floor not just below the bottom of this picture.

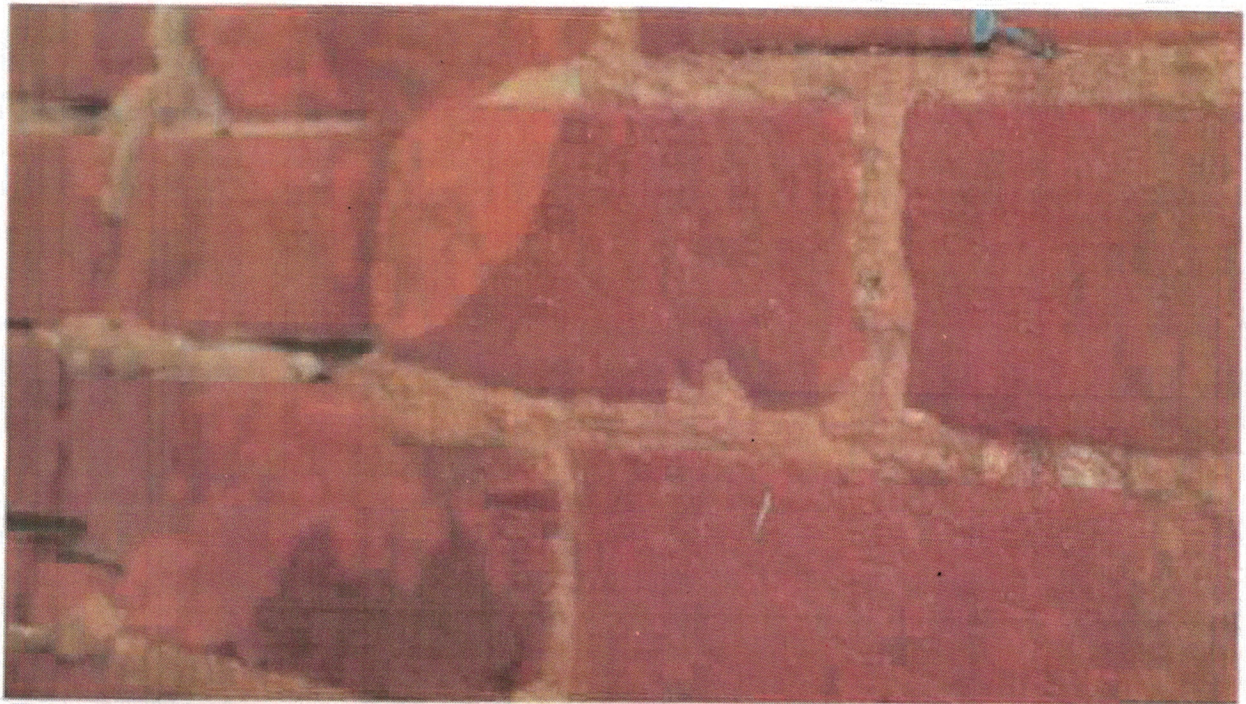
Photo 37 - Loft northeast unit looking east. Example of brick construction - sealant is evident in the darker colored brick. Where sealed the mortar is hard on the exterior of the brick, but soft 1/2" or so within the brick wall.

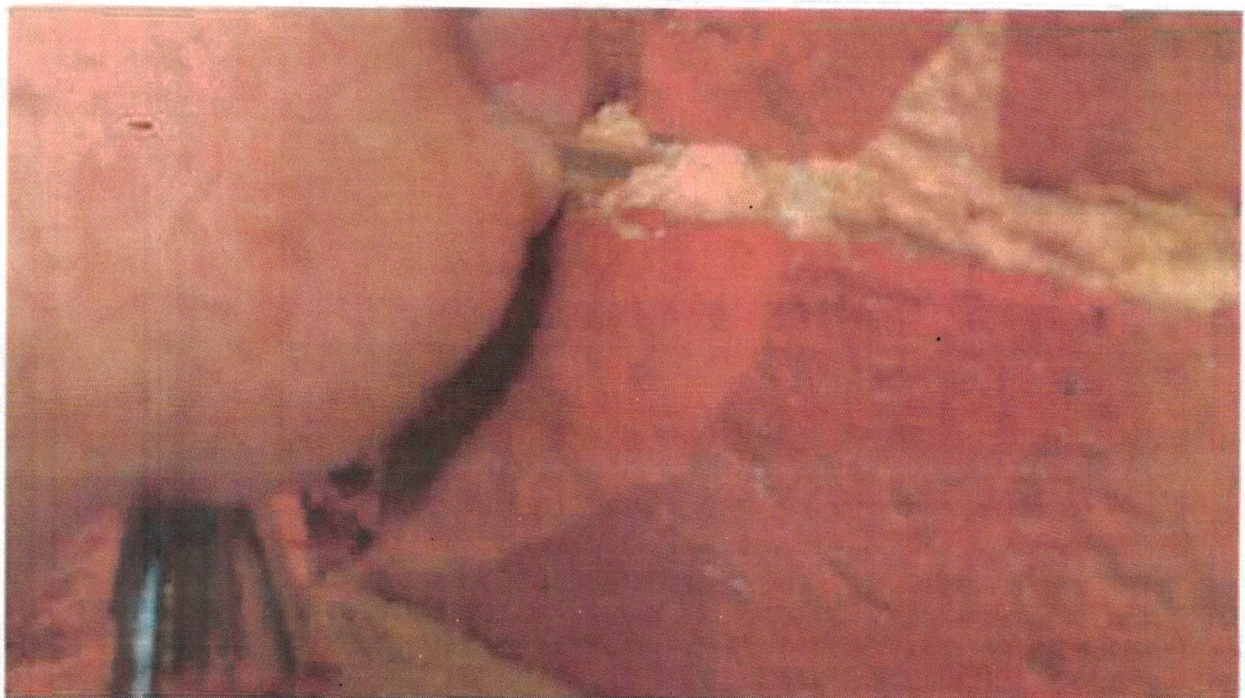
Photo 38 - Loft northeast unit looking east. Example of brick construction - Mortar is soft and can be scraped out with my key.

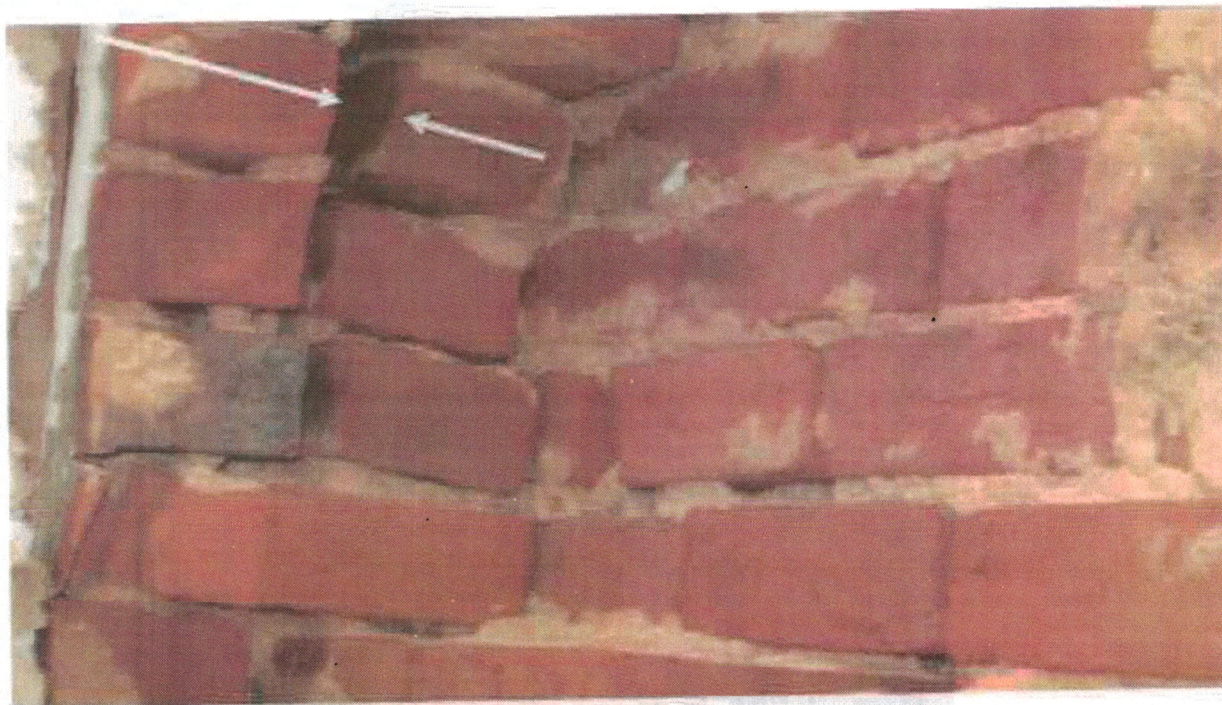
Photo 39 - loft northeast unit looking at same damaged area to brick. Interior face of brick has moved approximately 1" or more from interior wythes. Mortar not bonding - notice the lack of mortar on the face of brick units
