ADDITIONAL ENGINEERING EVALUATION ITEMS

Building Location: 100 W. Washington Ave., Jonesboro, AR

Building Located at 100 W. Washington in Jonesboro, Arkansas
(Previously the Citizens Bank Building)

**Structural Assessment
100 W. Washington Avenue
Jonesboro, AR 72401**

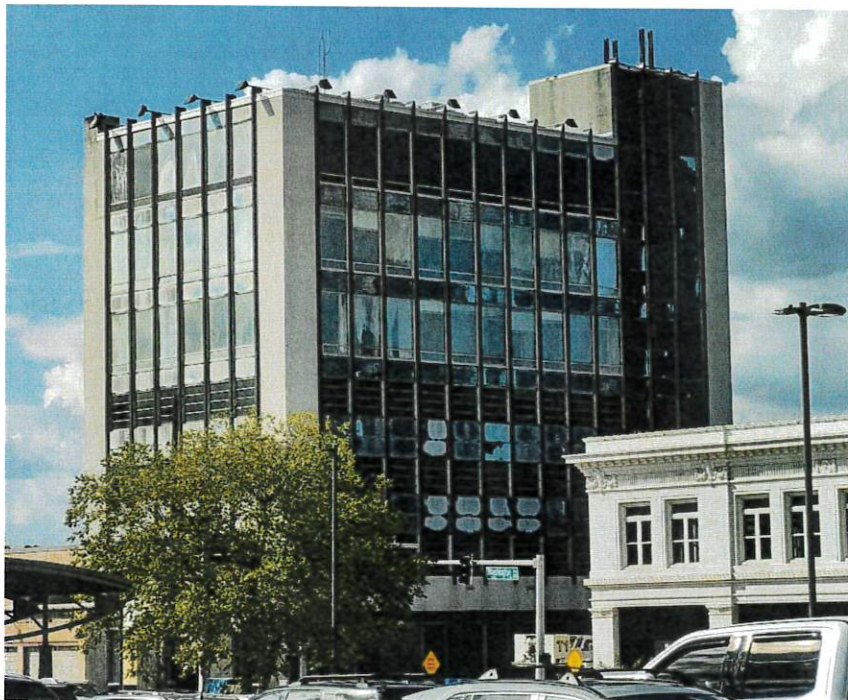
1. The exterior facade around the east and south sides of the building do not appear to be anchored properly to the structure. This can be seen visually on the east side of the building where the vertical precast columns are bulging out approximately 7 to 8 inches toward Main Street. This is a hazard for anyone occupying the building and for anyone outside the building.
2. The roof and walls are not sealed off from outside weather and it appears hazardous mold is present throughout the building structure.
3. The amount of asbestos present in the building is not known currently. Some asbestos fibers may be in the air and the building should not be occupied until this is resolved.

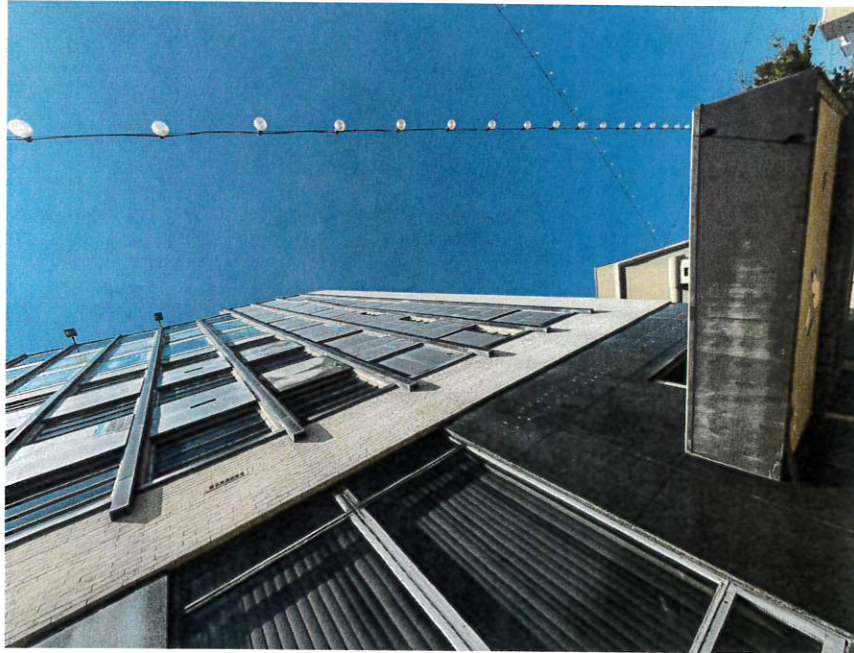
1. Building Face – East Side

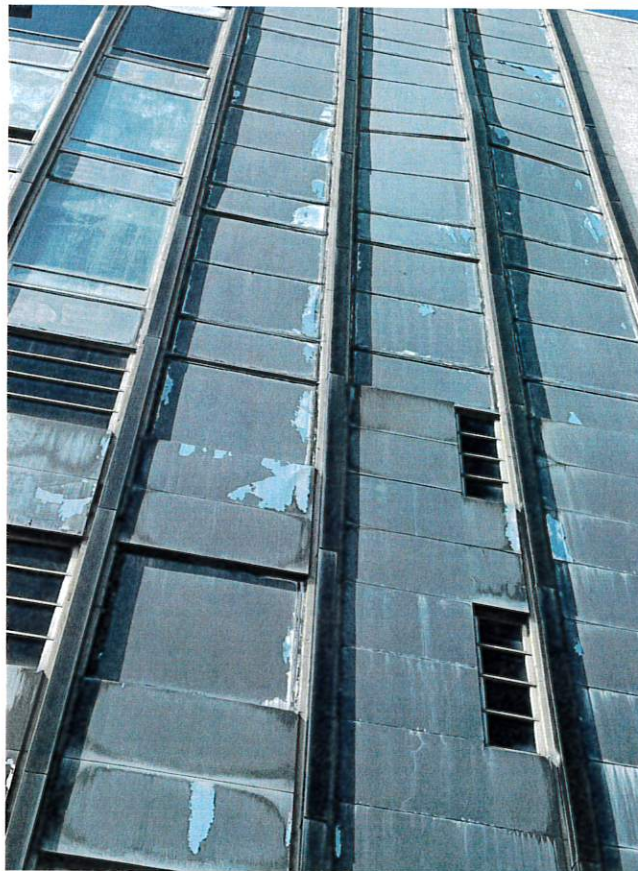
1. Trim between the windows appear to be bowing out (2).
2. Windows at sill appear to be separating from the floor; a gap is apparent (5, 6, 7, 10).
3. The attachment of the window sill to the floor edge appeared to be by means of concrete fasteners and the fasteners broke away from the floor (7)

1. The fact that few of the windows are bowing out may be an indication of loosening of the connection of the window frame to the building. This is evident at the sills of the windows that are visible.
2. It is not clear if and how the jambs of the widows are attached to the building structure.

3. Besides what is shown on the existing drawings, it is not clear how the precast panels are connected to the building structure and what the conditions of the connections are.
4. It is not clear what the cause of the excessive bow in the trim between the windows at two locations.
5. It shall be noted that high wind speed would impose suction on the face of the building and might cause the windows and porcelean panels to pull away from the building.

2. Bow at Widows and Trim

1. Expose the frames of the windows and the porcelean panels by removing the trim at the outside of the building and the finish material at the inside in order to inspect the connections.
2. Expose the connection of the precast veneer to the building structure
3. Inpect the connections that are referenced above in order to verify adequacy and determine further action
4. Reinforce connections as required

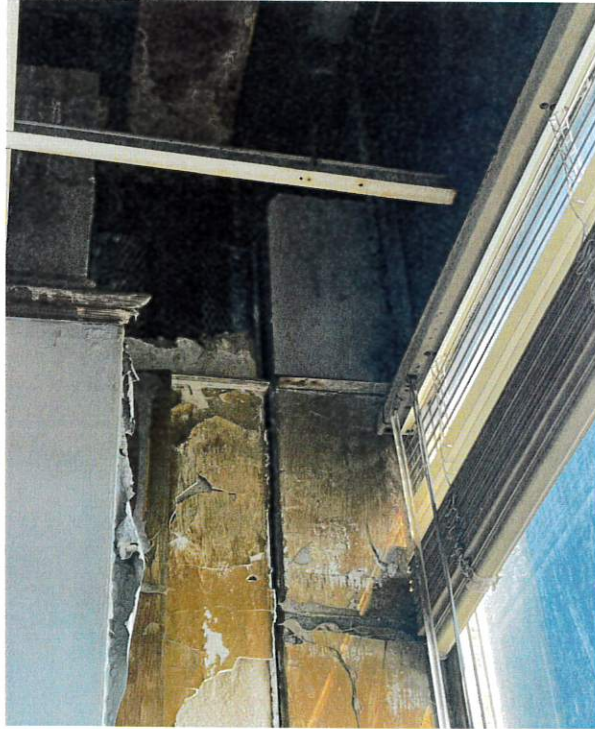
3. Precast at Column

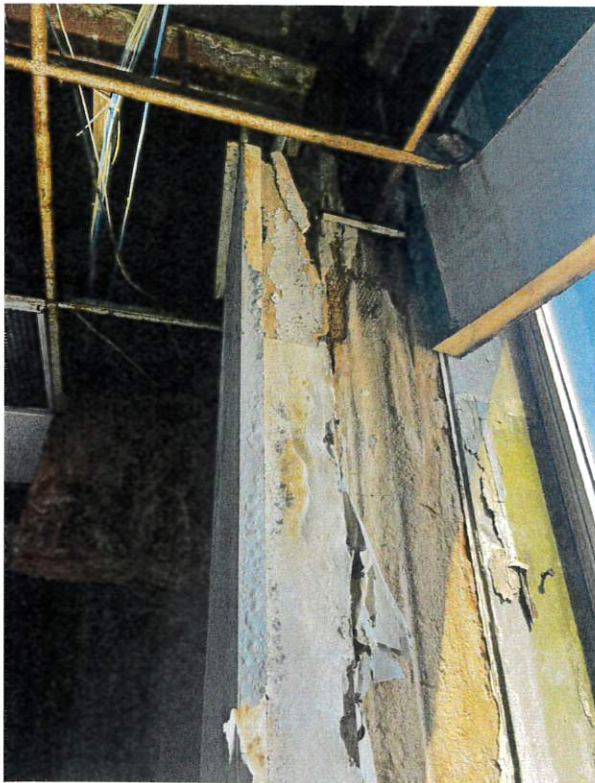
4. Floor Beam at Column

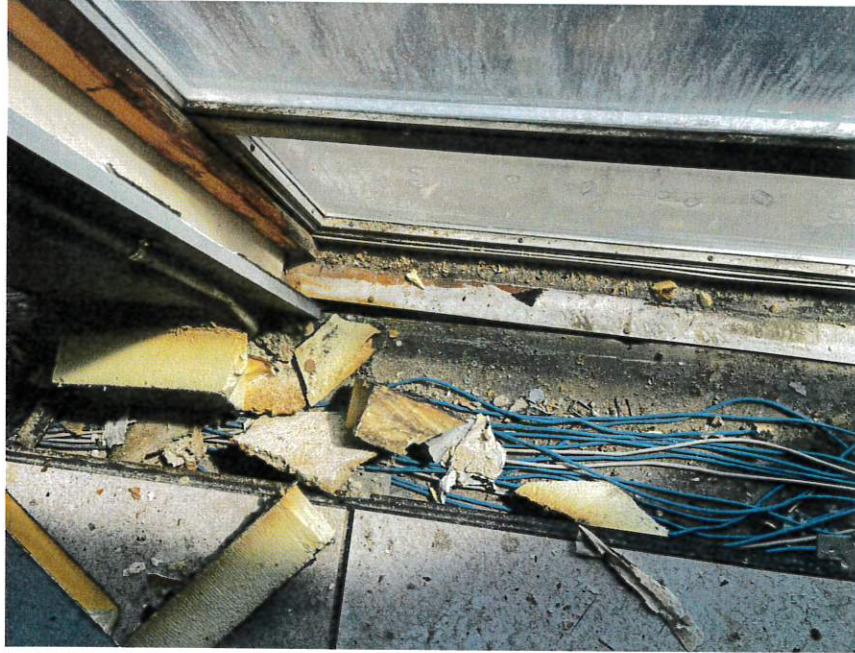
5. Gap at Window Sill

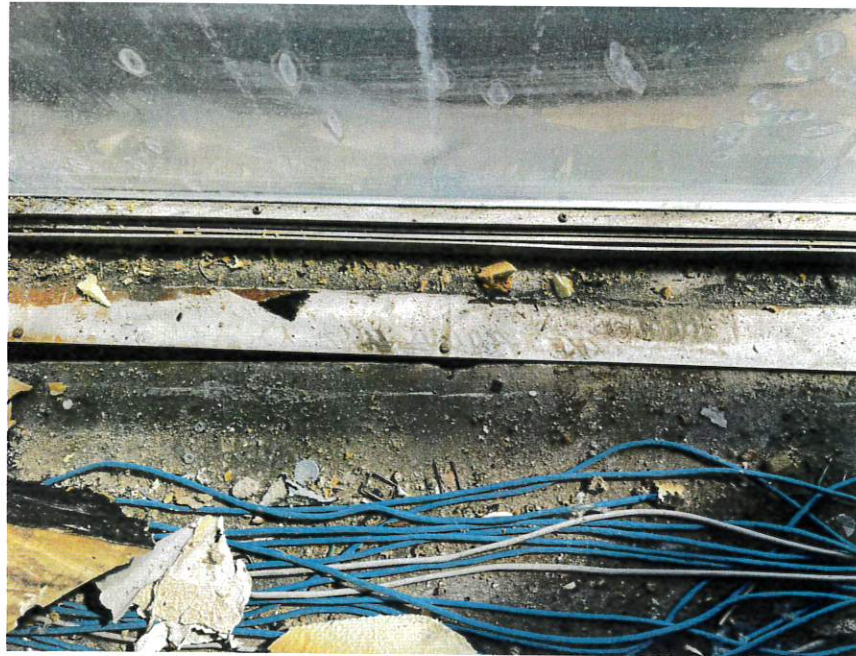
6. Gap at Window Sill

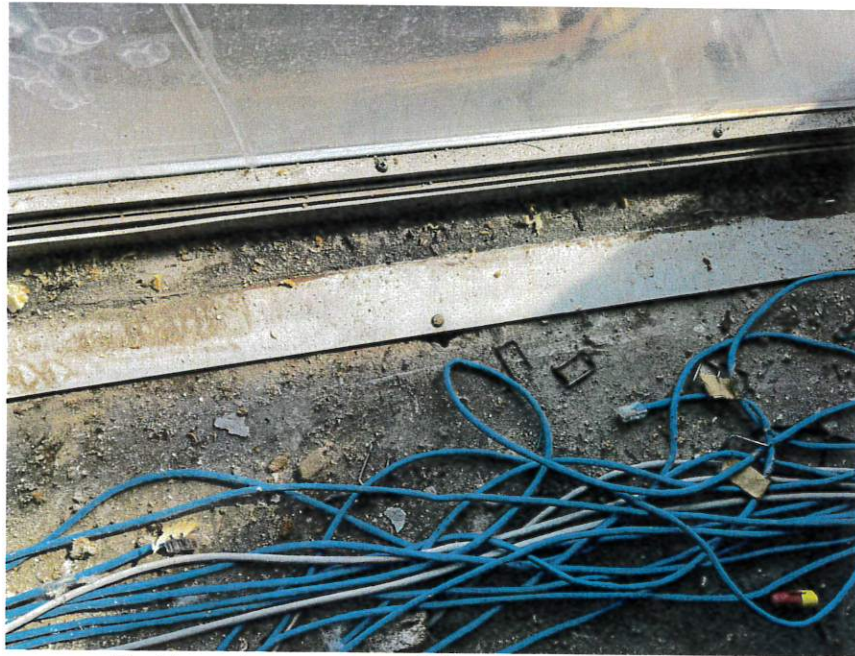
7. Fasteners are Missing at Window Sill

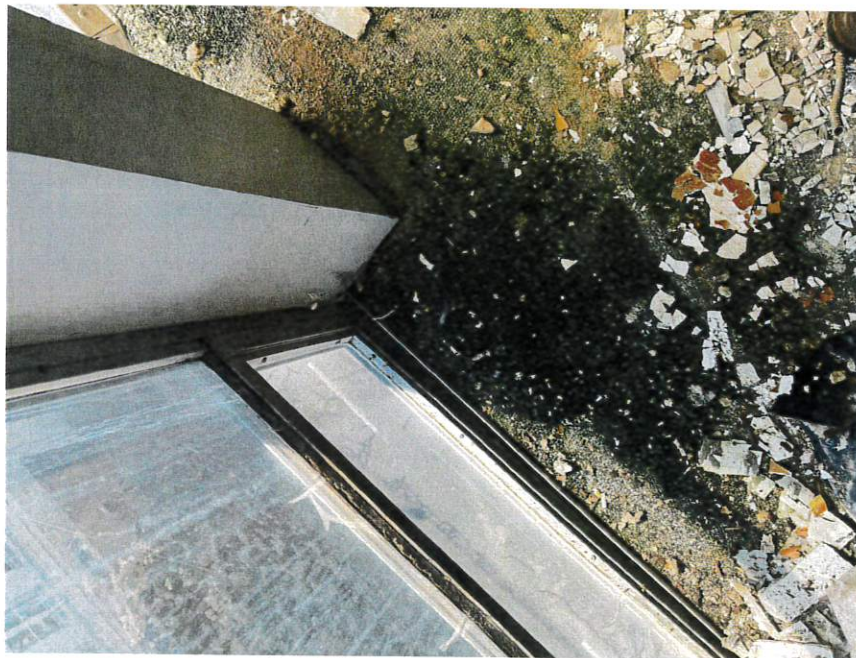
8. Window Jamb

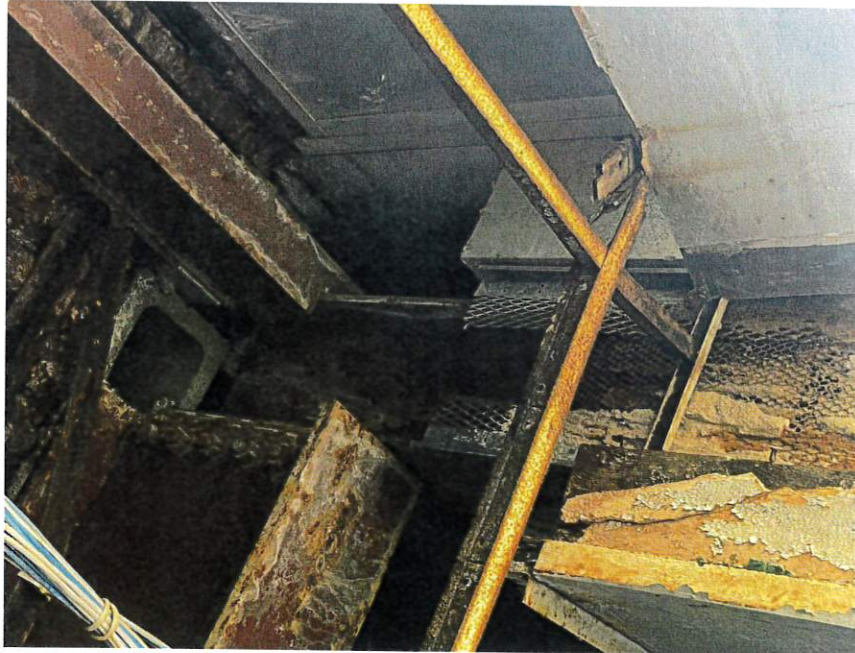
9. Floor Beam at Column Between Windows

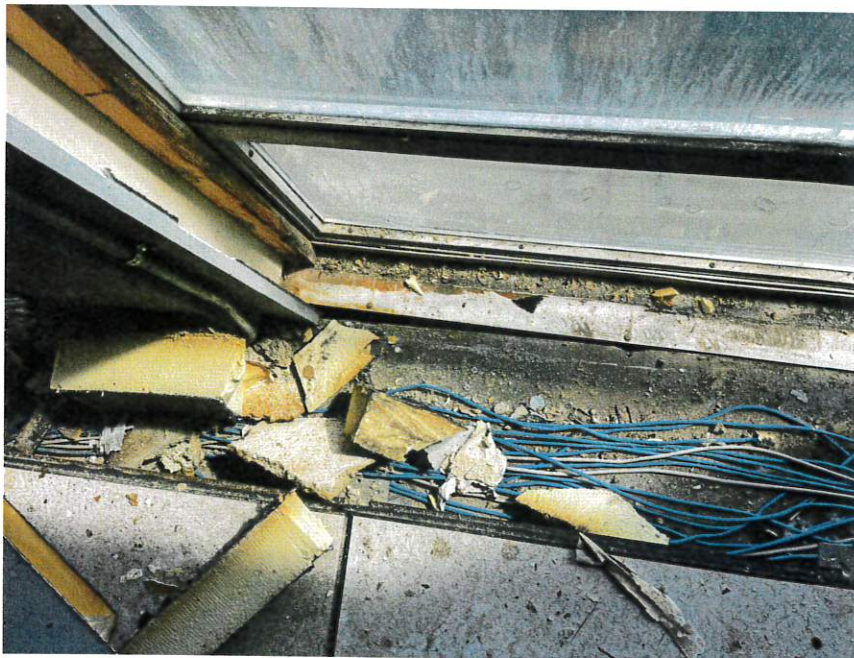
10. Gap at Window Sill
