**RE: JUSTICE COMPLEX TRUSSES**

RE: ROOF STRUCTURE - JONESBORO COURTS/OFFICE/POLICE CENTER

STRUCTURAL INSPECTION REPORT

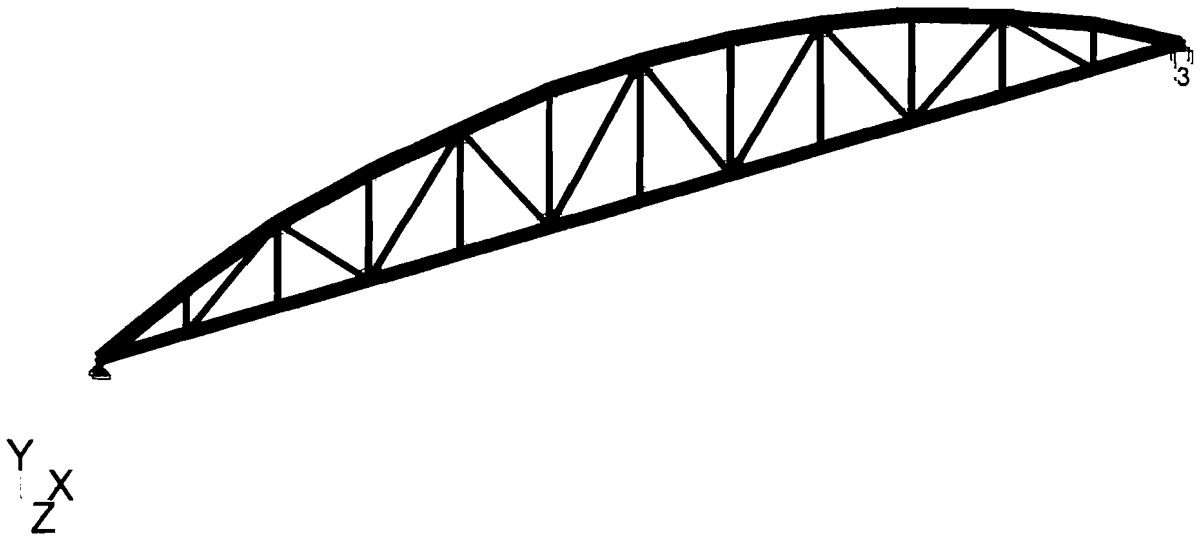
Figure 3 - Finite Element Model

The truss was modeled with one end pinned and the other end permitted to slide. This was done to account for the flexibility of the walls. The analysis of the dead load condition showed that the end of the truss slid 0.59" for a 200 tension pound load on the rods and 0.31" for the 10,000 pound load. The center line deflection was 1.46" and 1.14" respectively. When the live load was added to the truss, the end slid 1.16" and 0.88" for the 200 and 10,000 pound loads. The center line deflection was 2.89" and 2.54" respectively. The truss was 1172" long

Interaction values over one does not mean the roof would fail but the factor of safety is being reduced. The factor of safety for wood would range from 2 to 4. The factor is this large in order to account for the knots and other defects on the wood.
