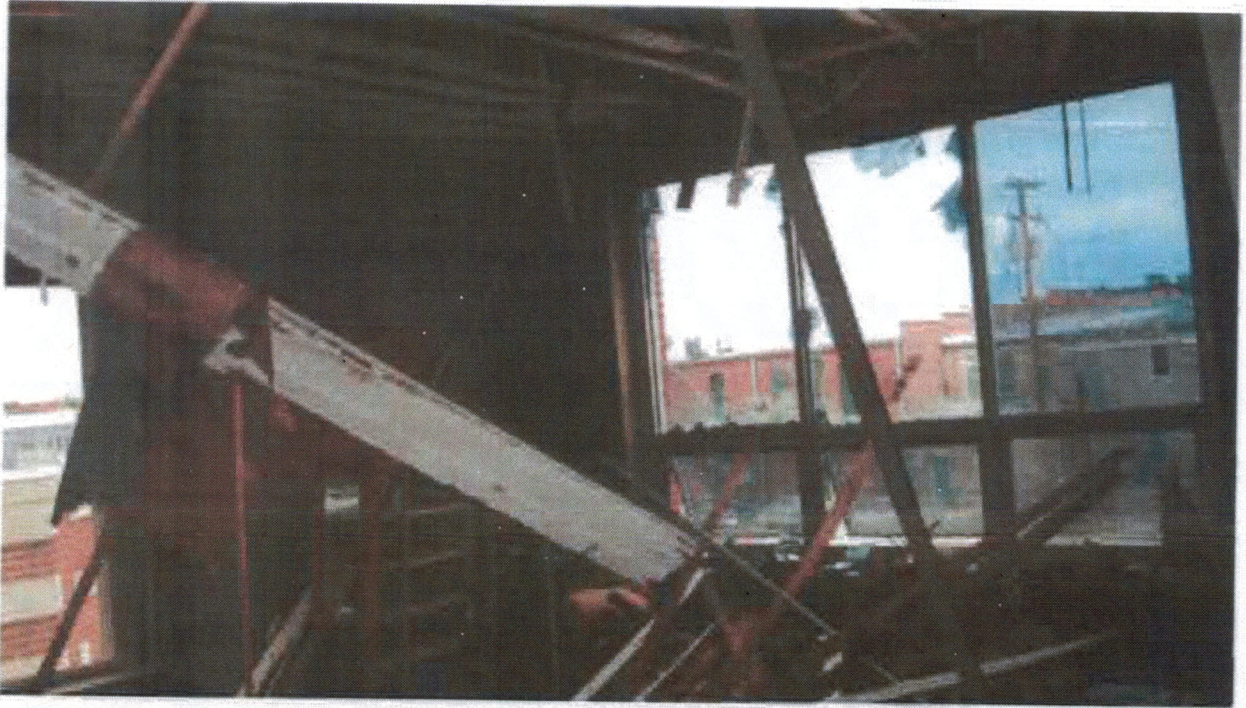
Photo 35 - Loft northeast unit looking at northeast corner of building. Ceiling collapse.

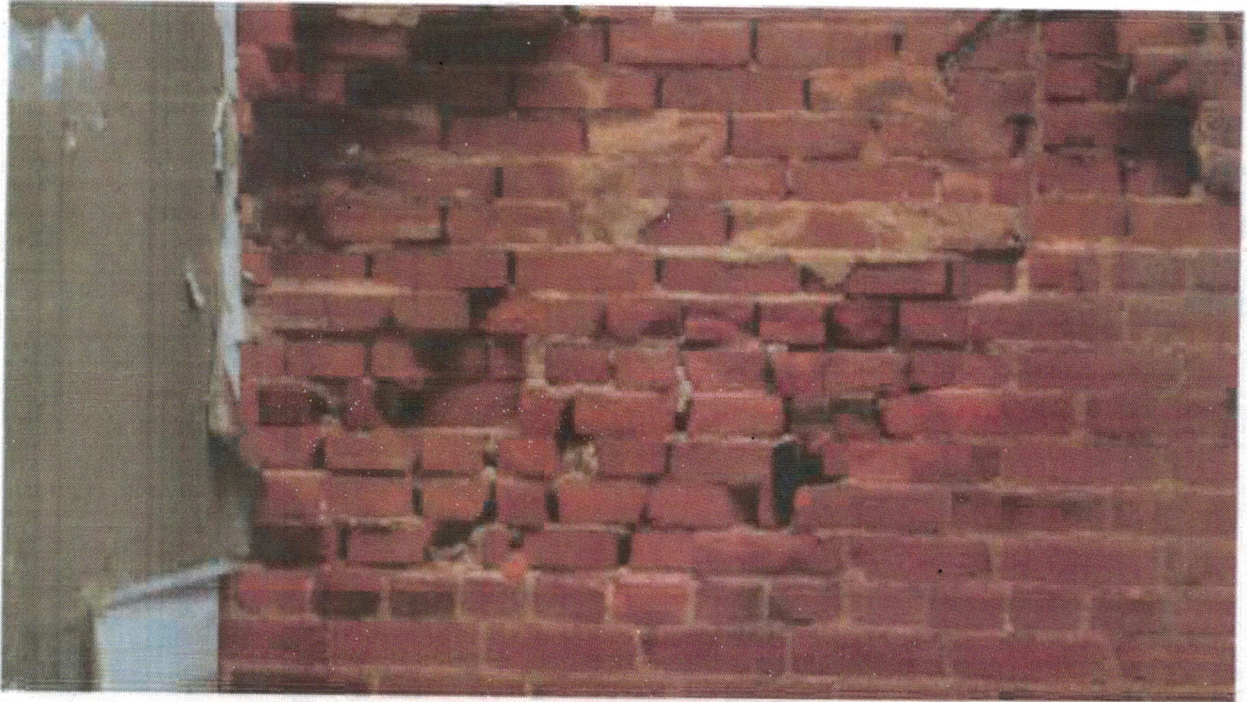
Photo 36 - Loft northeast unit looking east. Example of brick construction - missing bricks are piled on the floor not just below the bottom of this picture.

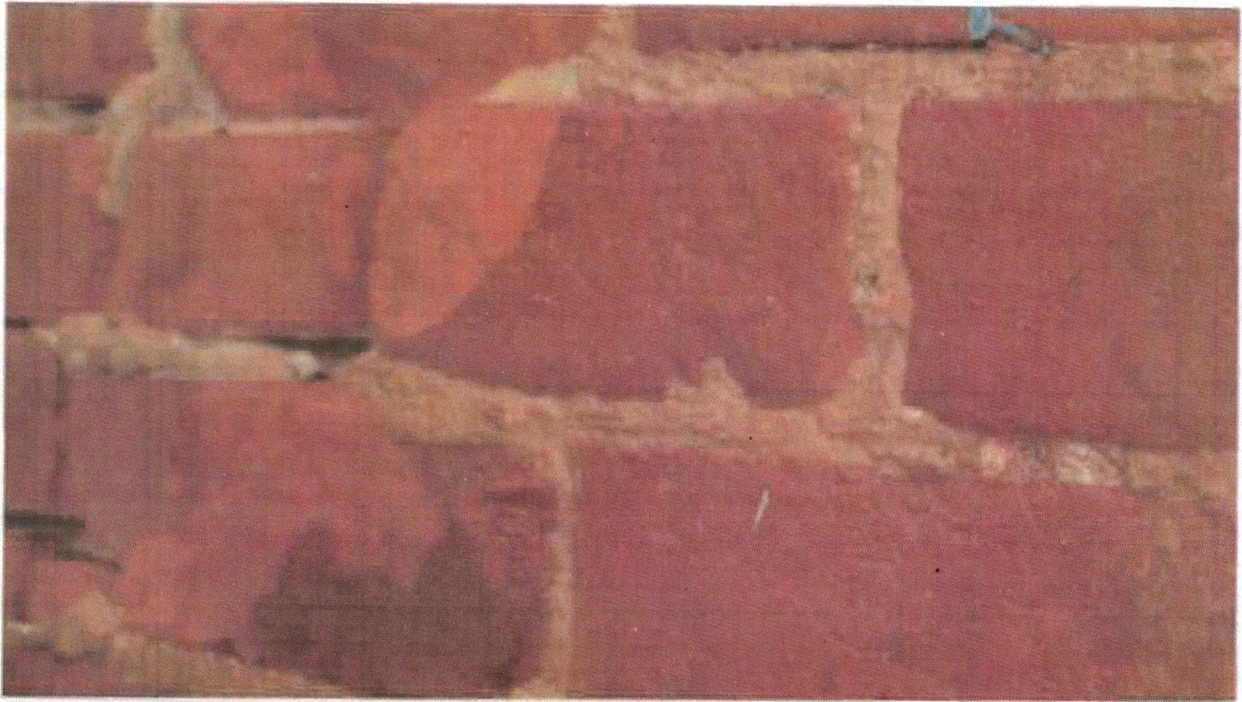
Photo 37 - Loft northeast unit looking east. Example of brick construction - sealant is evident in the darker colored brick. Where sealed the mortar is hard on the exterior of the brick, but soft 1/2" or so within the brick wall.

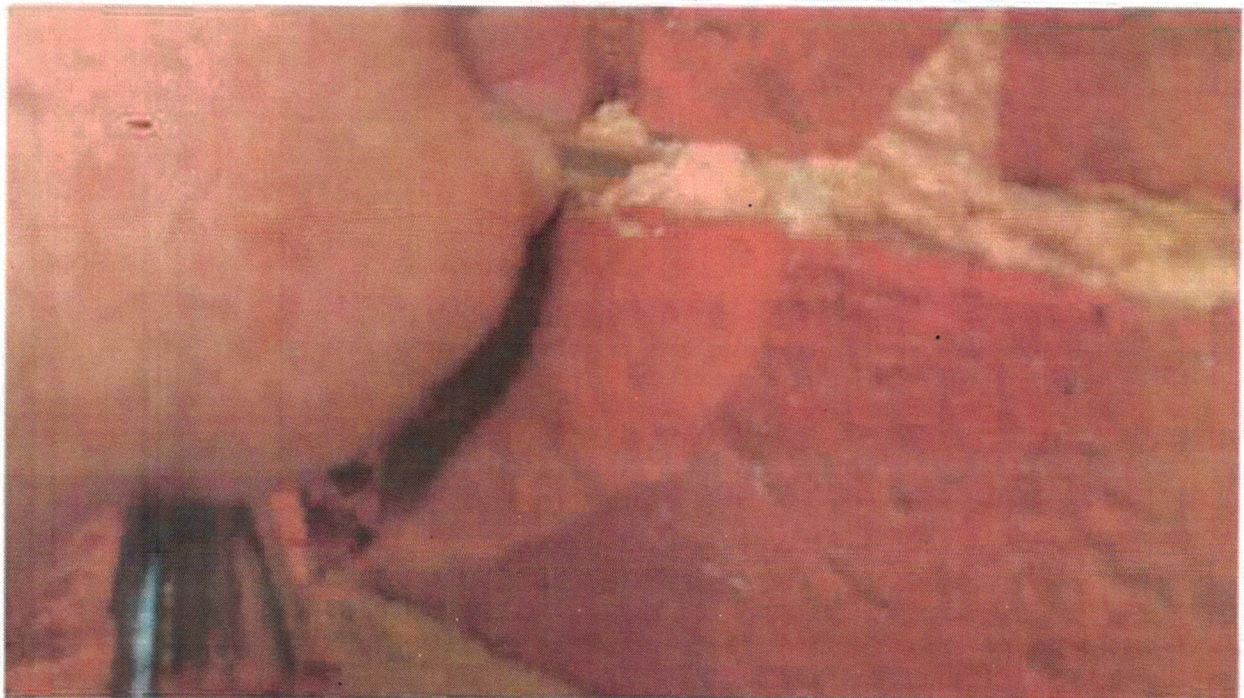
Photo 38 - Loft northeast unit looking east. Example of brick construction - Mortar is soft and can be scraped out with my key.

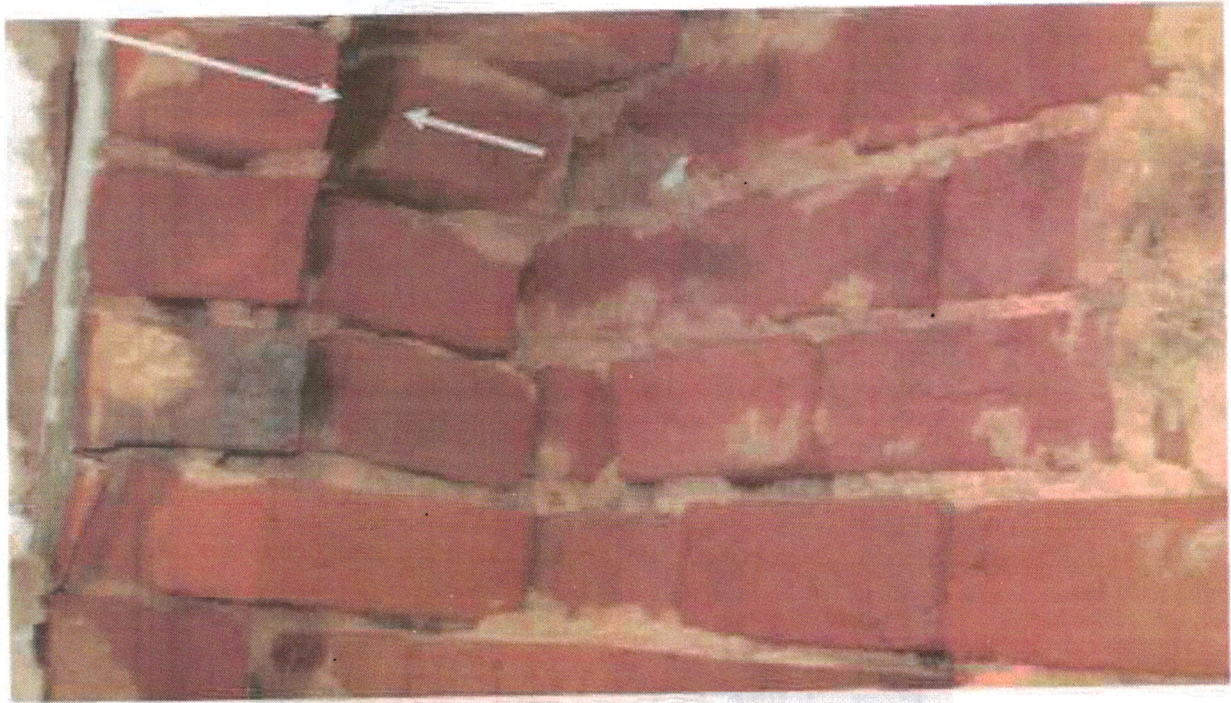
Photo 39 - loft northeast unit looking at same damaged area to brick. Interior face of brick has moved approximately 1" or more from interior wythes. Mortar not bonding - notice the lack of mortar on the face of brick units
