PHASE 1 IMMEDIATE ACTION REPORT

Jordan Lane, PE, SE
Structural Engineer
North Delta Engineering
1914 E. Matthews Ave.
Jonesboro, AR 72401
AR License No.: 12969

City of Jonesboro
300 Church Street
Jonesboro, AR 72401

Building Location: 100 W. Washington Ave., Jonesboro, AR

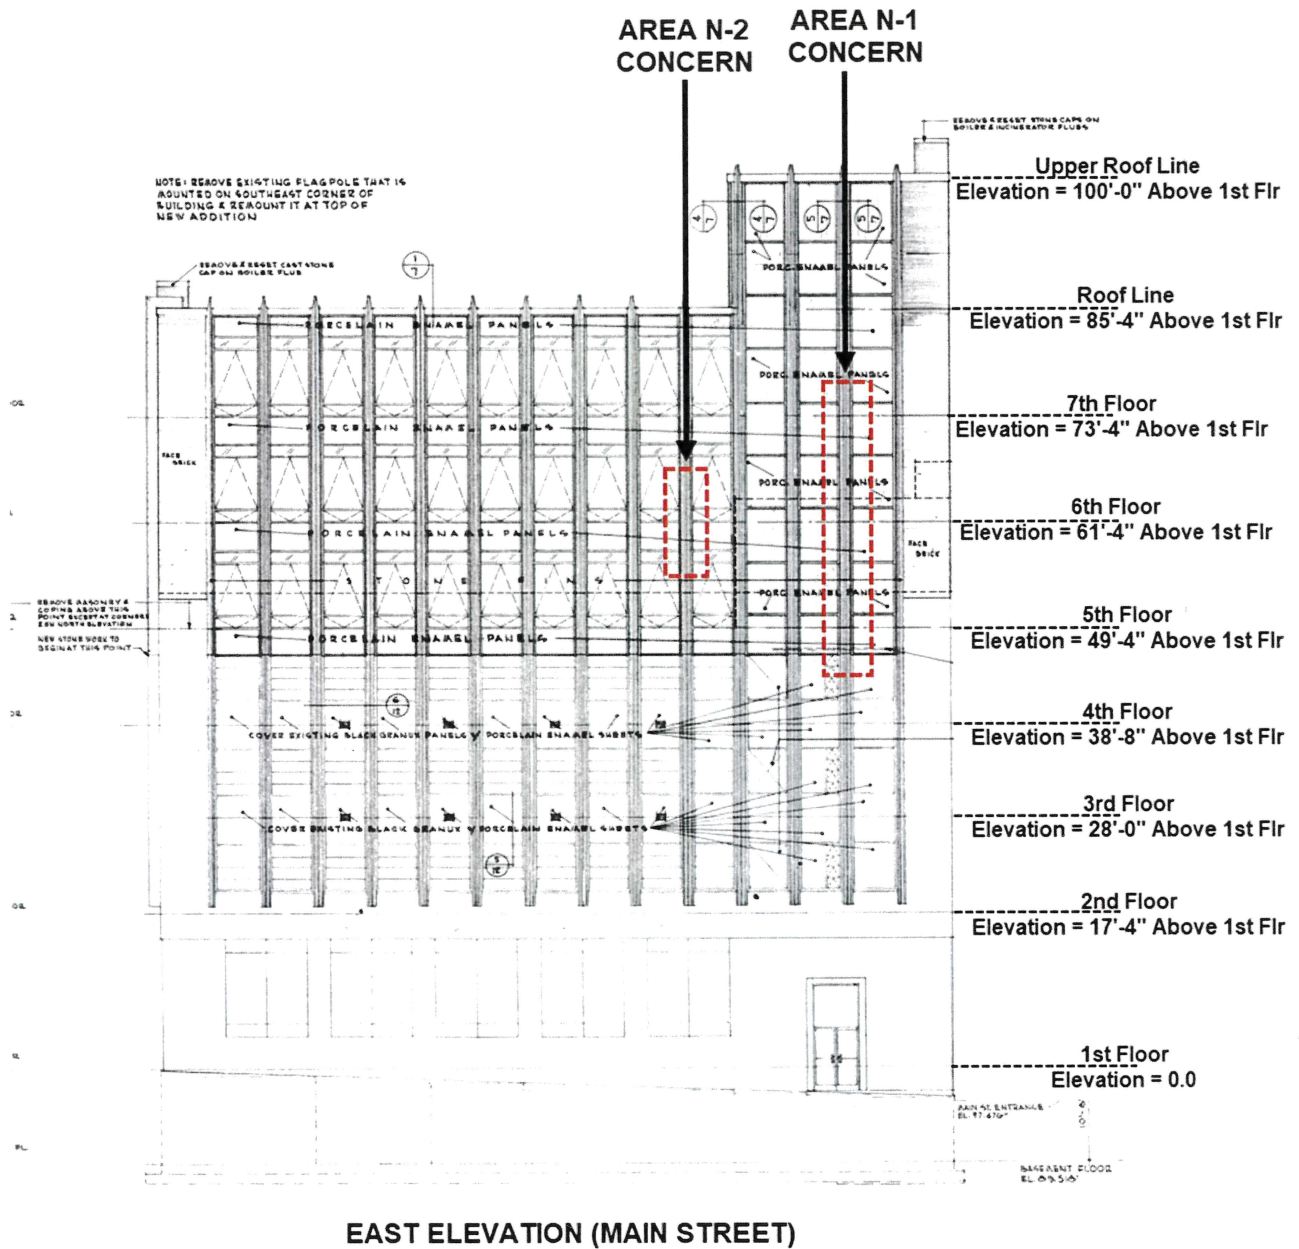
Figure 1: Elevation Showing Wall Areas That Have Lost Substantial Lateral Support

There are two areas where the exterior wall structure appears to have lost lateral support, and the wall structure has moved away from the building and is deflecting out to the east towards Main Street. See figure 1 and figure 2 below and photo 1 showing these areas. The wall structure area furthest north (between the stairwell and elevator structure) has moved the most and is the most concerning at this time. The area of concern for wall area N-1 is located between the 5th and 7th floor of the building between the stair structure and elevator structure. The area of concern for the wall area N-2 is more isolated and occurs above and below the 6th floor level.

Wall area N-1 is deflecting outward (towards the east) several inches and appears to be at risk of collapse. The lateral ties from the steel beams to the vertical precast elements at area N-1 have been compromised and appears to have lost support for at least a twenty foot vertical length near the 6th floor level. Area N-2 is also deflecting outward (towards the east) several inches but does not appear to be as concerning as wall area N-1 at this time.

After the scaffolding and wood protection wall is constructed, it is recommended to add lateral bracing to the vertical precast concrete elements at area N-1 and N-2. This should be done before any other work or demolition begins on the structure. The lateral bracing should be made to area N-1 near the 5th and 6th and 7th floor levels and can be extended into the building and anchored to the concrete floor slab or some other solid structure. The lateral brace can be in the form of steel angles to grab the vertical precast concrete elements and stabilize them and possibly even pull them back into the building slightly. A licensed contractor should be engaged to add the lateral bracing to areas N-1 and N-2 before any façade removal begins.

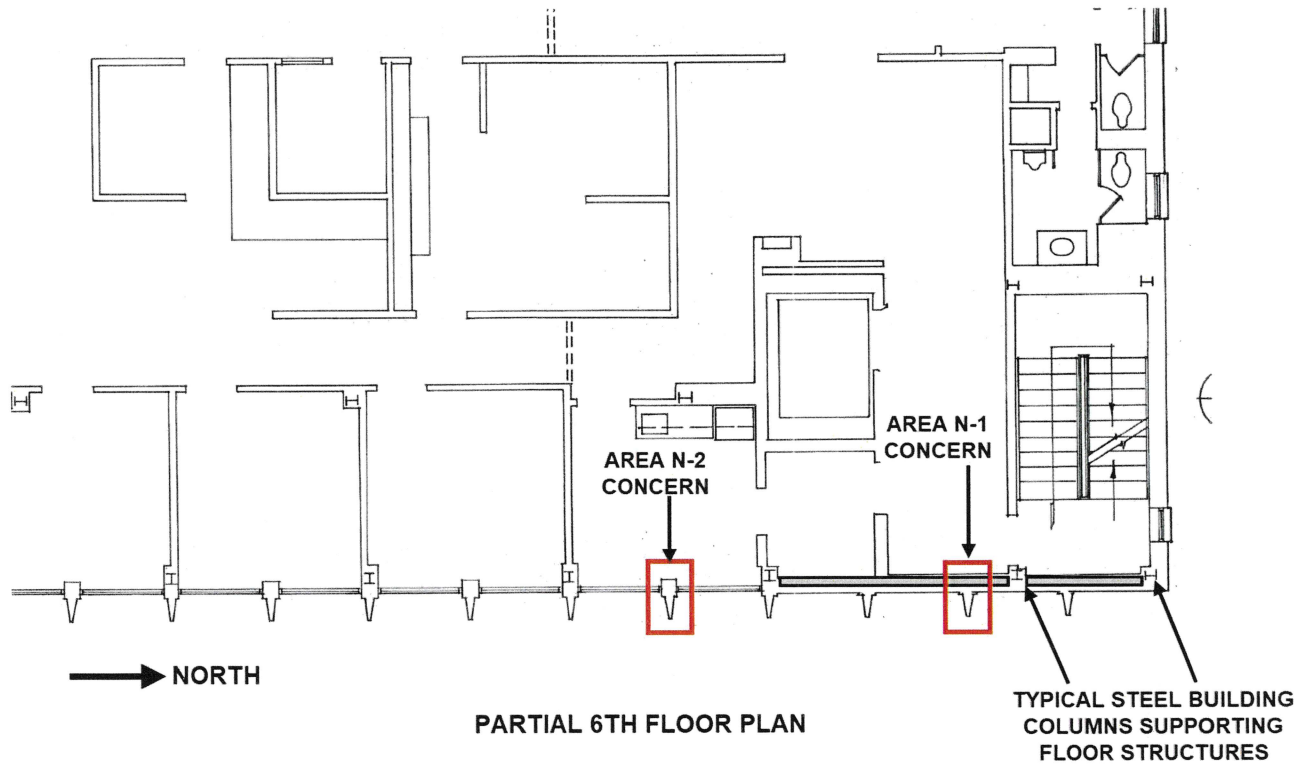
Figure 2: Floor Plan Showing Wall Areas That Have Lost Substantial Lateral Support

AREA N-2 AREA N-1
CONCERN CONCERN

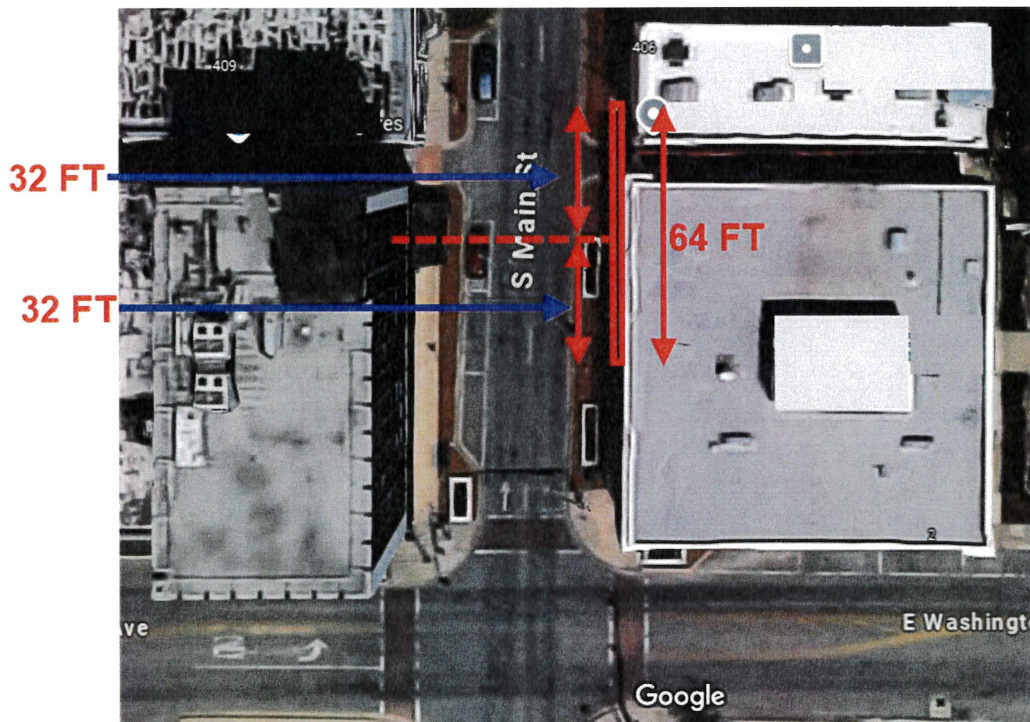
Figure 3: Aerial View Showing Recommended 2x6 Wood Protection Wall Location

Due to the risk of the vertical architectural precast concrete elements collapsing and falling away from the old Citizens Bank building, a protection wall is recommended to be constructed on the west side of the First Horizon building (located at 420 S Main Street) and on the west side of the Mutual of Omaha building (located at 408 S Main Street). The wall is recommended to be approximately 64 feet long and 16 feet tall to potentially protect any falling debris from entering or damaging the occupied these

two buildings. See figure 3 below for the recommended wall layout. The wall can be constructed approximately 32 feet north and 32 feet south of the unstable vertical precast at area N-1.

The wall is recommended to be constructed using steel scaffolding with 2x6 wood studs at 16-inches on center and attached to the scaffolding structure. The 2x6 wood stud wall should have 1 layer of 3/4-inch plywood nailed to each face of the wood studs. A lower diagonal 2x6 wood stud brace at 32-inches on center can be added at the bottom of the wall for additional lateral strength. A typical detail of the scaffolding and wood stud wall can be provided as needed.
