PHASE 1 IMMEDIATE ACTION REPORT

Jordan Lane, PE, SE
Structural Engineer
North Delta Engineering
1914 E. Matthews Ave.
Jonesboro, AR 72401
AR License No.: 12969

City of Jonesboro
300 Church Street
Jonesboro, AR 72401

Building Location: 100 W. Washington Ave., Jonesboro, AR

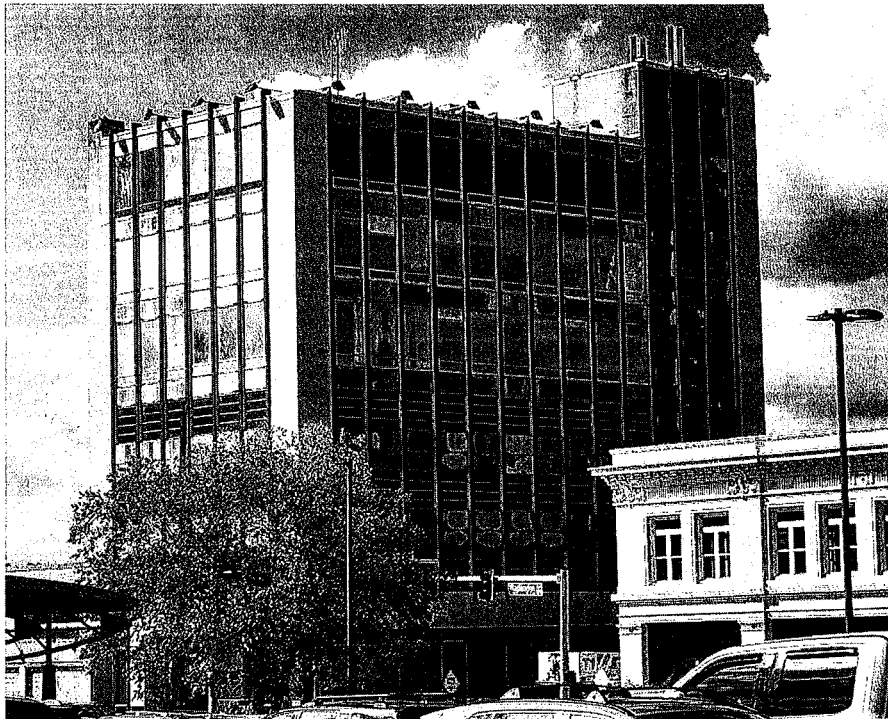
Building Located at 100 W. Washington in Jonesboro, Arkansas
(Previously the Citizens Bank Building)

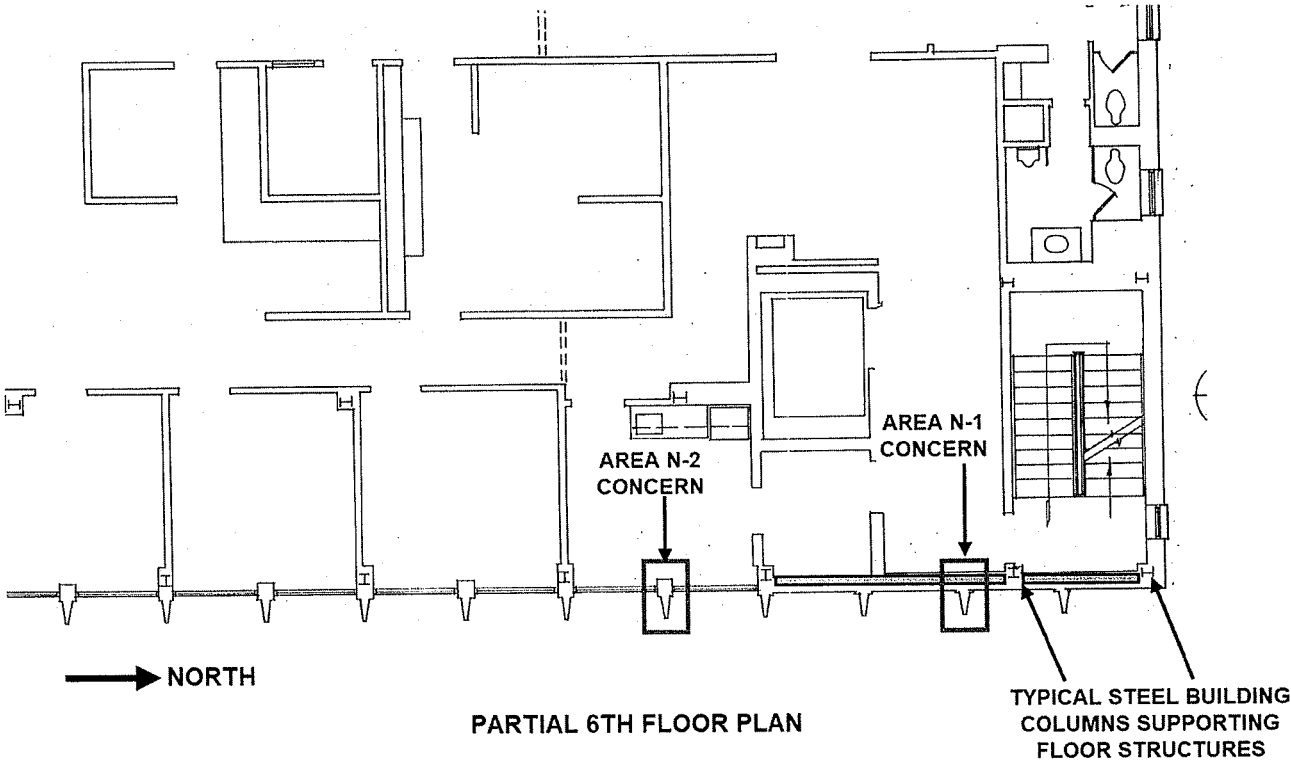
Figure 2: Floor Plan Showing Wall Areas That Have Lost Substantial Lateral Support

There are two areas where the exterior wall structure appears to have lost lateral support, and the wall structure has moved away from the building and is deflecting out to the east towards Main Street. See figure 1 and figure 2 below and photo 1 showing these areas. The wall structure area furthest north (between the stairwell and elevator structure) has moved the most and is the most concerning at this time. The area of concern for wall area N-1 is located between the 5th and 7th floor of the building between the stair structure and elevator structure. The area of concern for the wall area N-2 is more isolated and occurs above and below the 6th floor level.

Wall area N-1 is deflecting outward (towards the east) several inches and appears to be at risk of collapse. The lateral ties from the steel beams to the vertical precast elements at area N-1 have been compromised and appears to have lost support for at least a twenty foot vertical length near the 6th floor level. Area N-2 is also deflecting outward (towards the east) several inches but does not appear to be as concerning as wall area N-1 at this time.

AREA N-2 AREA N-1
CONCERN CONCERN

After the scaffolding and wood protection wall is constructed, it is recommended to add lateral bracing to the vertical precast concrete elements at area N-1 and N-2. This should be done before any other work or demolition begins on the structure. The lateral bracing should be made to area N-1 near the 5th and 6th and 7th floor levels and can be extended into the building and anchored to the concrete floor slab or some other solid structure. The lateral brace can be in the form of steel angles to grab the vertical precast concrete elements and stabilize them and possibly even pull them back into the building slightly. A licensed contractor should be engaged to add the lateral bracing to areas N-1 and N-2 before any façade removal begins.
