ASBESTOS INVESTIGATION REPORT

**Fire Station
316 West Washington Avenue
Jonesboro, Arkansas 72403**

PROJECT # 06-0111-025

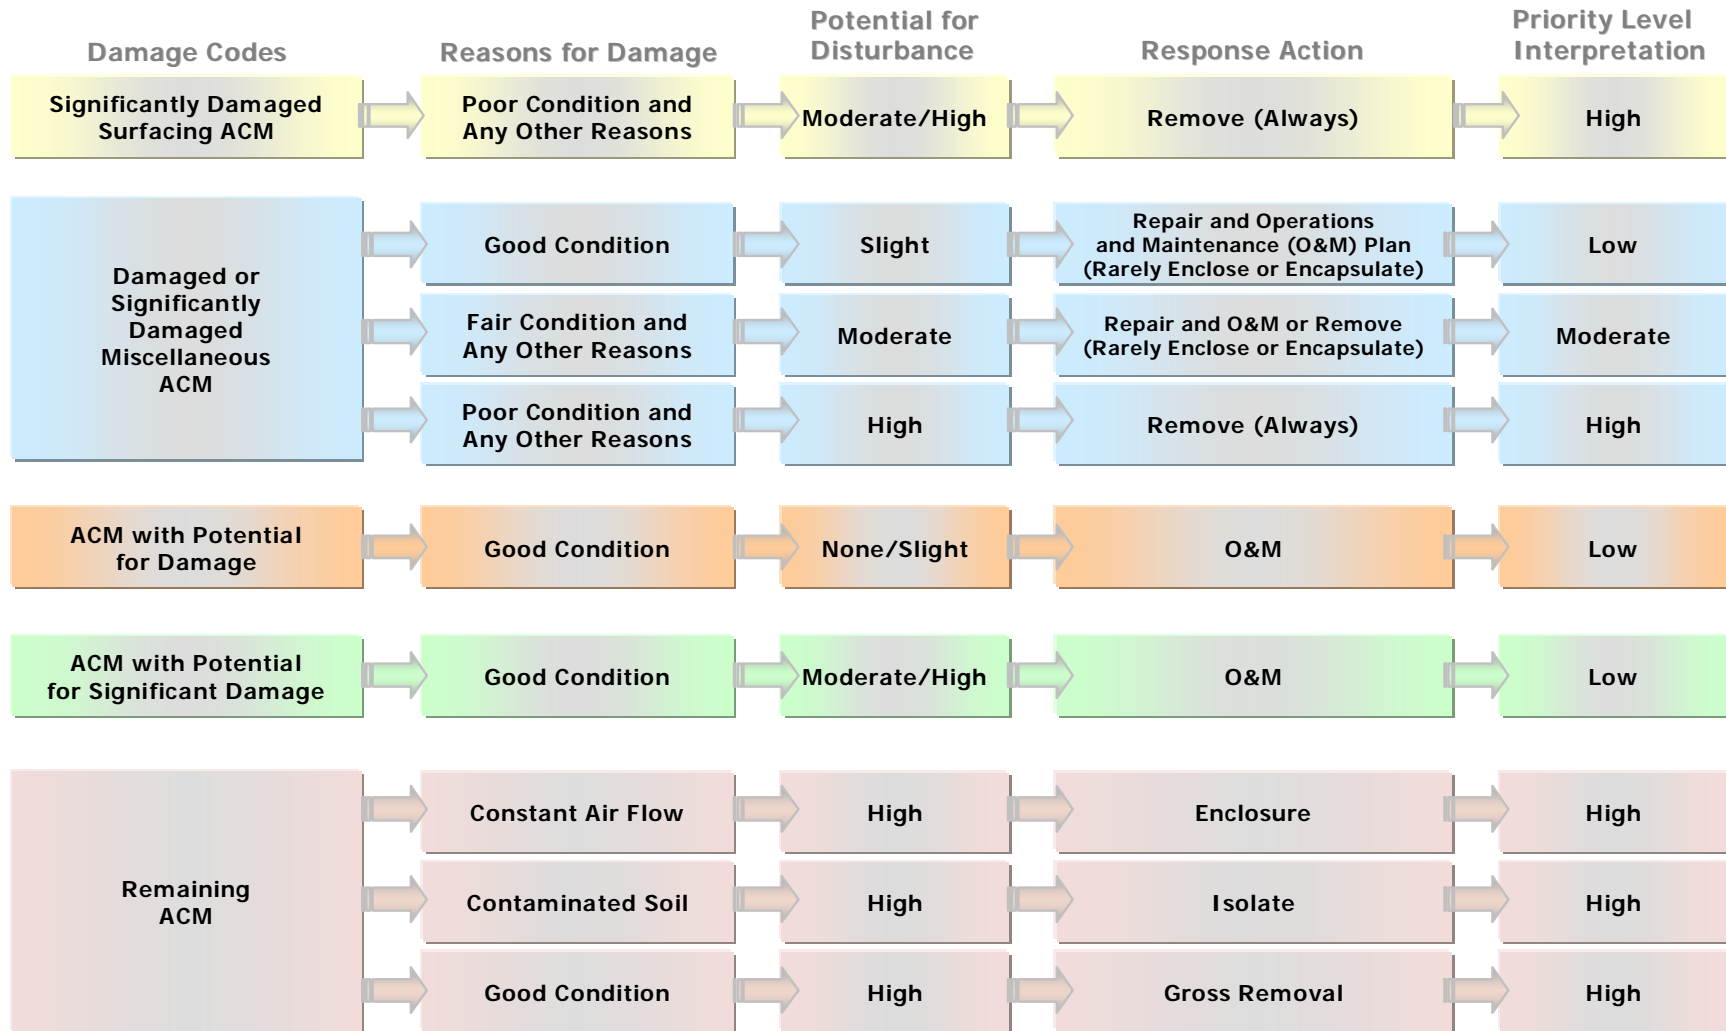
DECISION LOGIC FLOWCHART

for Hazard Assessments

Decision Logic Flow Chart for Hazard Assessments
